R E P O R T
of the
ORE DRESSING AND METALLURGICAL LABORATORIES.

Investigation No. 1483.

Examination of a Broken Bolt from an Autoclave.

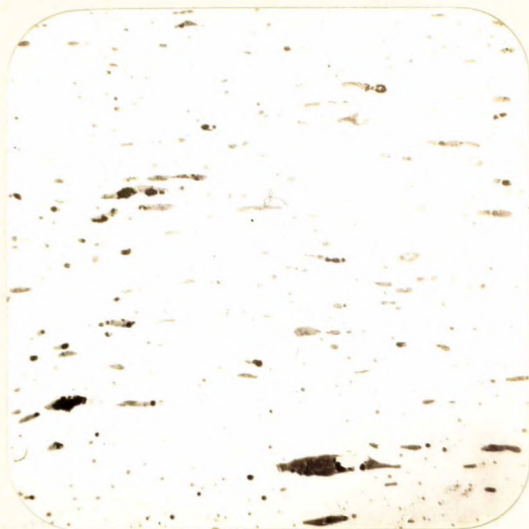
Figure 1.

Bolt structures, as shown in the etched and unetched conditions, are shown respectively in Figures 1 and 2. Both photomicrographs were obtained from the longitudinal sections. The dark particles shown are slag. The background is ferrite (the iron constituent). A large piece of slag was found in the vicinity of the centre crack. Apart from variations in slag particle size, the structure was uniform across the section.

X100, unetched.

Examination shows that the bolt was made from wrought iron of fairly good physical properties. Uniformity of slag size and distribution is none too good and apparently the fissure in the bolt occurred as a result of opening up around a rather large slag particle. The uniformity of structure across the section indicates that the duplex nature of the fracture could not be due to material variations. It seems likely, then, that the centre of this bolt broke some time before the final fracture.

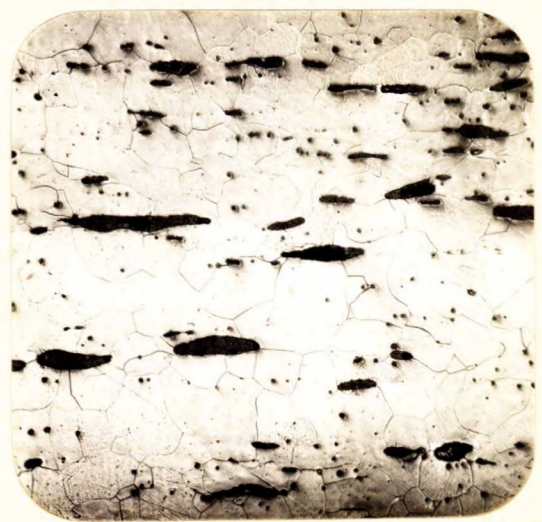
Figure 2.

X100, etched in
2 per cent picral.
