August 30th, 1943.

ORE DRESSING AND METALLURGICAL LABORATORIES.

Investigation No. 1485.

Examination of Snowmobile Bogie Wheel Suspension
Assemblies made by the Bombardier Snowmobiles,
Limited, Valcourt, Quebec.

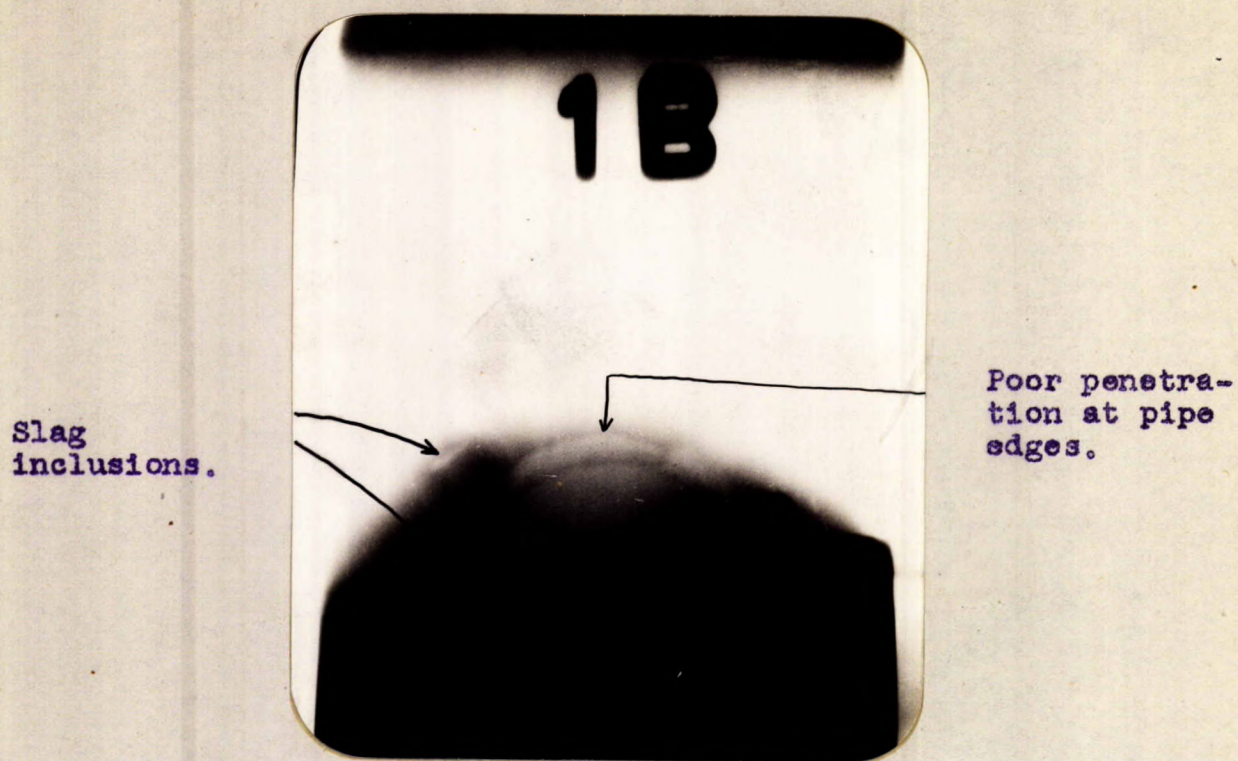
Figure 1.

PRINT OF AN EXOGRAPH OF ASSEMBLY NO. 1.
WELD JOINING SHAFT RING TO PIPE FRAME.

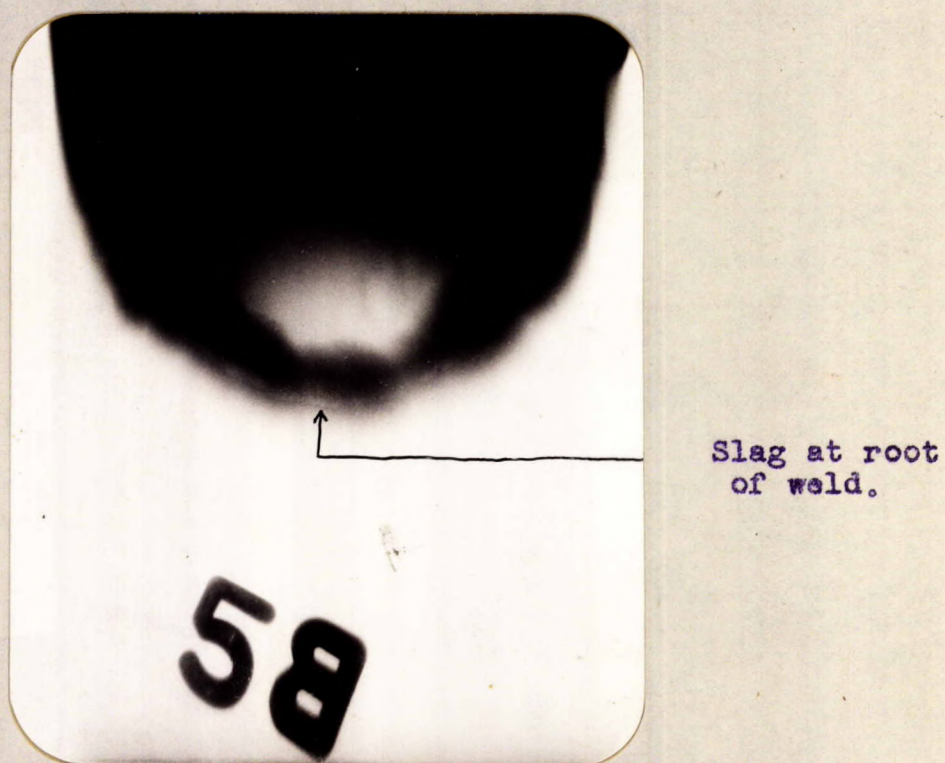
Figure 2.

PRINT OF AN EXOGRAPH OF ASSEMBLY NO. 5.
WELD JOINING SHAFT RING TO PIPE FRAME.

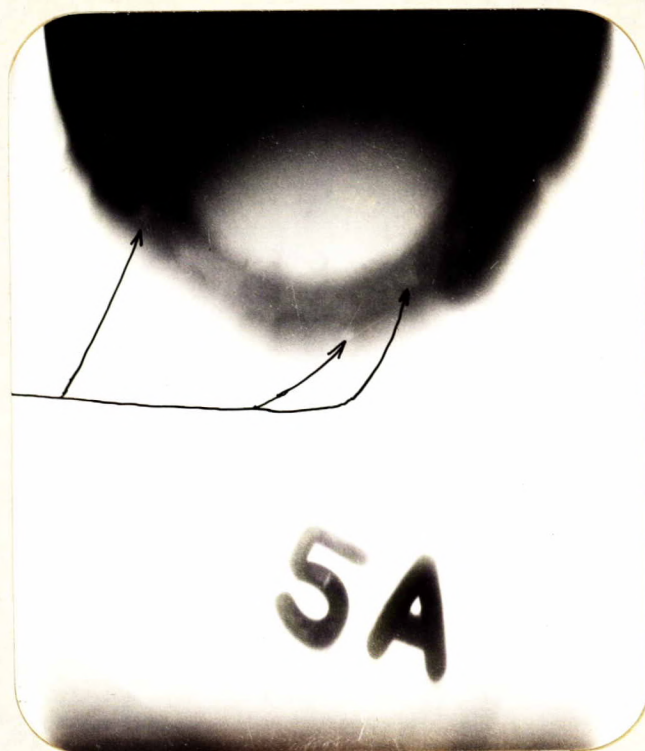
Figure 3.

- (1) Lack of penetration - partly due to electrode characteristics and partly to too low welding current.
- (2) Slag inclusions - partly due to electrode characteristics and partly to too low welding currents.
- (3) Undercutting - due to either or both of too high currents or too long an arc.
- (4) Incomplete fusion - due to welding steel surfaces not being thoroughly cleaned of scale and slag.
- (5) High piled-up welds - due to effort to mask welding defects or to erroneous belief that the weld strength is thereby increased.
- (6) Poor fit-up - due to improper or inaccurate measurements of parts to be fitted together.

Slag
inclusions.

PRINT OF AN EXOGRAPH OF ASSEMBLY NO. 5.
WELD JOINING SHAFT RING TO PIPE FRAME.

Of all these defects the first three were by far the most prevalent. Fortunately their cause is very easy to eliminate. In all cases the welding currents specified by the electrode manufacturer should be used and arc length kept to a minimum. These simple precautions should eliminate the most serious of the above defects. In the event that trouble is still encountered, a change to a Stelco No. 804 electrode (A.W.S.E 6030) would be beneficial.

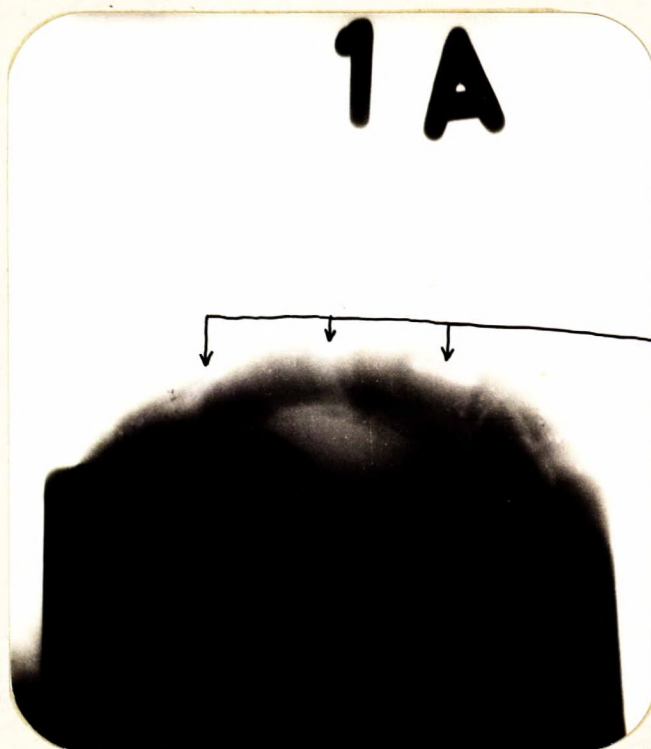
Figure 4.

Slag
inclusions.

PRINT OF AN EXOGRAPH OF ASSEMBLY NO. 1.
WELD JOINING SHAFT RING TO PIPE FRAME.

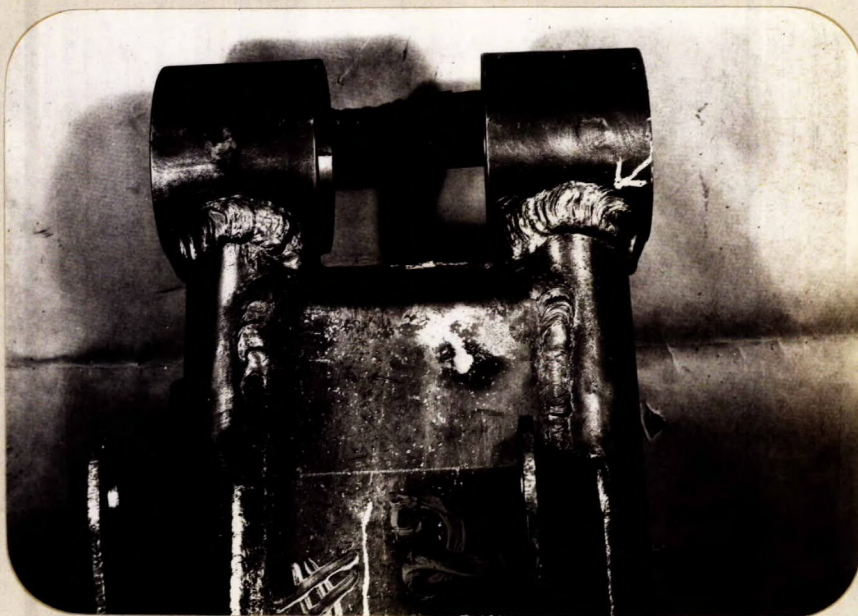
Figure 6.

shaft rings of Assembly No. 2 showing the fillet weld joining the pipe frame and the shaft rings. Note the width and irregularity of the weld and also undercutting as indicated by the arrow. Figure 7 is a close-up photograph of the opposite side of Assembly No. 2. Note the excessive width of the weld. Figures 8 and 9 show the split strap and complete strap methods, respectively, of attaching the shaft ring to the pipe frame. Figure 10 is a photograph of a fillet weld joining a strap to a shaft ring. Note the severe undercutting typical of all of these welds.

ASSEMBLY NO. 2. FILLET WELD JOINING
SHAFT RING TO PIPE FRAME.

Note width and irregularity of weld,
and also undercutting, indicated by arrow.

3. Welding electrodes should be used within the welding current ranges specified by the manufacturer.

4. Arc length should be kept to a minimum at all times.

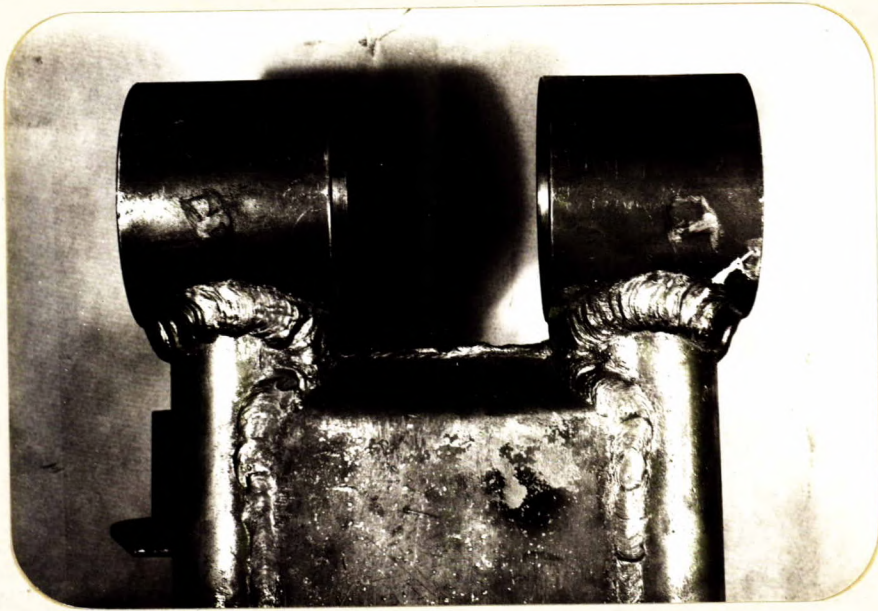
Figure 7.

ASSEMBLY NO. 2. - WELD JOINING SHAFT RING TO PIPE FRAME.

Note excessive width of weld.

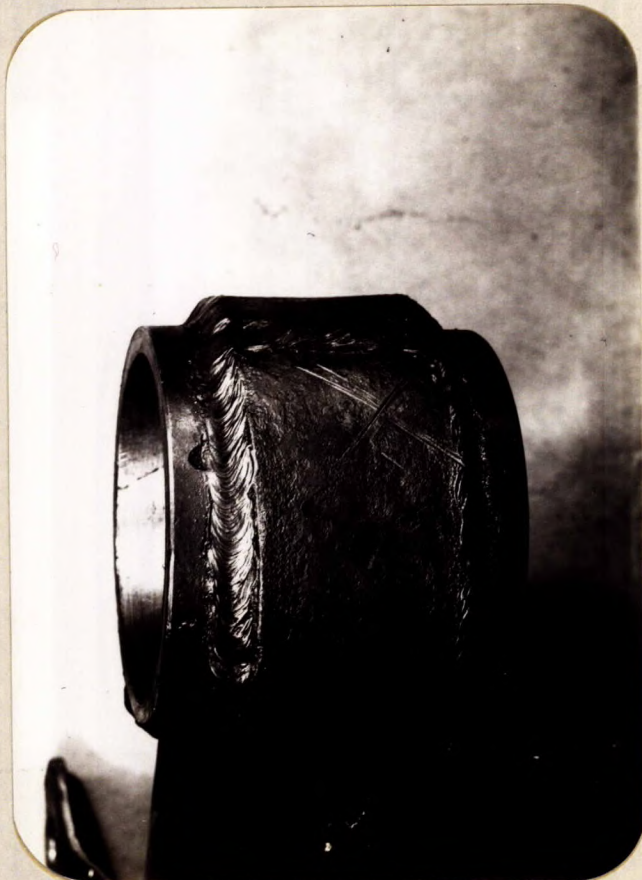
Figure 10.

FILLET WELD JOINING A STRAP TO A SHAFT RING.

Note severe undercutting, typical
of all of these welds.

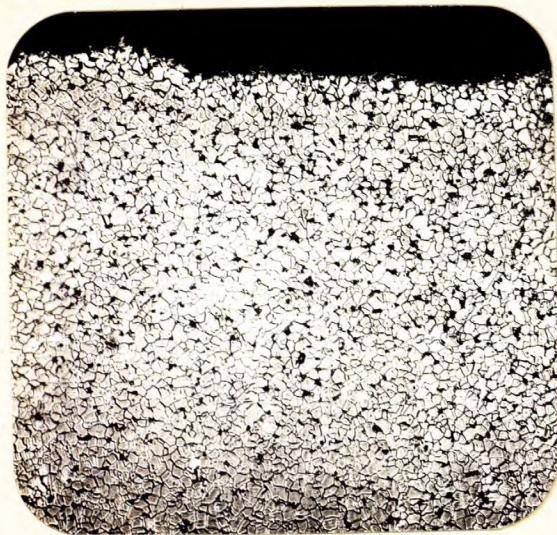
Figure 11.

(4). The broken shaft ring was sectioned and examined under the microscope. Figures 11 and 12 are structures adjacent to, and $\frac{1}{2}$ inch from, the fracture respectively. Hardness readings were taken in the same areas, using a Vickers machine and a 10-kilogram load. In both areas the hardness was 151 Vickers pyramid hardness.

Visual and microscopic examinations, together with hardness tests, fail to reveal any metallurgical reason for failure of the broken shaft ring. It was noted that the thickness of this broken ring was 3/16 inch whereas the same part in the test assemblies was 3/8 inch in thickness, indicating that the broken part was too thin to stand the stresses of service and that this had been recognized and corrected in the test assemblies. In the absence of any conclusive proof as to cause of failure, it is only possible to offer for consideration the possibility of overstressing in test.

X100, etched in 2 per cent nital.
STRUCTURE ADJACENT TO FRACTURE.

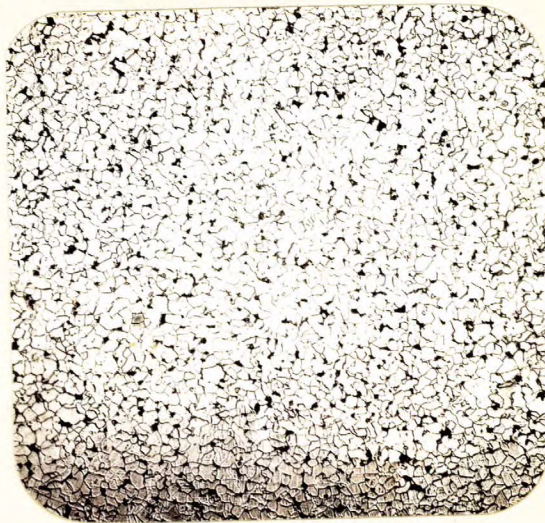
Figure 12.

X100, etched in 2 per cent nital.
STRUCTURE $\frac{1}{2}$ INCH FROM FRACTURE.

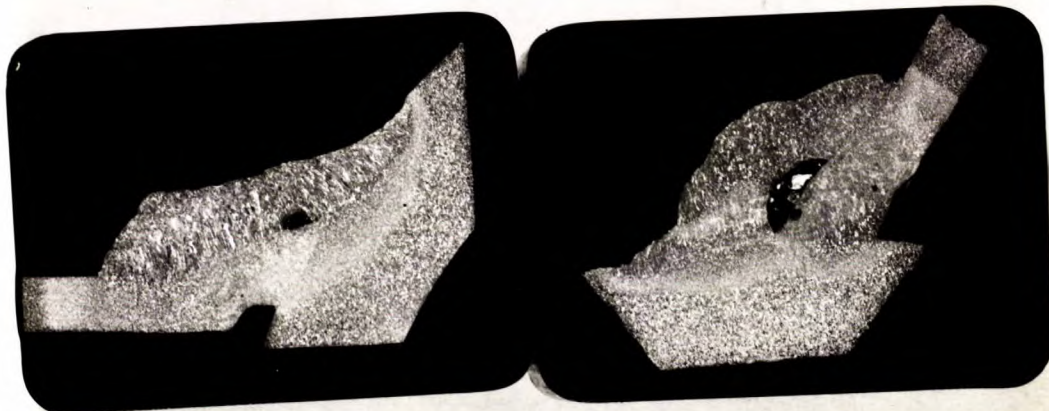
Figure 13.

(5). Assembly No. 2 was sectioned through the welds joining the shaft ring to the pipe frame in areas in which defects were shown in the X-ray examination. Figure 13 shows two typical sections (numbered 9 and 10). The remainder of the assembly was sectioned at random to secure typical samples of all welded joints in the assembly. Figures 14 and 15 show these samples (numbered 1 to 8).

ASSEMBLY NO. 2, - SECTIONS THROUGH WELD JOINING
SHAFT RING TO PIPE FRAME.

Note slag inclusions at root of weld.

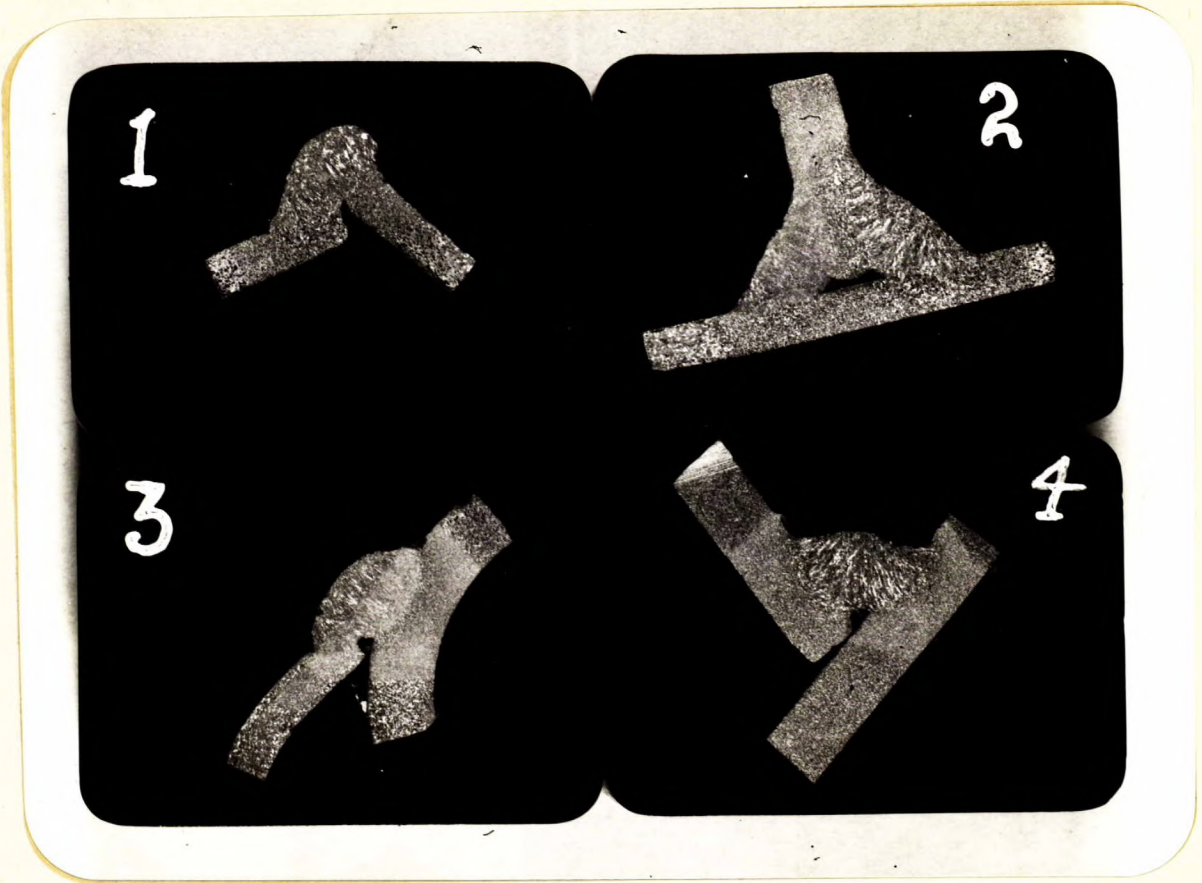
Figure 14.

ASSEMBLY NO. 2 - SECTIONS OF VARIOUS WELDED JOINTS.

Note poor penetration, slag inclusions, undercutting, and high, piled-up welds.

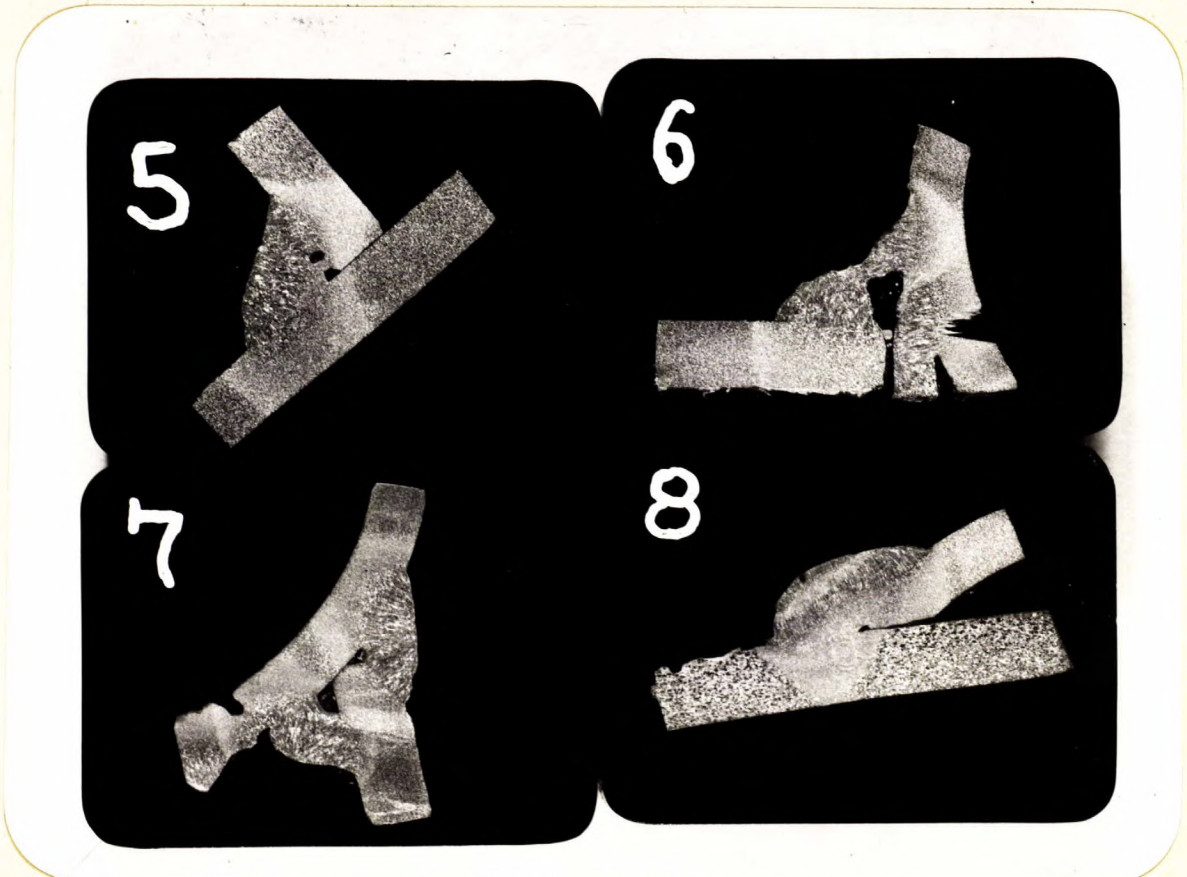
Figure 15.

ASSEMBLY NO. 2. - SECTIONS OF VARIOUS WELDED JOINTS.

Note poor penetration, slag inclusions, undercutting, and high, piled-up welds.
