ORE DRESSING AND METALLURGICAL LABORATORIES.

Investigation No. 1487.

Examination of Cheetah Engine Master Rod Bearing.

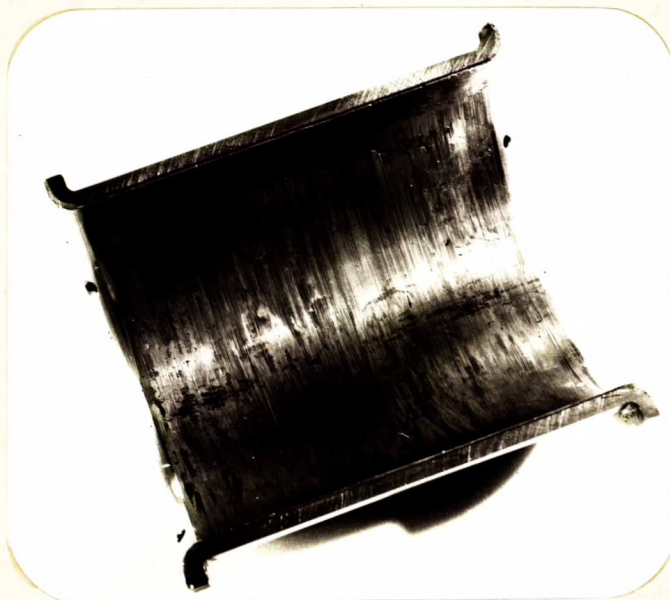
Figure 1.

HALF BEARING AS RECEIVED.
(Approximately 2/3 size).

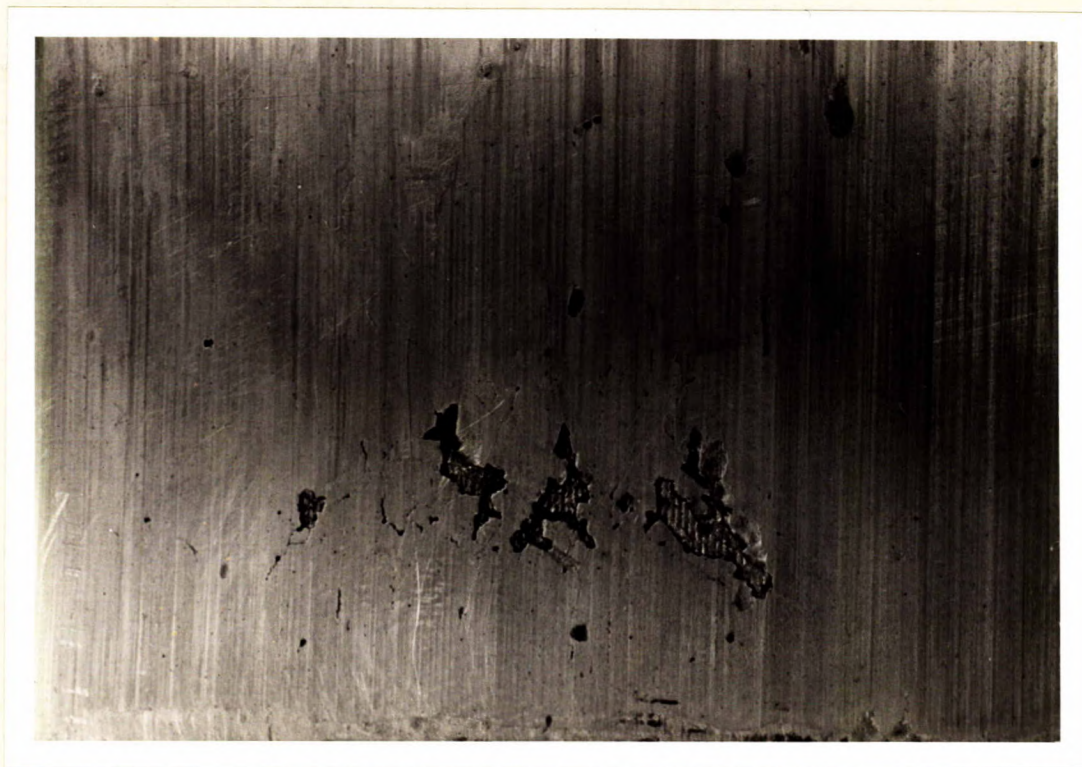
Figure 2.

CLOSE-UP OF ONE OF DEFECTIVE AREAS.
(Approximately X4).

A network of cracks was noted in regions which had become defective.

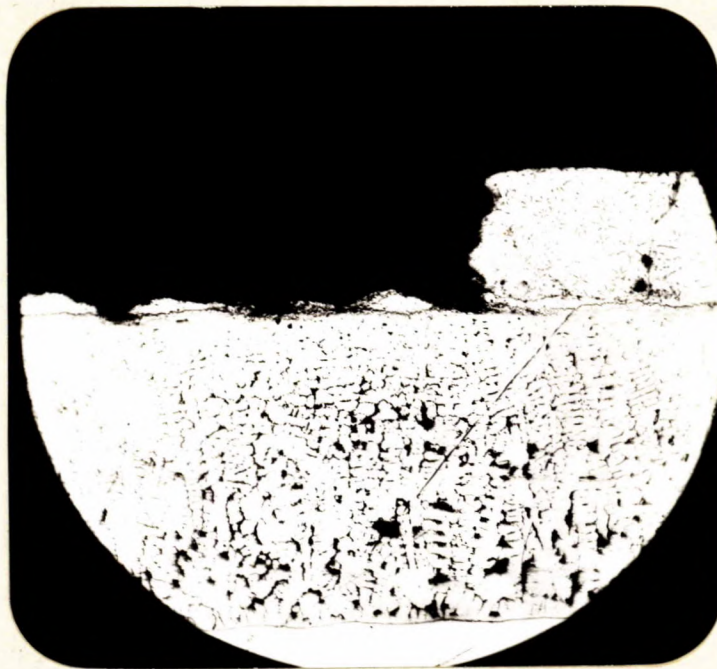
Figure 3.

A section cut through one of the regions which had become defective was mounted in bakelite and polished. In areas where the tin-base alloy had separated from what appeared to be a copper-lead alloy back, there was still some whitemetal adhering (see Figure 3).

X75, unetched.

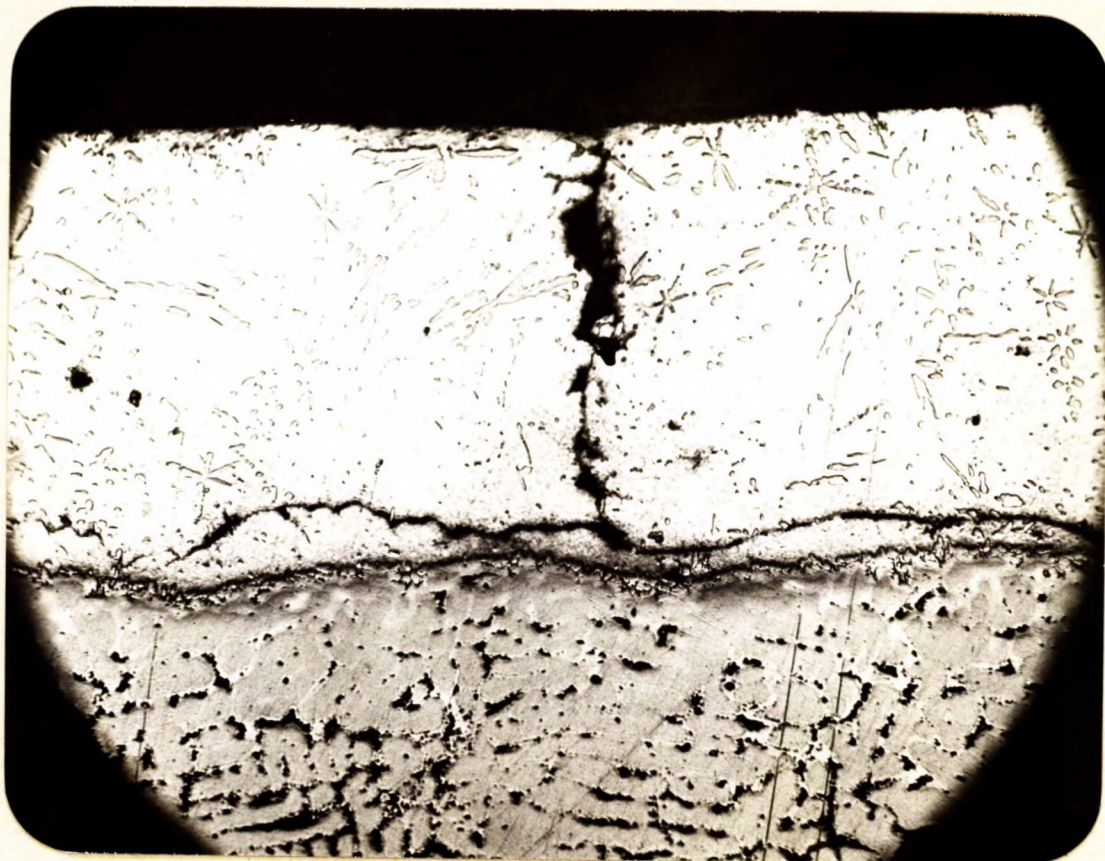
Figure 4.

Several cracks were found to be developing in the tin-base bearing alloy. These cracks apparently began at the outer surface and developed inward until the bond was approached but not reached and then either turned at right angles or met circumferential cracks near the bond. The former of these conditions probably applies, because no circumferential cracks were found without the accompanying radial cracks. However, radial cracks which had just begun to develop were found unaccompanied. Figure 4 illustrates a typical crack at 250 diameters.

The comparatively hard particles seem to be well distributed (see Figure 4) in the matrix of this whitemetal lining. Some porosity is present, as would be expected, but it does not appear to be excessive or connected with the failure.

X250, unetched.

Macro- and micro-examinations definitely indicate that this bearing failure was brought about by fatigue cracking of the tin-base bearing alloy. The cracks evidently developed radially inward from the outer surface of the bearing metal and turned at right angles when the bond was neared but not reached. These cracks developed until another similar one was reached and the section, thus undermined, fell out.

its fatigue strength or fatigue resistance must be increased. This might be accomplished by reducing, if possible, the thickness of the bearing materials or by adopting a bearing metal with a higher fatigue limit.

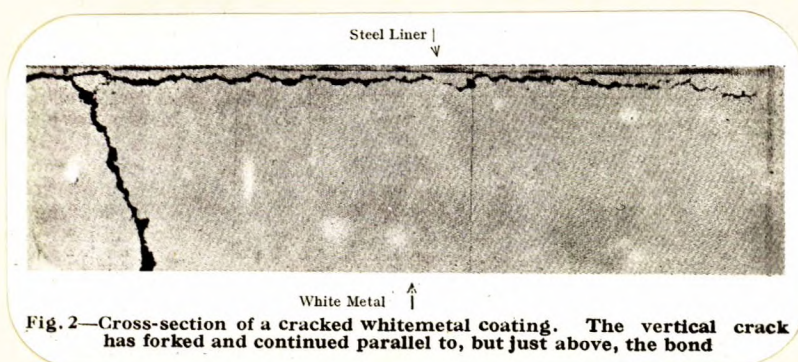
Figure 5.

"These features of the defect have resulted in a general acceptance of the view that the failure by cracking is not primarily due to brittleness of the bond but to fatigue cracking of the whitemetal itself."

Note similarity of crack to that shown in Figure 4.
