September 2nd, 1943.

Investigation No. 1488.

Examination of Defective Brass Fuze Bodies.

CANADA
DEPARTMENT
OF
MINES AND RESOURCES
Mines and Geology Branch

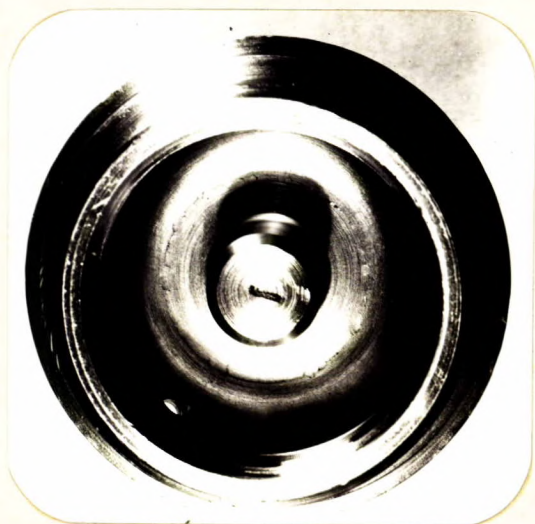
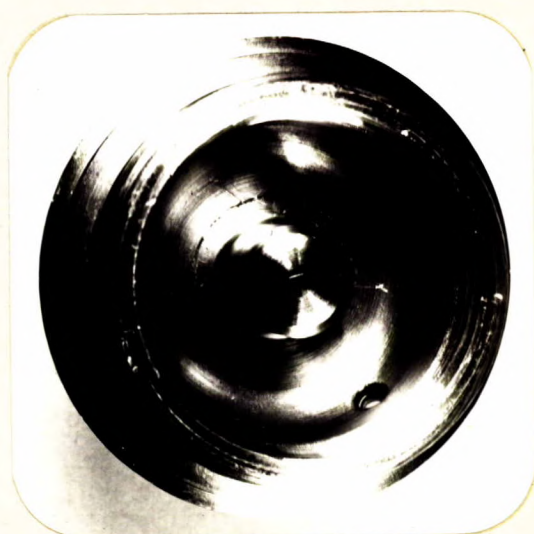
Figures 1 and 2 show two of the submitted fuze bodies, revealing the circumferential cracks in the fuze body cavity.

SAMPLES AS RECEIVED.

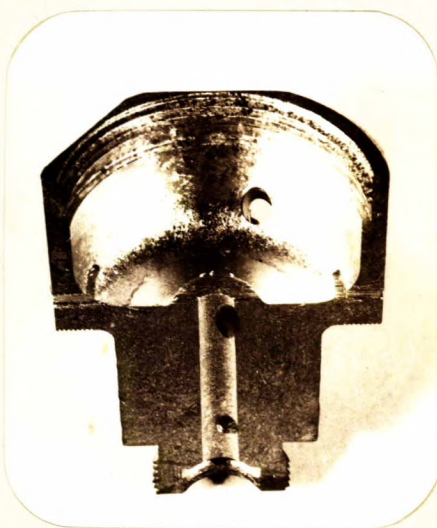
Figure 3.

Figure 3 shows the crack on a section of one of the fuze bodies after deep-etching and cutting off the elongated boss which extended into the fuze body cavity.

APPEARANCE OF THE CRACK AFTER DEEP-ETCHING.

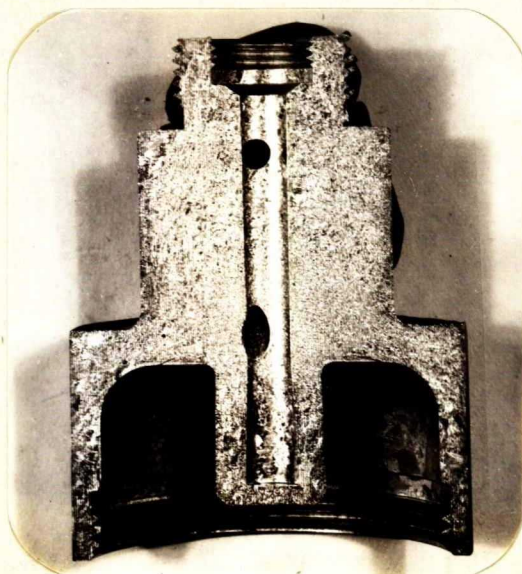
Figure 4.

Figure 4 shows the longitudinal section of the machined fuze body, revealing the character and direction of the crack.

LONGITUDINAL SECTION OF MACHINED FUZE BODY.

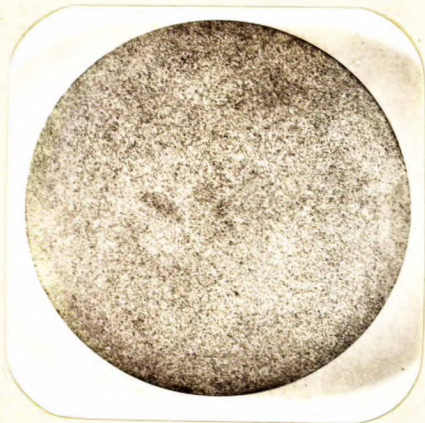
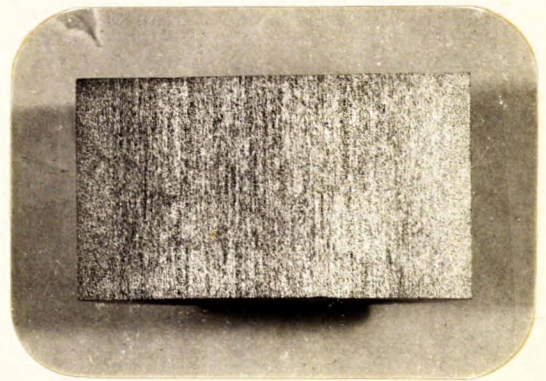
Figures 5 and 6 show respectively the cross-section

and the longitudinal section through the axis of the extruded brass rod. No metallurgical defects (segregation, inclusions, cracks, etc.) were observed, other than the directionality of the grains, normal in extruded products.

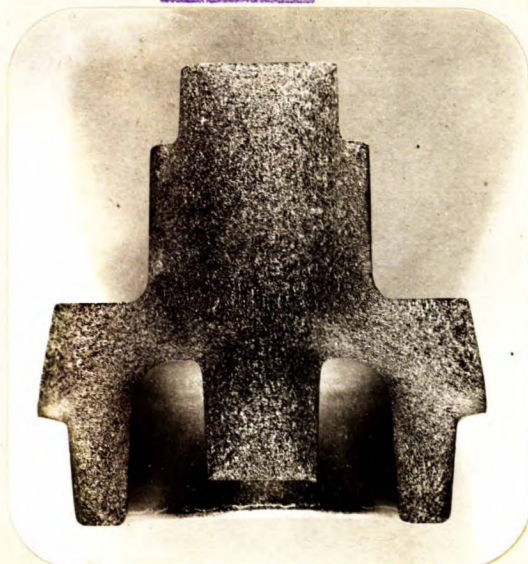
Figure 7.

Figure 7 shows the macrostructure of the longitudinal section of the brass forging. Differences in grain size and flow lines are due to the forging operation.

MACROSTRUCTURE OF BRASS FORGING.
(Approximately 7/8 size).

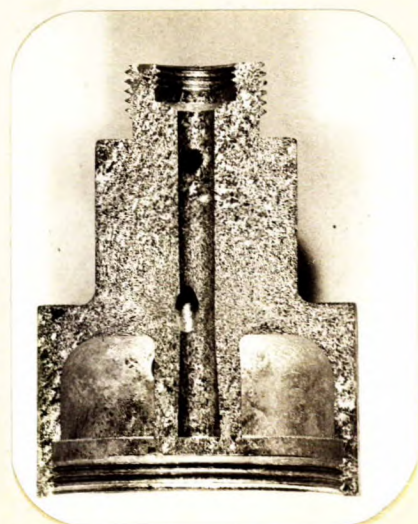
Figure 8.

Figure 8 shows the macrostructure of the longitudinal section of a finished, machined fuze body.

MACROSTRUCTURE OF FUZE BODY.
(Approximately 7/8 size).

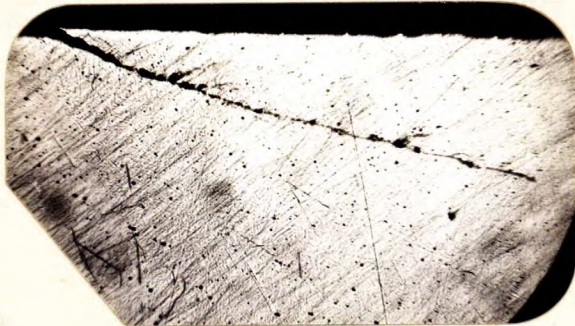
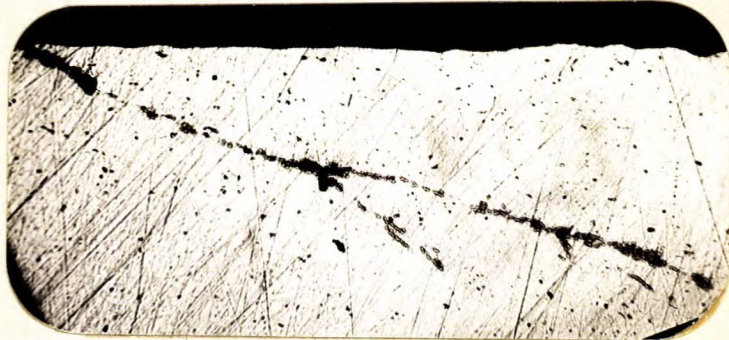
Figures 9 and 10 show the crack on a longitudinal section of the fuze body (see Figures 4 and 8).

The character of the cracks and the apparent inclusions of oxides, visible on the whole length of the cracks, indicate that this failure was encountered in the forging operation, probably as a result of improper forging conditions. The crack seems to be a form of "fire-cracking" and could be caused by faulty heat distribution or by internal stresses at the juncture of the two different directions of flow in the forging. Leaded alpha-beta brasses are especially susceptible to fire-cracking. The lead addition, of course, materially improves machinability.

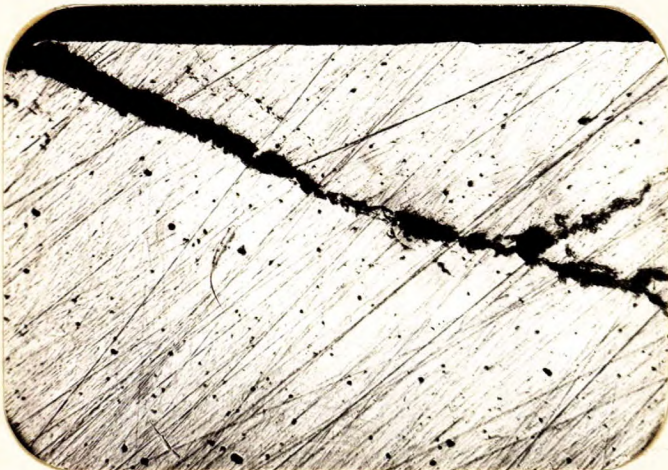
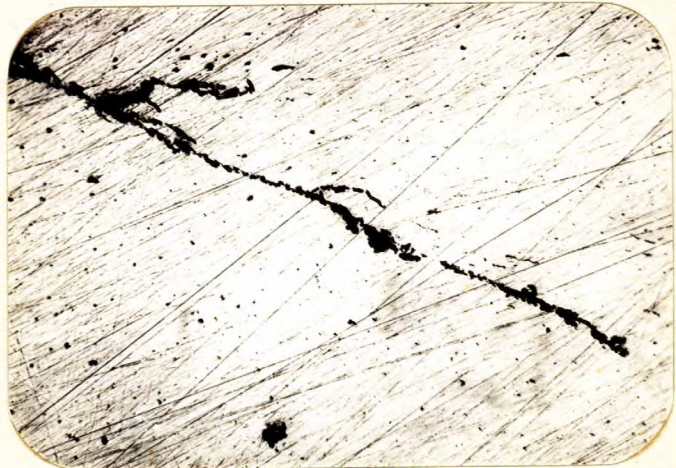
Figure 11 and 12 show a larger magnification of the crack in Figure 9, revealing its character and its inclusions of oxides.

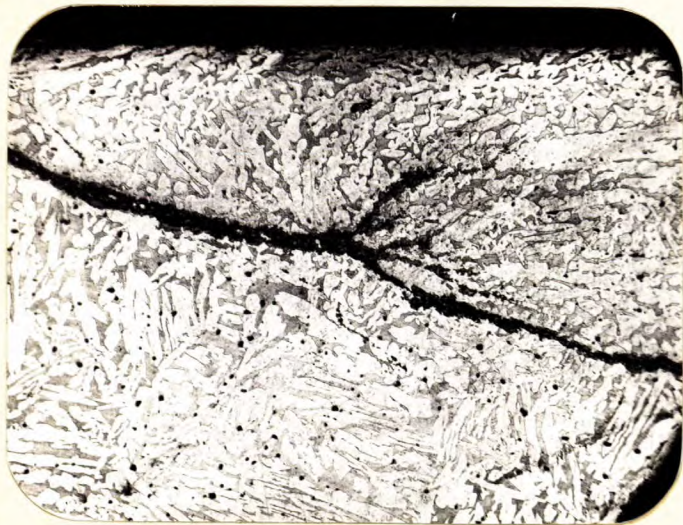
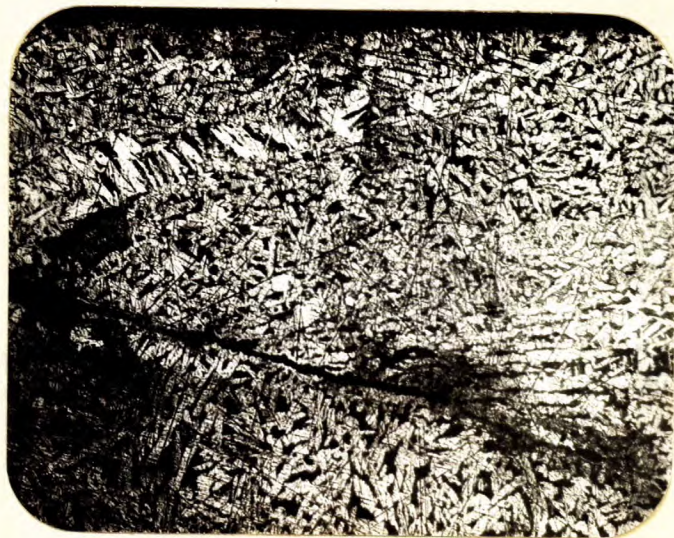
Figures 13 and 14 show the microstructure of the material around the crack shown in Figures 9, 11, and 12.

MICROSTRUCTURE AROUND THE CRACK.
