ORE DRESSING AND METALLURGICAL LABORATORIES.

Investigation No. 1490.

Examination of Two Broken Universal Carrier Track Links.

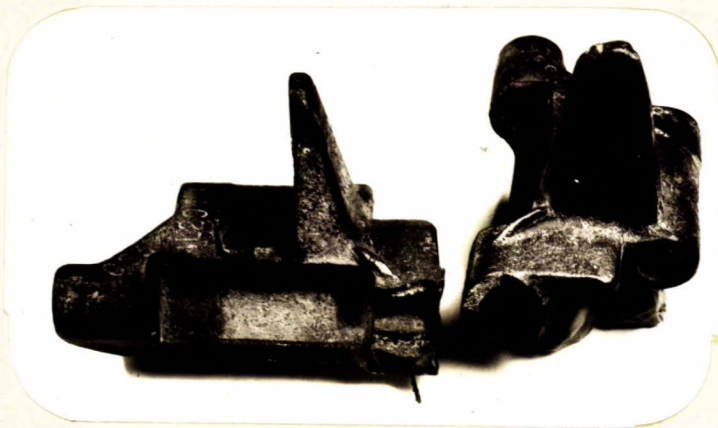
Figure 1.

Both links failed across the eye-hole and barrel on the three-eye side. Figure 1 shows the nature of this fracture. Observe the shrink at the fracture of Link No. 1. Figure 2 illustrates a section cut through the shrinkage area.

NATURE OF FRACTURE.
(Arrow indicates shrink).

Undoubtedly the shrink in the eye-hole of Link No. 1 was at least a contributory cause of failure.

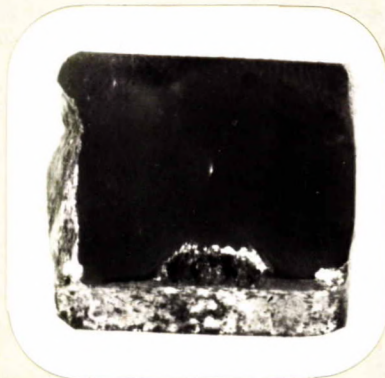
Figure 2.

SHRINKAGE AREA.
(Twice actual size).

1. A contributory cause of failure of one of the links was the presence of a shrinkage area in the eye-hole.
2. The other broken link did not have the properties required in the austempered product. Also, excess decarburization in the eye-hole area further decreased the strength.

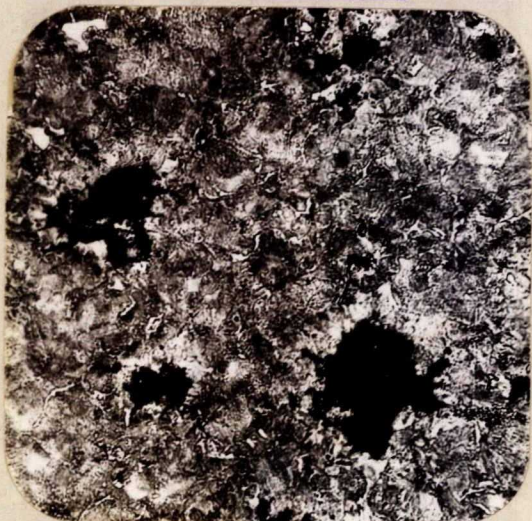
Figure 3.

The structure of the remainder of the eye-hole consisted, in the case of Link No. 1, of temper carbon and pearlite (in which were dispersed small particles of ferrite and cementite) and, in the case of Link No. 2, of temper carbon in a background of approximately equal parts of ferrite and pearlite. These structures are shown respectively in Figures 3 and 4.

The presence of cementite areas in Link No. 1, although not considered a serious defect, indicates that the link cooled too rapidly in the annealing operation.

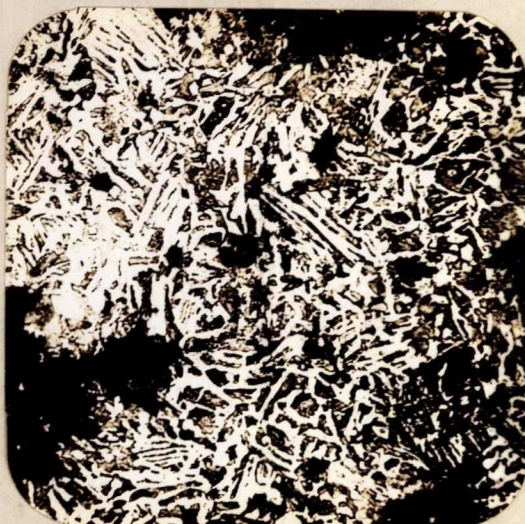
Figure 4.

The microscopic examination shows that the low hardness value of Link No. 2's eye-hole metal is not due to faulty austempering treatment but rather to excess decarburization. Apart from the effect of the ferrite areas on the hardness, the lower carbon material is subject to the additional disadvantage that it is very difficult to austemper.
