September 11th, 1943.

ORE DRESSING AND METALLURGICAL LABORATORIES.

Investigation No. 1493.

Examination of Two Cheetah Engine Cylinder Heads,
Cracked in Service.

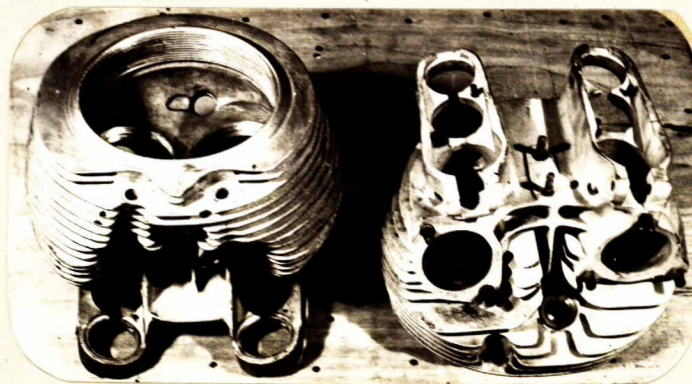
Figure 1.

CASTINGS AS RECEIVED.
(Approximately 1/5 size).

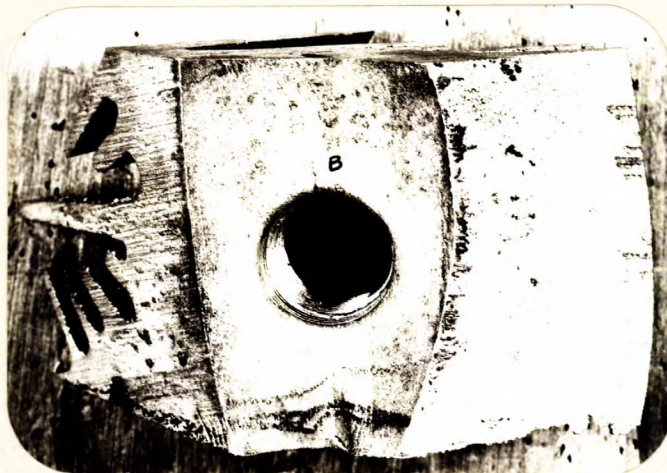
Figure 2.

CRACK AT SPARK PLUG HOLE (Point B).
(Approximately 7/8 size).

The cracks around the spark plug hole in Cylinder Head No. 1 had just begun to develop and their nature was not visually ascertainable.

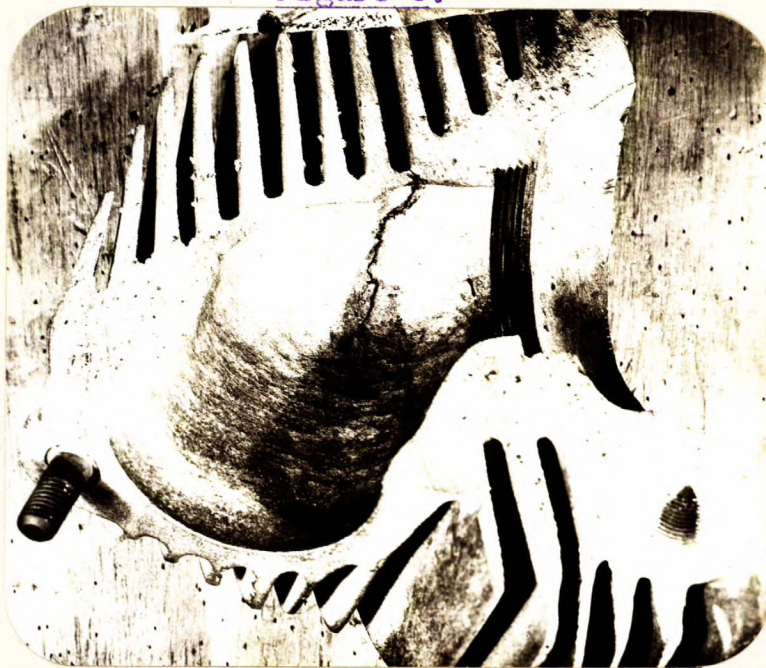
Figure 3.

CRACKS IN EXHAUST PORT.
(Approximately 2/3 size).

On breaking open the No. 2 casting at the extensive cracking in the exhaust port, the cracked area was seen to be

definitely duplex in nature, one portion, which appeared to be of more recent origin, exhibiting conchoidal markings. The nucleus of the failure could not be located because that part of the fracture was covered with a black residue (apparently carbon). It was noticed, however, that the fracture extended farther on the outside of the part between the fins than it did on the inside.

surfaces, particularly noticeable in the case of Cylinder Head No. 2, would fairly definitely indicate that failure was of a fatigue nature. The direction of the conchoidal markings on the fractured surface of Cylinder Head No. 2, as well as the fact that the fracture extended farther on the outside of the part than on the inside, would seem to indicate that failure originated on the exterior surface of this casting between the fins.

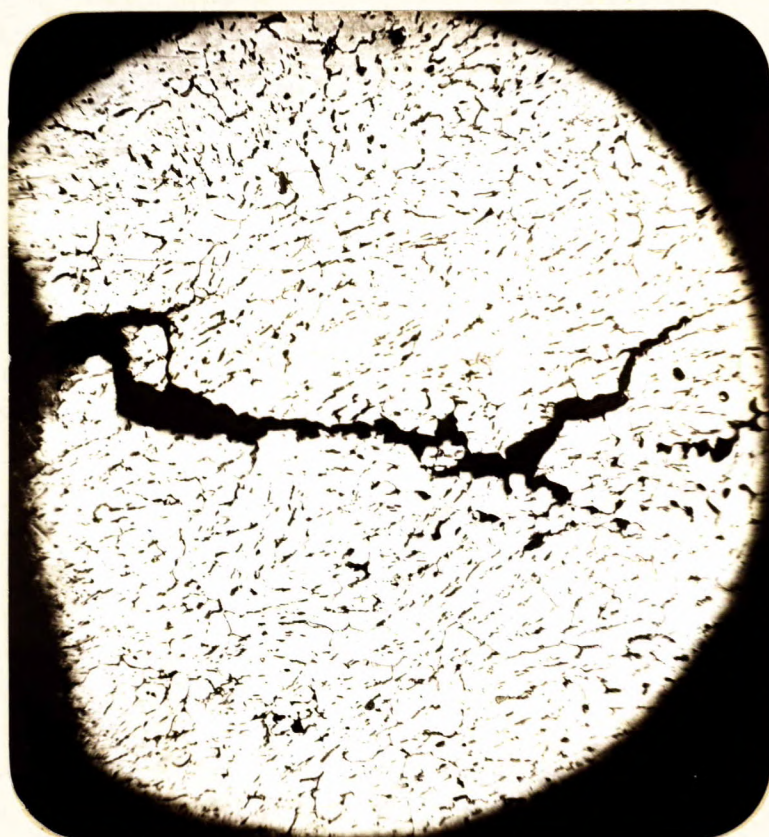
Figure 4.

X42. Etch, 0.5 per cent HF in water.

CRACK AT SPARK PLUG HOLE.

Note shrinkage cavities.

Shrinkage cavities, and some accompanying stringers that may possibly be oxide, present in the region of the fracture would materially lower the fatigue resistance of the parts. Because of the extreme complexity of the castings, however, these shrinkage defects may be difficult, if not impossible to eliminate. No other defects were discovered in the microscopic examination.

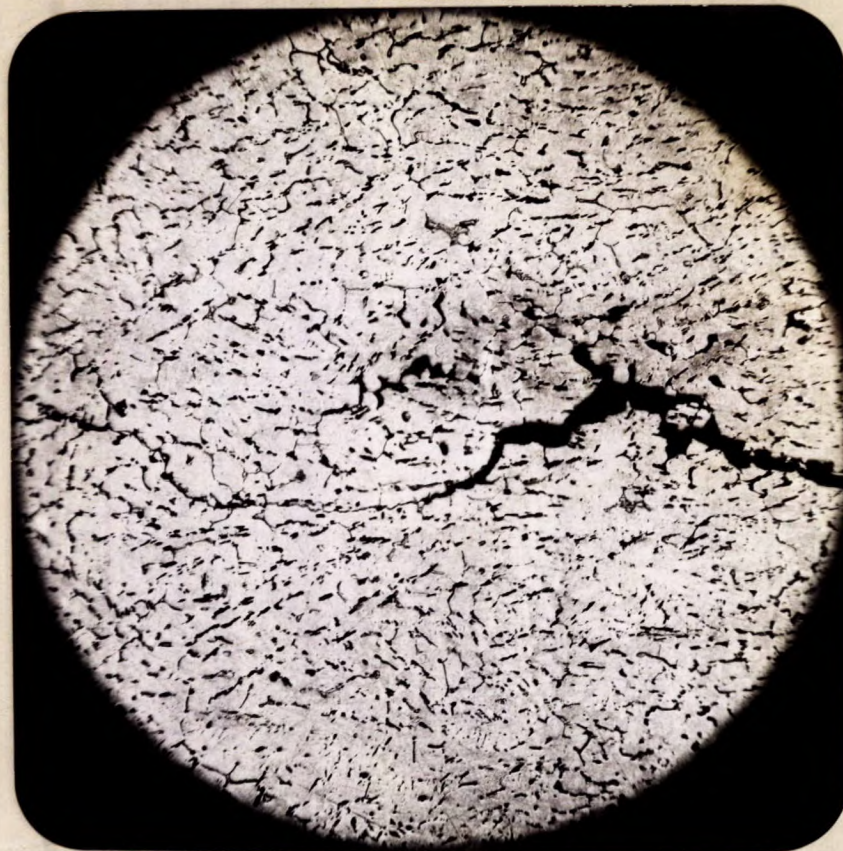
Figure 5.

X42. Etch, 0.5 per cent HF in water.
CONTINUATION OF CRACK SHOWN IN FIGURE 4.
Note shrinkage cavities.

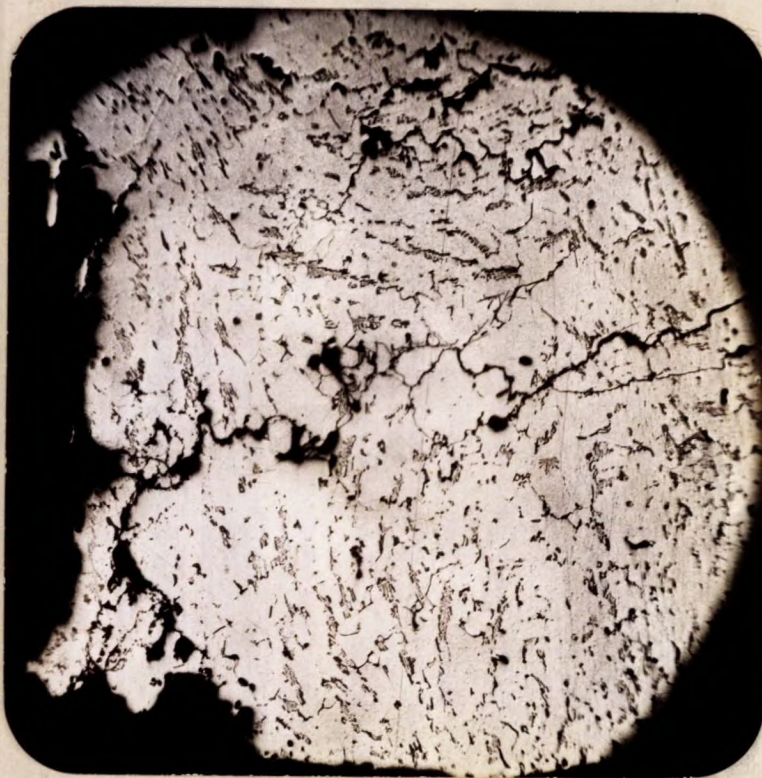
Figure 6.

X42. Etch, 0.15 per cent HF in water.
CRACK IN EXHAUST PORT.

Vertical edge of photomicrograph is exterior edge of casting. Horizontal edge at bottom is fractured surface. Note other cracks and shrinkage cavities.

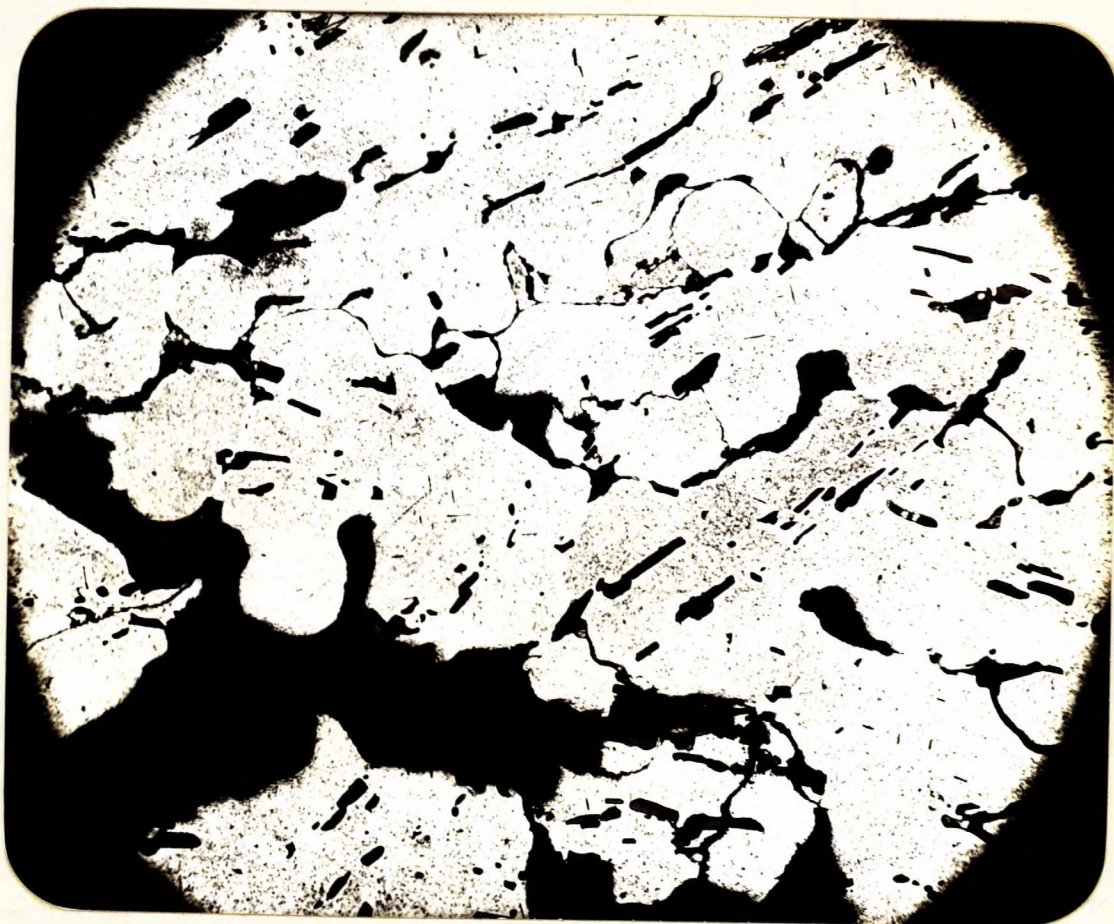
Figure 7.

X250. Etch, 0.5 per cent HF in water.

TAKEN FROM CYLINDER HEAD NO. 1.

Note shrinkage cavities (black voids) with connecting stringers or streaks. Black void near bottom of photomicrograph is part of the crack.
