ORE DRESSING AND METALLURGICAL LABORATORIES.

Investigation No. 1494.

Examination of Corroded Aluminium Alloy Sheets.

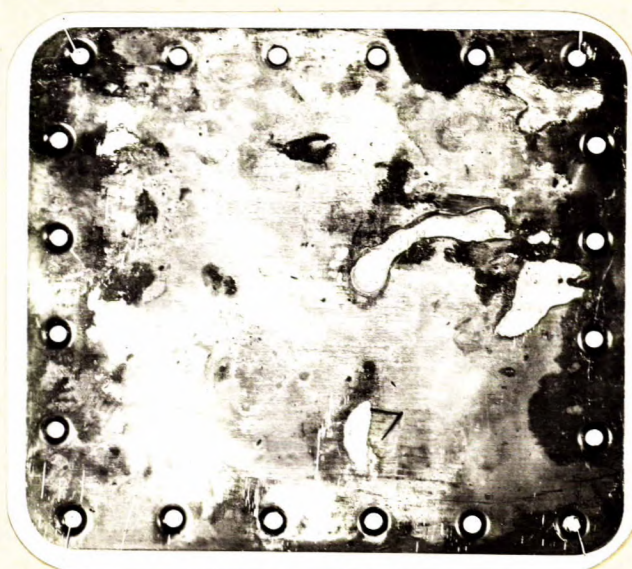
Figure 1.

SHEET SAMPLE AS RECEIVED.
(Approximately $\frac{1}{2}$ size).

The surfaces of these samples show areas of discolouration and regions of apparent corrosion.

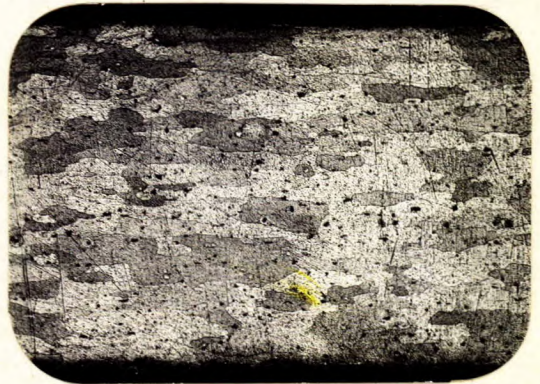
Figure 3.

Figure 3 shows the generally sound structure of the material.
