ORE DRESSING AND METALLURGICAL LABORATORIES.

Investigation No. 1495.

Examination of Three Welded Armour Plate Sections
(Sponson Plate to Side Plate).

CANADA
DEPARTMENT
OF
MINES AND RESOURCES
Mines and Geology Branch

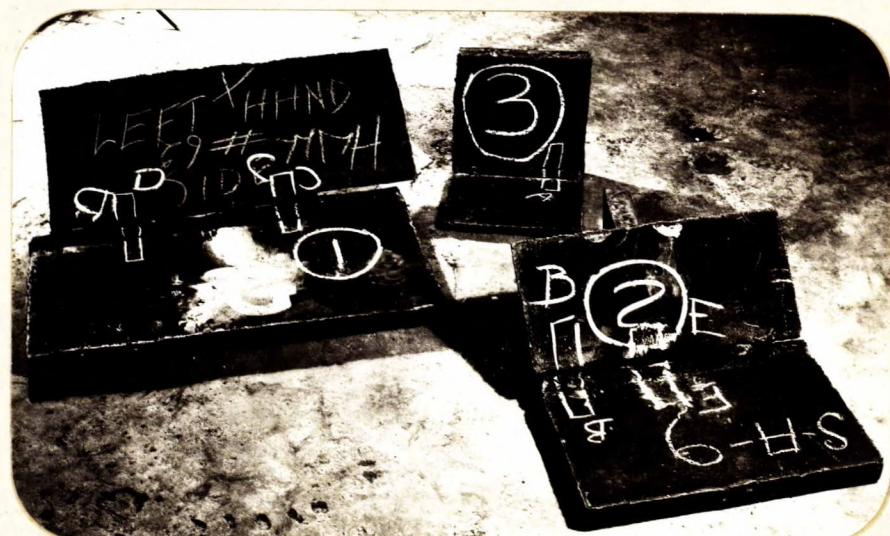
Figure 1.

Figure 1 is a photograph of the three specimens as received. The two first specimens were each in two pieces and Specimen No. 3 was in one piece. This photograph shows, also, where the sections for examination were cut.

SHOWING THE THREE WELDED SPECIMENS "AS RECEIVED"
AND THE LOCATION OF SECTIONS TAKEN FOR EXAMINATION.

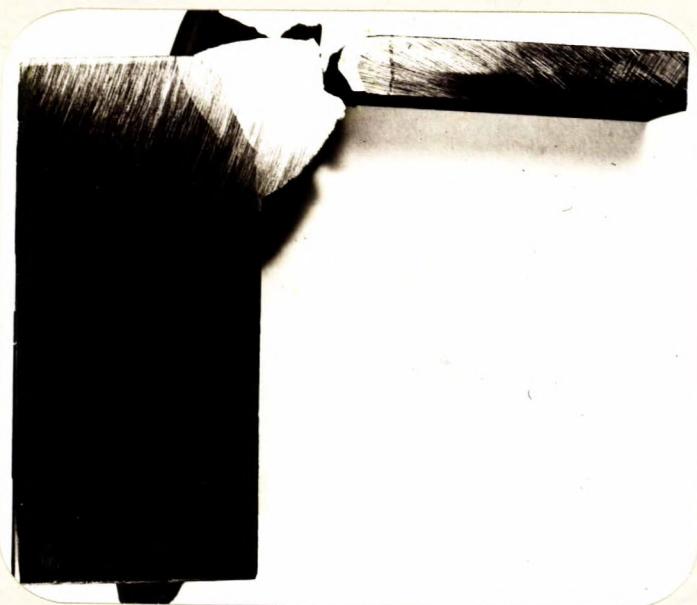
Figure 2.

The Unionmelt weld of Specimen No. 1 showed pronounced waving. Two types of fracture were distinguished. Figure 2 shows a section where failure occurred in the hand weld. The penetration of weld metal and extent of the heat-affected zones are also represented, by means of macro-etching in a solution of 10 per cent ammonium persulphate. (These conditions are shown in Figures 2 to 5 inclusive). The section shown in Figure 2 was taken from location D on Figure 1.

PHOTOGRAPH OF SPECIMEN NO. 1, SHOWING A
FRACTURE IN THE WELD METAL, THE DEPTH OF
PENETRATION, AND EXTENT OF HEAT-AFFECTED ZONE.

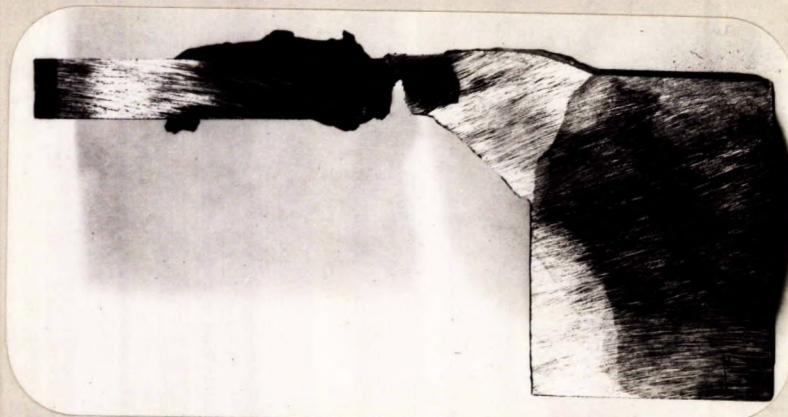
Figure 3.

at C in Figure 1) in Specimen No. 1. This one occurred in the transition zone from the heat-affected to the normal plate metal, in the sponson plate. There was no indication of bullet proofing in this specimen, so that no conclusion could be drawn as to where the fracture originated.

SPECIMEN NO. 1.

Showing a fracture in the transition zone in sponson plate, the depth of penetration, and extent of heat-affected zone. (This is section marked "C" in Figure 1).

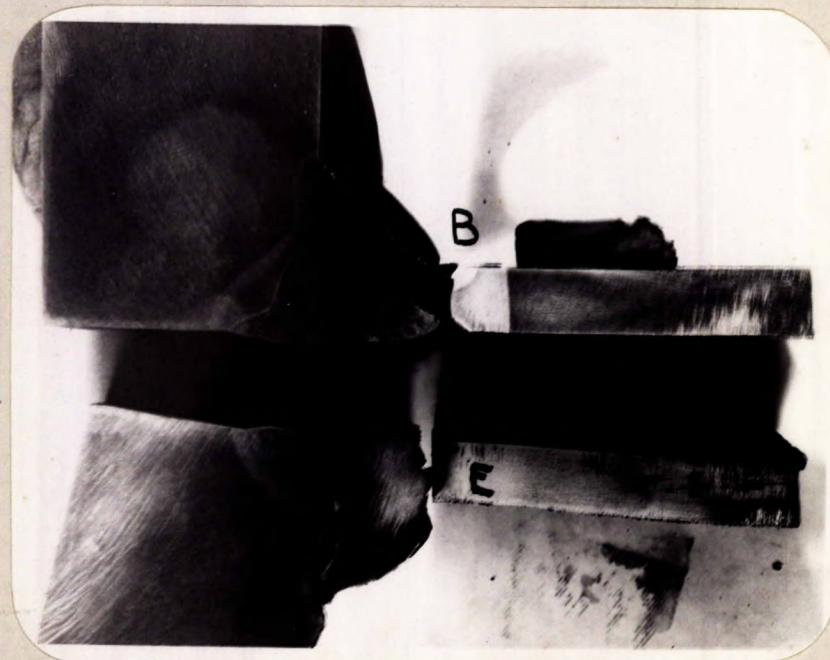
Figure 4.

The Unionmelt weld of Specimen No. 2 was much smoother externally than Specimen No. 1. Two types of fracture were observed here also. In the vertical section struck by the bullet, fracture occurred entirely in the weld metal itself. This position is represented at E in figure 1. The other fracture ran practically through the weld metal and the sponson plate. This section (represented at B in Figure 1), and the section containing the first fracture, are shown in Figure 4, both being macro-etched in 10 per cent ammonium persulphate.

Fracture in Specimen No. 2 originated in the weld metal, as shown in Figure 4 (Specimen No. 2-E).

ending (as in Figure 4) should be noted. Where a hard zone runs perpendicular to the sponson surface any impact will readily cause a failure through this zone. In the case of a hard zone following a V shape, failure on impact is much less probable. The carbide precipitation in the slip planes (see Figure 25) may be due to a drastic cooling caused by the chilling effect of the side plate.

SPECIMEN NO. 2.

Showing two fractures (1) in the weld metal (Section 2-E); (2) partly in the weld and in the sponson plate (Section 2-B). Shown also are depth of penetration and extent of heat-affected zone.

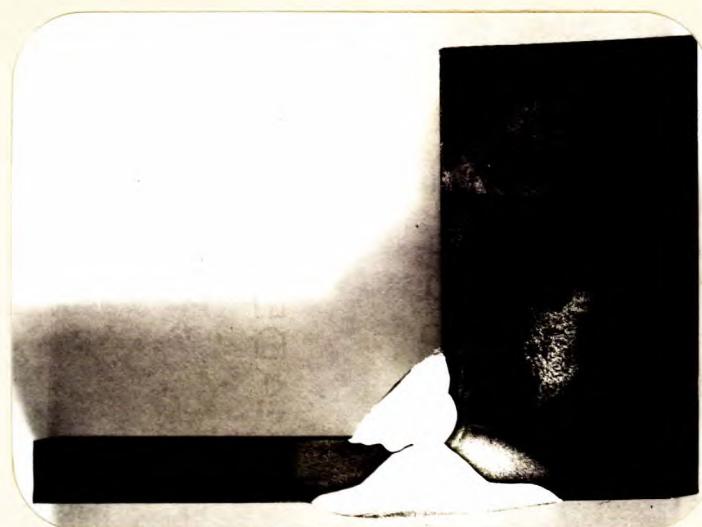
In Specimen No. 3, the Unionmelt weld also had a smooth exterior appearance. A section, taken at A in Figure 1, is shown in Figure 5. The abnormal extent of the width of the upper part of the weld metal, and its small depth, together with a stringer of unfused parent metal in the sponson plate, are the most striking features of this section.

Specimen No. 3 was welded with low welding speed and high energy input per linear inch (as shown by abnormal width of weld metal at the top and small depth of penetration).

SPECIMEN No. 3.

Showing depth of penetration and extent of heat-affected zone.

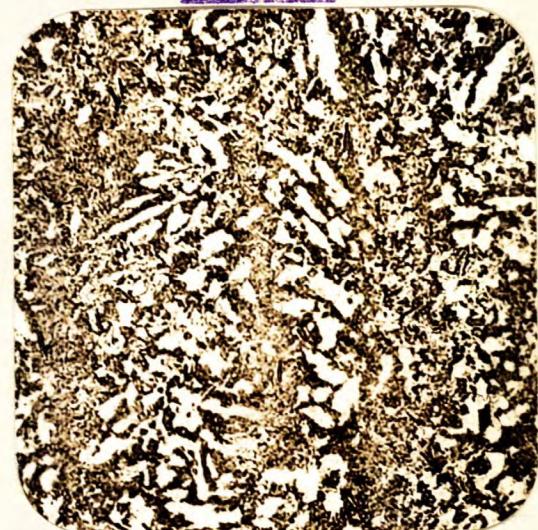
Figure 7.

However, it is remarked that these values are definitely too low in the case of Sponson Plates Nos. 1 and 3. Reference to Figures 7, 10 and 13 will bring out the correlation between banded structures and low impact value. This argument, moreover, is well supported by the three types of fracture. The fibrous fractures of Specimens Nos. 1 and 3 are well in accordance with the banding effect observed.

The transition zone shows a marked precipitation of ferrite. In Specimens Nos. 1 and 3 (Figures 7 and 13) the banding effect due to lack of homogeneity is well brought out. The detrimental effects on the toughness of the plate have already been noted. This heavy precipitation in this zone is one of the most important factors of the present problem. While it is accepted that ferrite must precipitate between the two criticals, the problem arises of whether it is possible to minimize the ferrite growth by shortening the time during which the steel is between the two criticals. This problem has not yet been solved and a study will be undertaken in these Laboratories of the influence, upon ferrite growth, of the time interval between the two criticals. As a matter of fact, higher alloy would appear to be less subject to the effect of ferrite growth but, on the other hand, one must always keep in mind the fact that increasing the alloy content would mean a higher hardenability and lower weldability.

X500, picral etch.
TRANSITION ZONE IN SPONSON PLATE NO. 1.

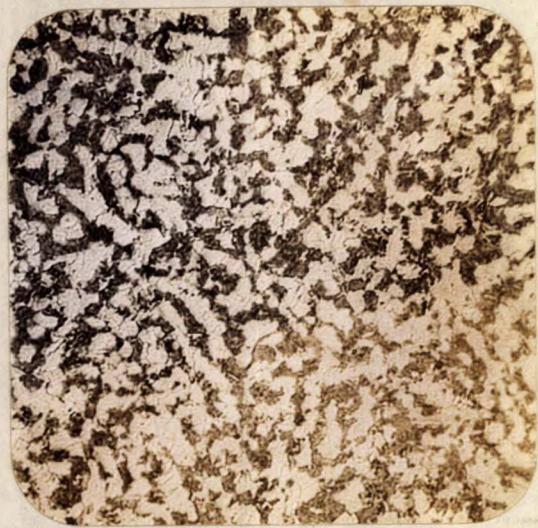
Figure 10.

TRANSITION ZONE IN
SPONSON PLATE NO. 2.

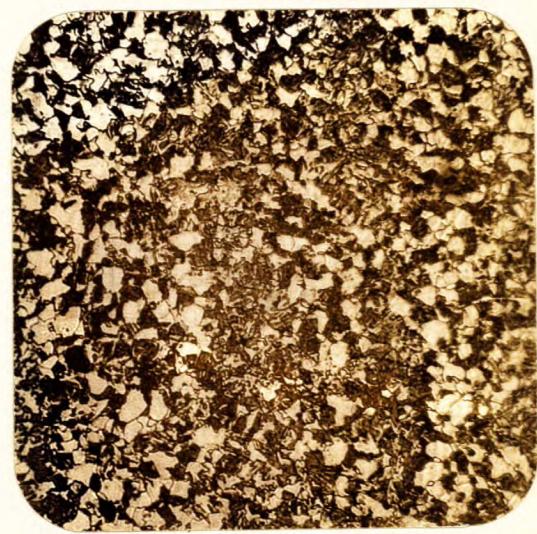
Figure 13.

TRANSITION ZONE IN
SPONSON PLATE NO. 3.

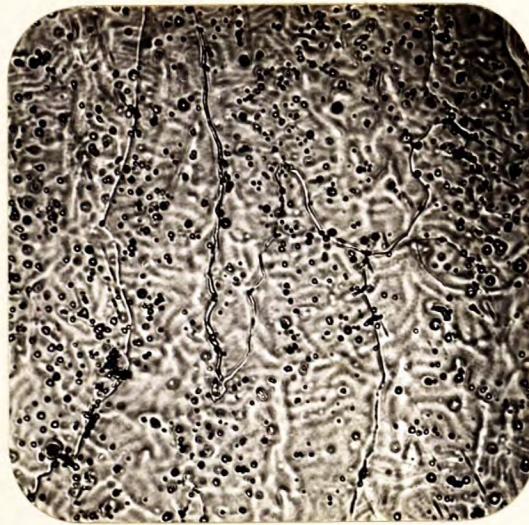
Figure 24.

Figure 24 shows a precipitation of carbides at the grain boundaries of the austenite in the Unionmelt bead. This type of microstructure was observed near the fracture in Section No. 1-D (c.f. Figure 1).

The other defect is the existence of carbides at the grain boundaries of the austenite (see Figure 24). This condition is known to have a detrimental effect on the strength and toughness of the material. The occurrence of carbides at the grain boundaries is due either to slow cooling or to the annealing effect given during the subsequent hand welding. In any case, it is proportional to the dilution resulting in increased precipitation of carbides.

5. The Unionmelt bead of Specimen No. 1 (from Hull 62) shows a carbide precipitation at the grain boundaries. This may be a contributing cause of failure. In this weld, martensite was found only at the fusion line.

SHOWING CARBIDES AT THE
GRAIN BOUNDARIES OF
GRAIN BOUNDARIES OF THE
AUSTENITE IN SPECIMEN
NO. 1 (UNIONMELT).

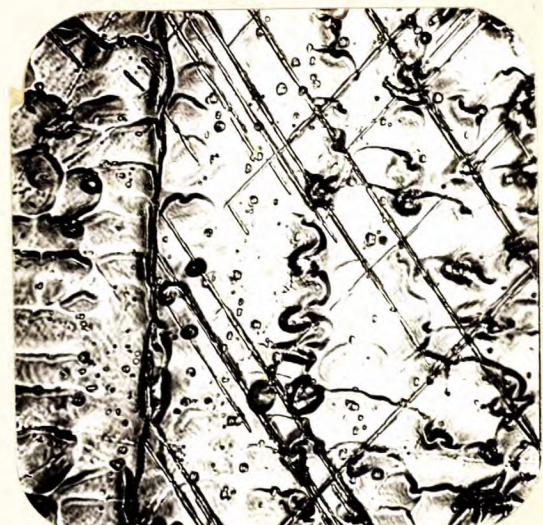
Figure 25.

Figure 25 shows a precipitation of carbides on the slip planes of the austenite. This condition was present in the Unionmelt bead near the fusion line connecting with the side plate.

SHOWING CARBIDE PRECIPITATION
AT THE SLIP PLANES OF THE
AUSTENITE IN SPECIMEN
NO. 1 (UNIONMELT).

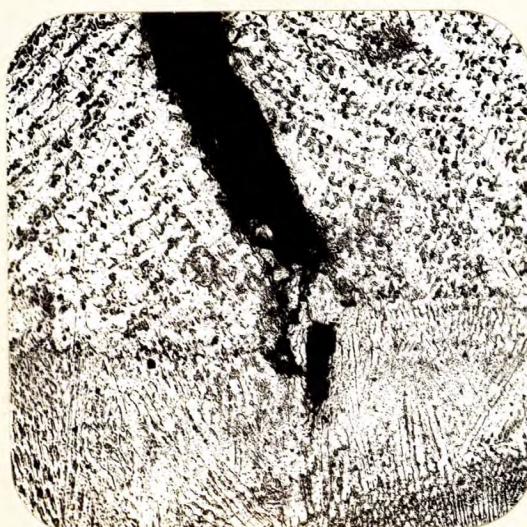
Figure 26.

The Unionmelt bead in Specimen No. 1 was found to have two major defects. First, a crack was found to run all along the weld as received. This crack (Figure 28) existed prior to the laying down of the first hand bead (see Figure 26). The crack is of the common shrinkage type, as is well shown in Figure 27.

SHOWING THE CONNECTION BETWEEN
THE CRACK IN UNIONMELT AND
THE FIRST DEPOSITED HAND BEAD
IN SPECIMEN NO. 1.

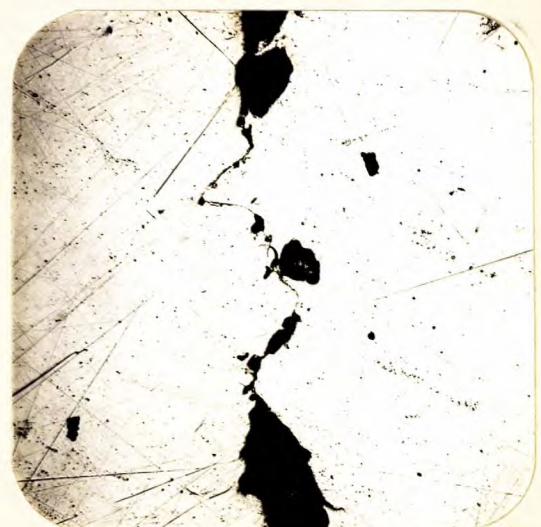
Figure 27.

Figures 26, 27, and 28 all refer to a crack which was found to run all along the Unionmelt bead. Figure 26 shows the connection of this crack and the first deposited hand bead. Figure 27 shows a typical section of the crack where the shrinkage nature of the defect is evident. Figure 28 shows how this crack occurs only in the Unionmelt bead, at the surface formed by intersection of two sets of cleavage planes.

SHOWING THE SHRINKAGE
NATURE OF THE CRACK
IN SPECIMEN NO. 1
(UNIONMELT).

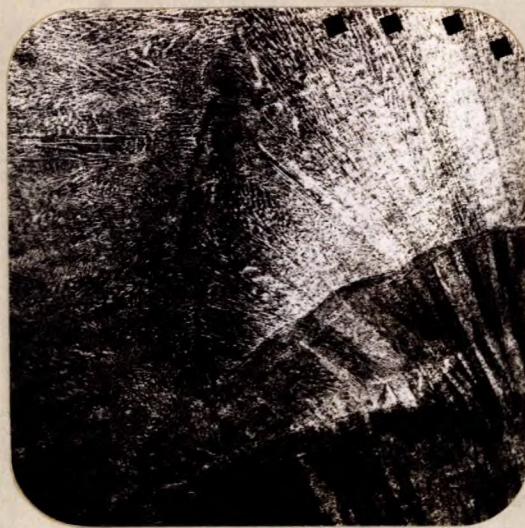
Figure 28.

3. Ferrite precipitation in the transition zone of the sponson plate was excessive in width and appreciably less in the side plate.
4. The Unionmelt bead of Specimen No. 1 (from Hull 62) contained a serious shrinkage crack.

X75, etch in a saturated solution of ferrichloride in hydrochloric acid.
SHOWING THE GENERAL APPEARANCE OF THE CRACK IN SPECIMEN NO. 1.

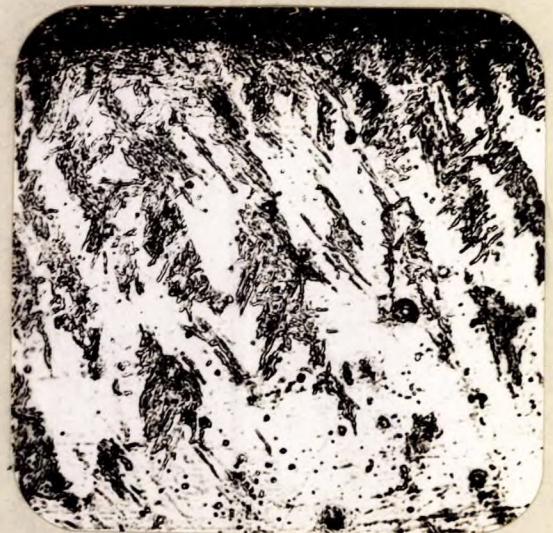
Figure 29.

Figure 29 was taken at the fusion line of the weld metal. It shows a typical example of martensite in austenite. This condition was found in all the specimens at the same location, in the automatic as well as in the hand welds.

X500, etch in 5% HCl, 1% picral solution.
SHOWING THE MARTENSITE IN THE AUSTENITIC MATRIX AT THE FUSION LINE IN SPECIMEN NO. 1.

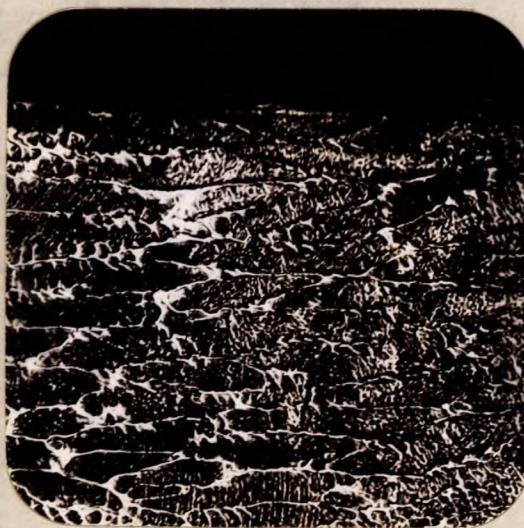
Figure 30.

Figure 30 shows the austenite and martensite structure near fracture. Figure 31 shows a typical example of cored austenite in the last deposited hand bead. This structure was

In Specimen No. 2, martensite was found in the Unionmelt bead and near the fracture (see Figure 30); it is well known that this condition has an embrittling effect on the steel, and fracture might very well be attributed to this defect.

X250, etch in 5% HCl, 1% picral solution.
SHOWING THE MARTENSITIC AND AUSTENITIC STRUCTURE AT FRACTURE IN SPECIMEN NO. 2 (UNIONMELT).

Martensite found in this type of welding is caused by dilution, which decreases the alloy content. Only a proper control of this dilution can make the steel retain its austenitic condition.

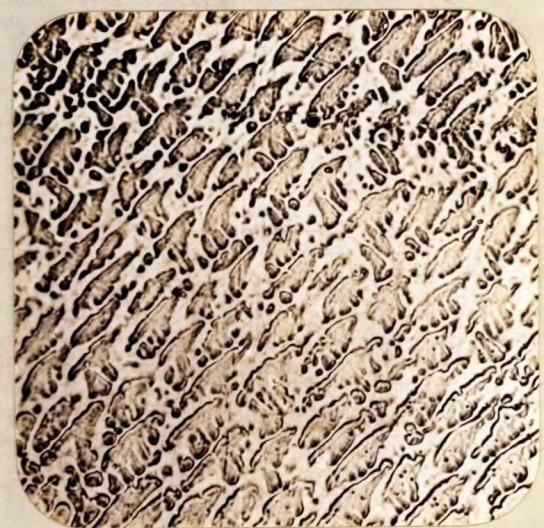
Figure 31.

X500, etch in 5% HCl, 1% picral solution.
SHOWING THE CORED AUSTENITE IN THE LAST-DEPOSITED HAND BEAD IN SPECIMEN NO. 2.

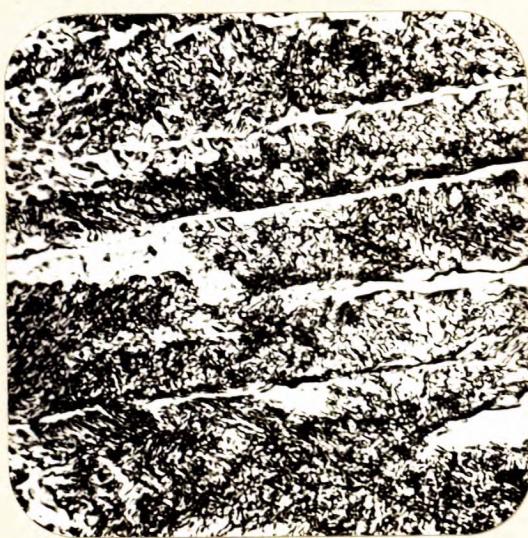
Figure 32.

Figure 32 shows a typical example of austenite and martensite in the No. 1 hand bead. In the automatic beads few patches of martensite in austenite were found. This condition was shown in Figure 34. A comment can be made at this point, namely, the quantity of martensite was found to check very closely with the magnetic measurements.

In Specimen No. 3, only one bead was found which was martensitic. This bead was the first hand bead deposited and had penetrated too much into the side plate metal in relation to its size.

7. In Specimen No. 3, isolated patches of martensite were found in the Unionmelt bead. In one particular hand bead, the structure was martensitic. This bead had penetrated too deeply into the side plate metal.

X1000, etch in 5% HCl,
1% picral solution.

SHOWING THE MARTENSITE
IN AUSTENITE IN THE FIRST
HAND BEAD OF
SPECIMEN NO. 3.

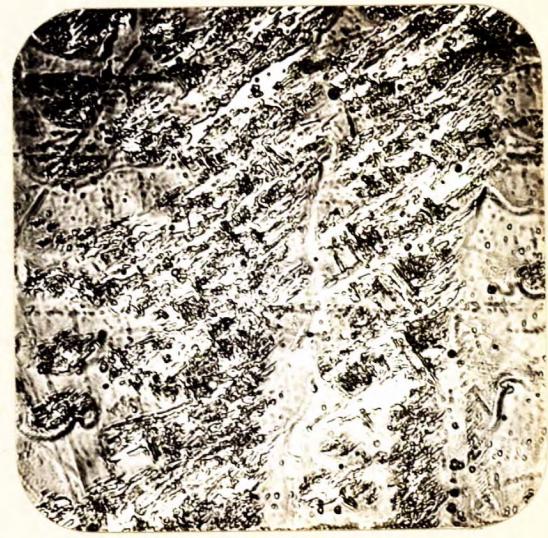
Figure 33.

In Specimen No. 3, isolated patches of martensite were found in this bead (see Figure 32).

SHOWING AN EXAMPLE OF
A PATCH OF MARTENSITE
IN AUSTENITE IN SPECIMEN
NO. 3 (UNIONMELT).
