ORE DRESSING AND METALLURGICAL LABORATORIES.

Investigation No. 1497.

An Examination of Recarburized End
Connectors, No. C-55592.

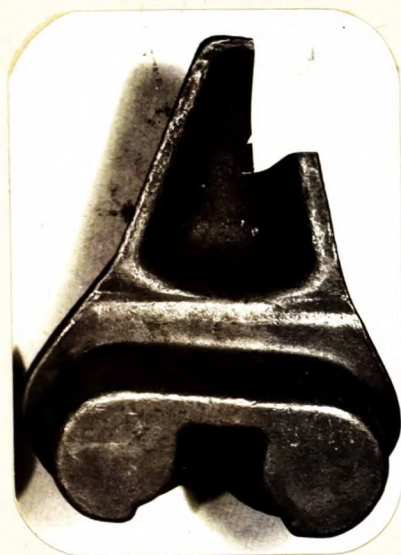
Figure 1.

Figure 1 is a photograph (about 2/5 natural size) showing the unmachined forging. This was taken after part of the ear was cut away for examination. Figure 2 is a photograph of a finished end connector. Note where the machining has occurred.

PHOTOGRAPH OF END
CONNECTOR FORGING, ABOUT
2/5 ACTUAL SIZE.

Note portion has been
removed from ear for
examination.

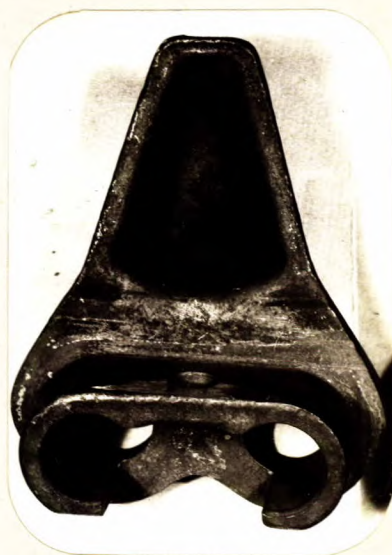
Figure 2.

PHOTOGRAPH OF FINISHED
END CONNECTOR, ABOUT
2/5 ACTUAL SIZE.

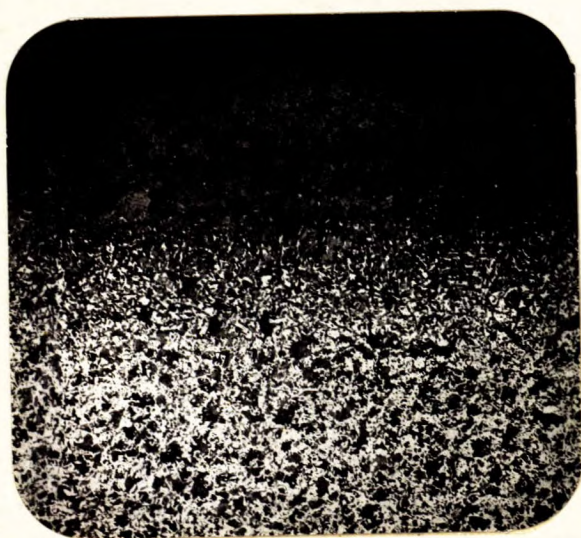
Figure 3 is a photomicrograph, at X30 magnification, showing the structure under the recarburized surface of the unmachined, unheat-treated forging.

It will be noted that there are three zones in Figure 3. Just under the surface, in Zone 1, there is no ferrite; then there is an intermediate zone of finely divided ferrite and pearlite; and, finally, in Zone 3 there is the normalized structure of the normal N.E. 9445 steel.

The bottom of Zone 2 is about 0.05 inch below the surface, which corresponds to the depth of the original decarburization. Comparing Zone 2 with Zone 3, it would appear that the carbon content of Zone 2 is no lower than that of Zone 3. This is evidence that all traces of decarburization have been eliminated. However, from the appearance of the structure of Zone 1 it is evident that a true high-carbon case has now been created.

PHOTOMICROGRAPH SHOWING
STRUCTURE IN RECARBURIZED
METAL BEFORE HEAT TREATMENT.
Note the presence of three
distinct zones.

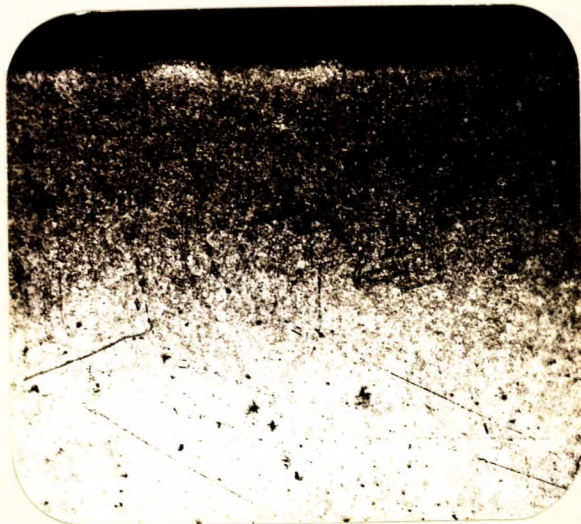
Figure 4.

Figure 4 is a photomicrograph, at X30 magnification, showing the structure under the recarburized surface after the end connector has been fully machined and heat-treated.

PHOTOMICROGRAPH SHOWING
STRUCTURE IN RECARBURIZED
METAL AFTER HEAT TREATMENT.

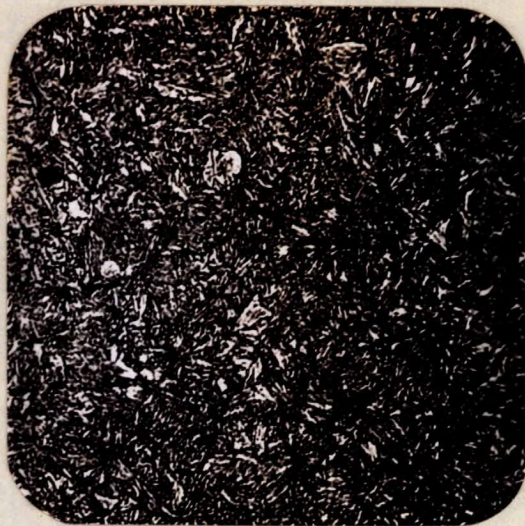
Figure 5.

The structure of this case after complete heat treatment is shown in Figure 5, at a magnification of 500 diameters, and the normal structure of the heat-treated steel is shown in Figure 6, also at 500 diameters. There is nothing unusual in these structures.

PHOTOMICROGRAPH SHOWING STRUCTURE IN
RECARBURIZED CASE AFTER HEAT TREATMENT.

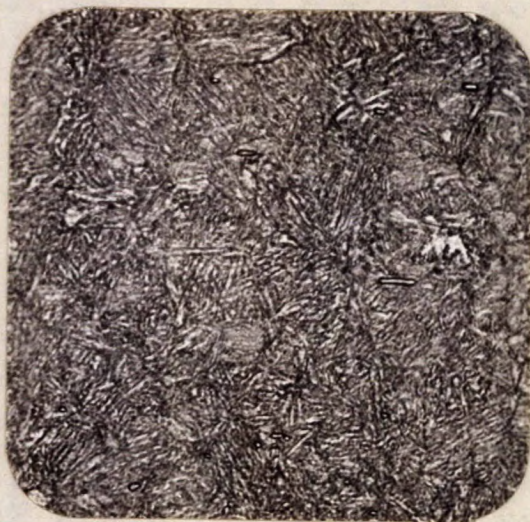
Figure 6.

PHOTOMICROGRAPH SHOWING NORMAL
STRUCTURE OF HEAT-TREATED N.E. 9445 STEEL
IN END CONNECTORS.

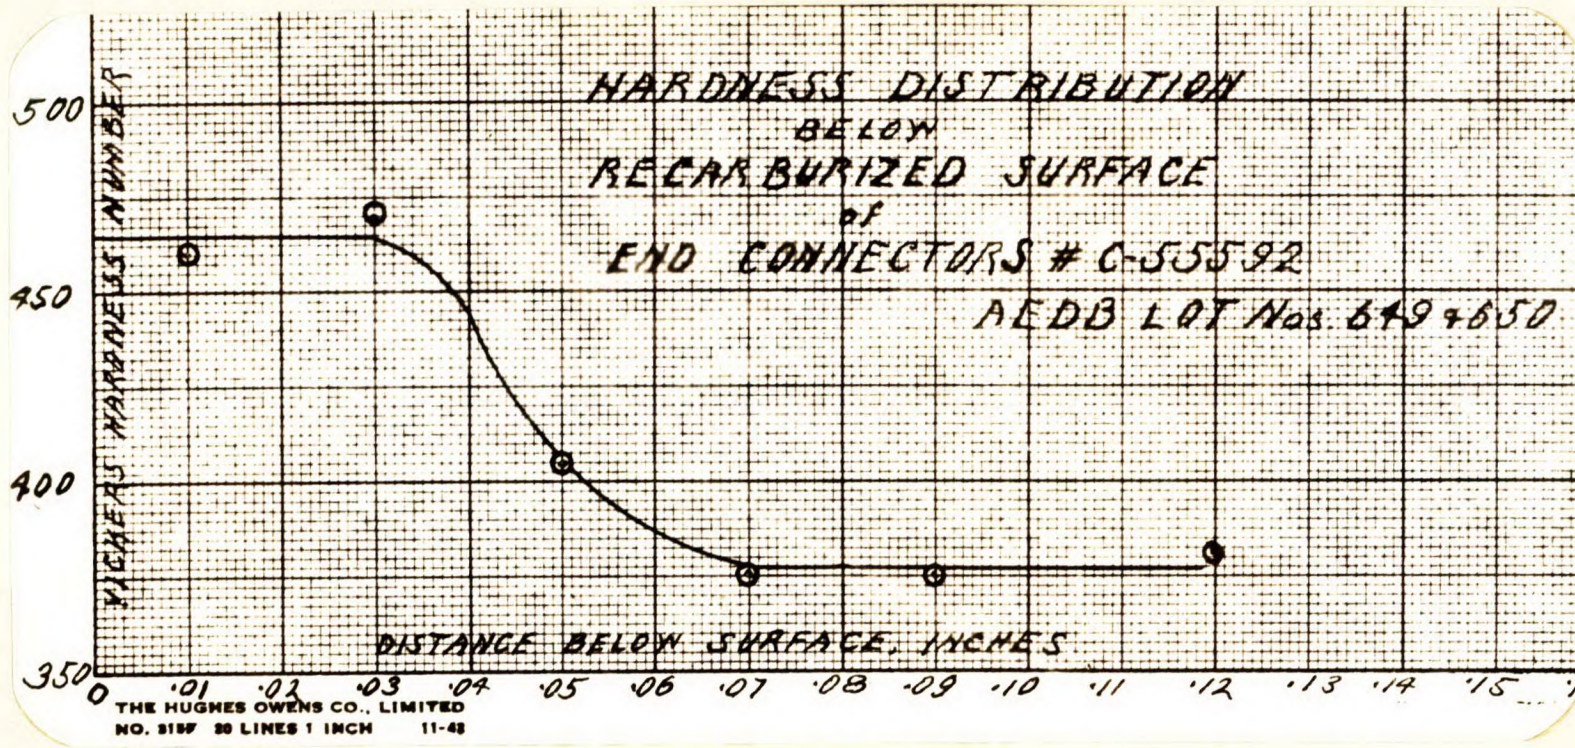
A hardness survey of the metal below the recarburized surface was made on a sample taken from one of the finished end connectors. The results are shown in the chart, Figure 7.

From the examinations conducted it is evident that all traces of decarburization have been removed. Where the original forged surface remains on the finished end connector, there is actually a case, created by recarburizing. This case penetrates to a depth of 0.04 inch and has a hardness of 460-470 Vickers hardness number. It is not considered that this case will be detrimental to the performance of these parts.

HARDNESS SURVEY CHART.
