Investigation No. 1500.

Examination of a Corroded Tin-Coated Water Filter.

Bureau of Mines
Division of Metallic
Minerals

CANADA
DEPARTMENT
OF
MINES AND RESOURCES
Mines and Geology Branch

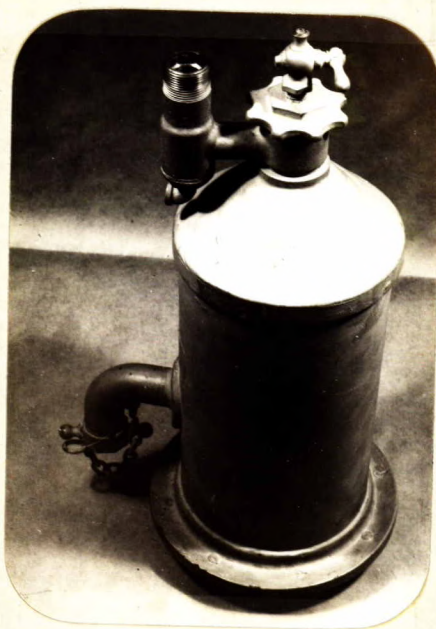
Figure 1.

PHOTOGRAPH SHOWING THE WATER
FILTER "AS RECEIVED".

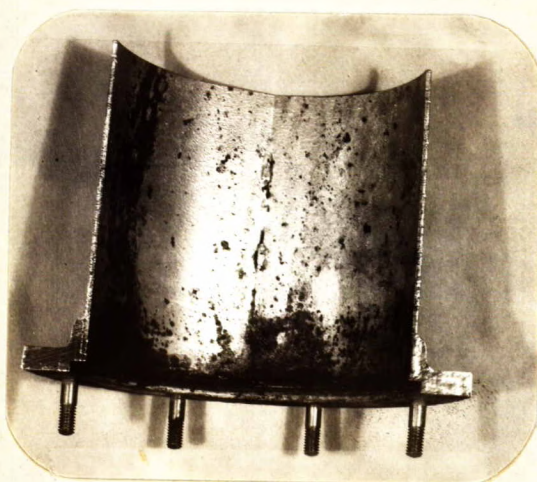
Figure 2.

A visual examination revealed that the corroded areas were covered with rust. Pits in the tin coating were also visible.

SHOWING AN EXAMPLE OF
INSIDE SURFACE CORROSION.

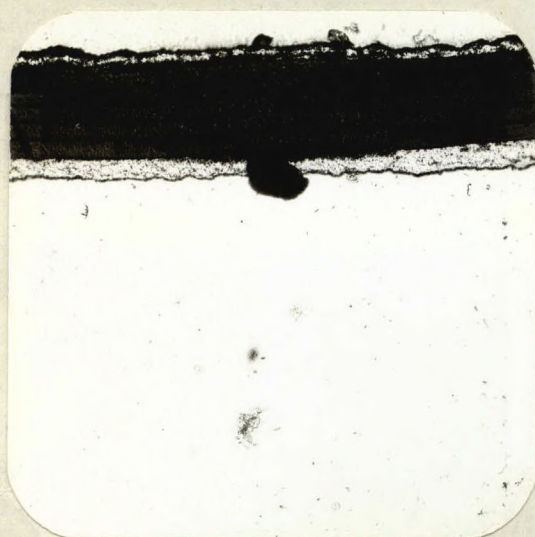
Figure 3.

Samples were prepared for micro-examination. Pits in the section were found and Figures 3 and 4 are representative of this condition. Figure 4 also shows corrosion in the iron base under tin coating.

1. From the visual examination, as well as from the microscopic examination, it is evident that the tin coating is porous. The existence of such pores in a tin coating is a common defect. Even a well-prepared surface is subject to this defect. However, a good means of preventing porosity is to increase the thickness of the coating.

SHOWING POROSITY IN
THE TIN COATING.

The safest procedure would be to change the material. The use of a paint coating or a copper tubing would be advisable.

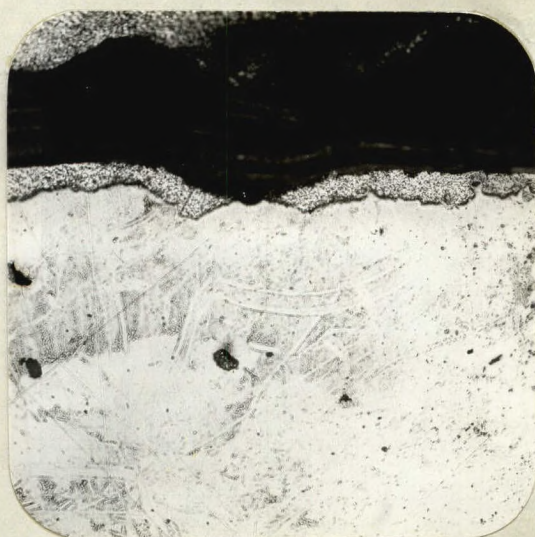
Figure 4.

2. Under normal conditions, porosity in tin coatings leads to preferential corrosion of the iron base. Tin does not normally afford anodic protection like zinc in galvanized iron. The well-known exception to this rule is the tin can, in which chemical conditions are such that tin possesses the ability to protect the iron base. In the present case, the dissolution and precipitation of iron shows that the iron has been corroded preferentially.

SHOWING POROSITY AND
CORROSION IN THE TIN COATING.
