R E P O R T
of the
ORE DRESSING AND METALLURGICAL LABORATORIES.

Investigation No. 1501.

Examination of Austenitic Manganese Steel Track
Shoes Containing Cracks in Various Sections.

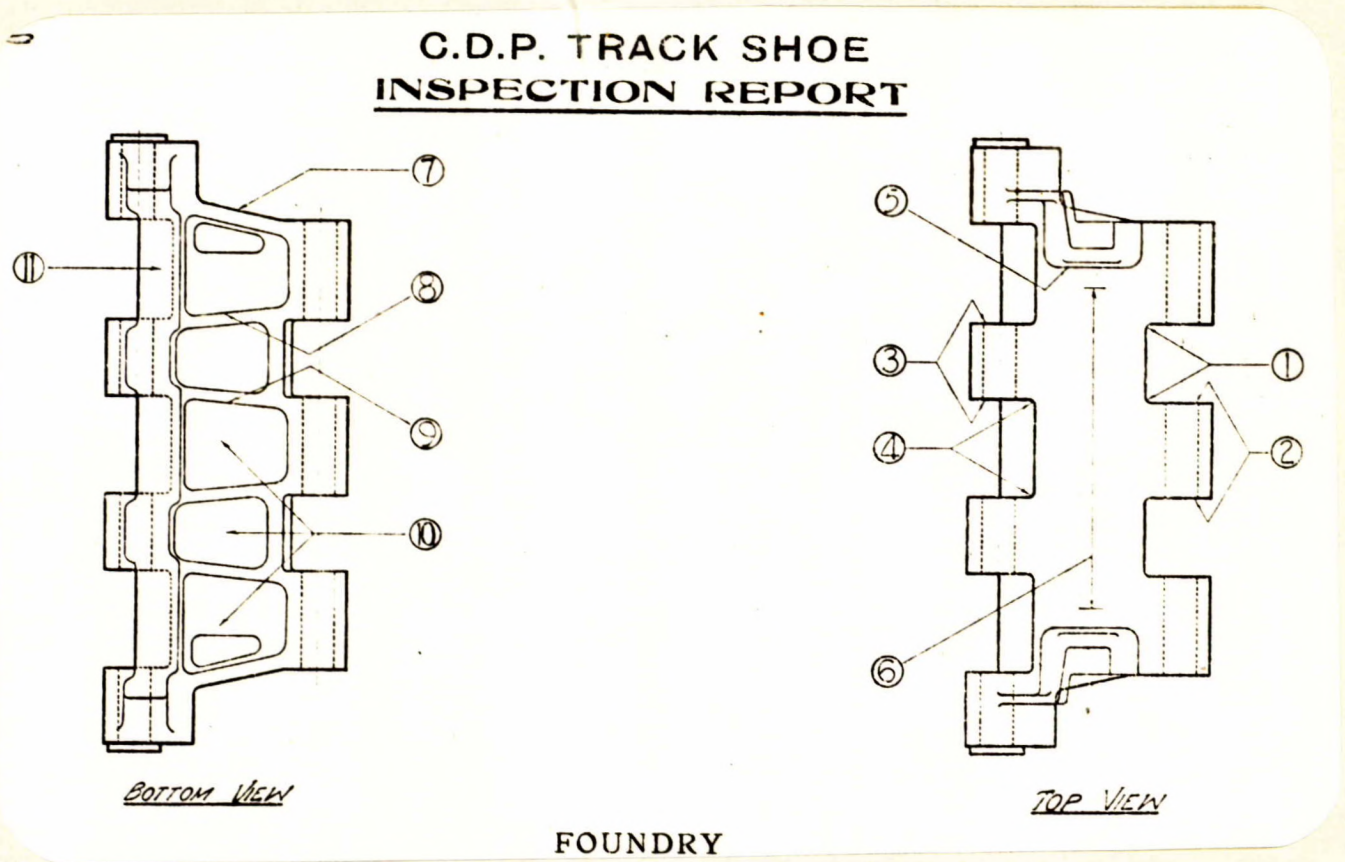
Figure 1.

Figure 1 is a chart showing the system of referring to various parts of the shoe by number. With reference to it, the shoes were cracked as follows:

1	shoe	cracked	at	Station	No.	1.
1	"	"	"	"	"	4.
2	"	"	"	"	"	5.
1	"	"	"	"	"	6.
1	"	"	"	"	"	7.
1	"	"	"	"	"	11.

The cracks were quite deep, extending almost through the section in every instance.

REFERENCE CHART FOR NUMBERING THE VARIOUS PARTS OF THE SHOES.

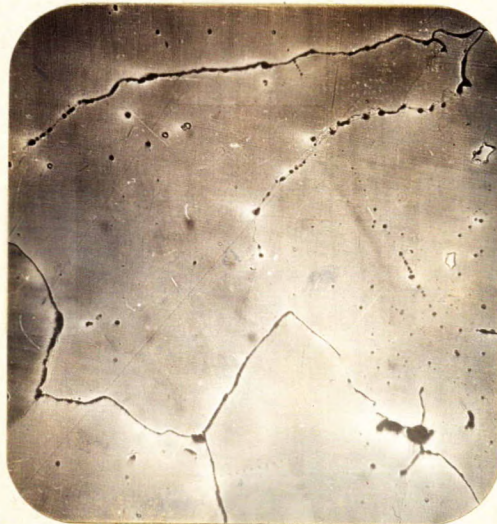
Figure 2.

In the two specimens from the shoe before reheat treatment, very few free carbides were observed. However, there were a large number of microshrinks present, particularly at the grain boundaries. Figure 2, at 100 diameters, shows

such a shrink on the section near the crack.

X100, nital etch.

SECTION NEAR CRACK.

Note shrinkage at the grain boundaries.

The metallographic examination indicates the presence of microshrinks, particularly at the grain boundaries. Some carbides were observed also, but the condition is not a serious one.

The cause of the cracks cannot be definitely determined by a routine metallurgical examination. The microshrinks certainly contributed to some extent, but it is felt that the shoes cracked largely because of some fundamental defect in the steel. If it is true that the steel has not been sufficiently refined, this may well be the underlying cause.
