R E P O R T
of the
ORE DRESSING AND METALLURGICAL LABORATORIES.

Investigation No. 1503.

Examination of Steel Stampings from the
Stewart-Warner-Alemite Corporation
of Canada, Belleville, Ontario.

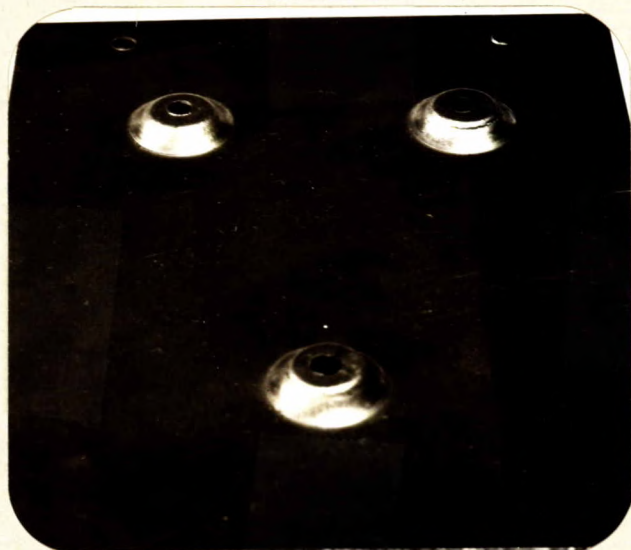
A view of one of the plates as received, showing failures in two of the drawn areas, is given in Figure 1.

PLATE AS RECEIVED.

Note crack in upper right draw and crack in bottom draw (slightly out of focus).

The fact that the same two draws fractured in both plates would, of itself, seem to indicate that failure was caused by faulty plant operation rather than by defects in the metal.

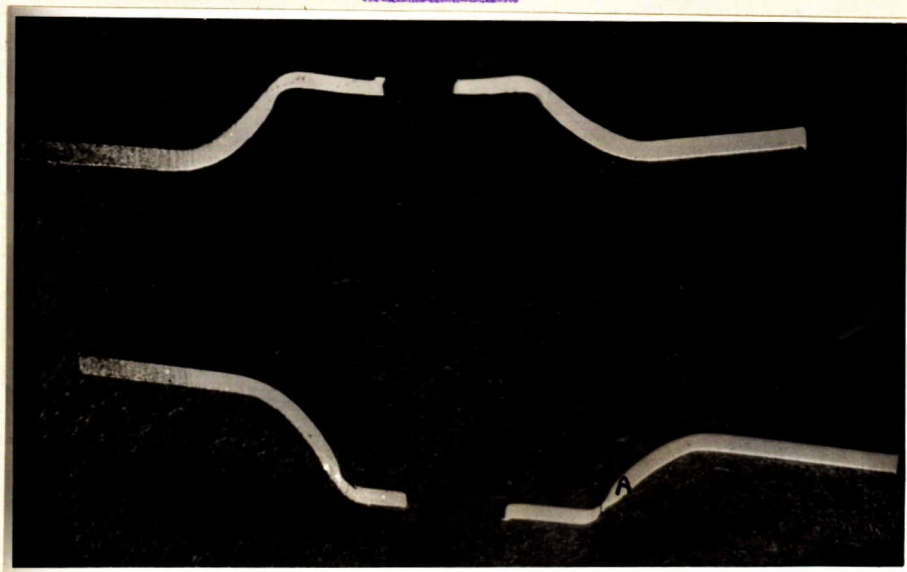
Figure 2.

It was noticed that the same two draws in each of the plates submitted were fractured; the third, in both cases, was satisfactory. When a section was cut through one of the fractured draws the metal was seen to have "necked down" considerably at the failure (see Figure 2).

Note "necking down" at fracture.

By using conversion tables the 105 Vickers hardness of this sheet is seen to correspond to about 61 Rockwell 'B' hardness. Since, according to the American Society for Metals Handbook, 1939, the hardness of $\frac{1}{4}$ hard sheet should be Rockwell 'B' 65 ± 5 , the sheet used in these stampings meets the hardness requirements. This, as well as the fact that the metal "necked down" considerably at the point of failure, indicates that age embrittlement was not the cause of failure.

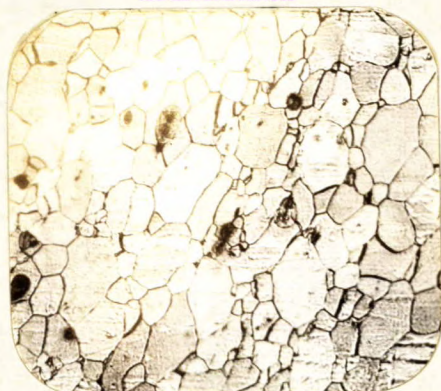
Figure 3.

Cross-sections from a failed and a satisfactory draw were mounted in bakelite, polished, and etched with a 5 per cent solution of ammonium persulphate in water. The ferritic grain size of both samples was found to be the same (see Figures 2 and 3). No extraordinary metallurgical defects that might have caused failure or variable performance in the same sheet were found.

SATISFACTORY DRAW.

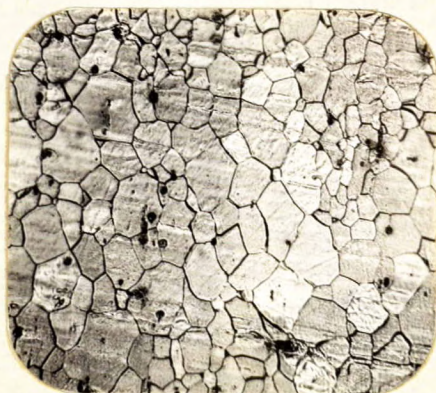
Figure 4.

FAILED DRAW.

Microstructure examination failed to reveal any difference between satisfactory and cracked draws.

This examination indicates that failure was caused by mechanical defects in fabrication rather than by metallurgical deficiencies in the metal itself.
