O T T A W A October 2nd, 1943.

ORE DRESSING AND METALLURGICAL LABORATORIES.

Investigation No. 1504.

Examination of Bombardier Snowmobile Bogie
Wheel Suspension Assembly made with
Improved Welding Technique.

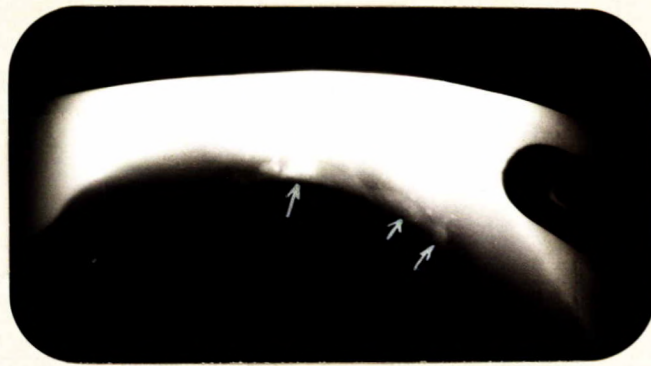
Figure 1.

An X-ray examination of the fillet weld joining the other shaft ring to the pipe frame reveals an entrapment of slag. This slag is located in an area in which the arc has been broken (probably to replace a used electrode) and then continued. The crater remaining after the arc was broken was not properly filled when welding was continued, allowing slag to be caught in the root of the weld (see Section 9, Figure 7).

PRINT OF EXOGRAPH OF A FILLET WELD JOINING
A SHAFT RING TO THE PIPE FRAME AT AN AREA
IN WHICH BEADS FROM TWO ELECTRODES HAVE
BEEN JOINED.

Arrows point to slag inclusions.

1. There is a considerable improvement in the welding technique used to fabricate this assembly as compared with the technique previously used.
2. Slag inclusions were found in shaft ring welds, indicating the need for greater care in laying root beads and in joining up two beads.
3. Provided that the above defects are eliminated, the present improved welding technique should prove satisfactory.

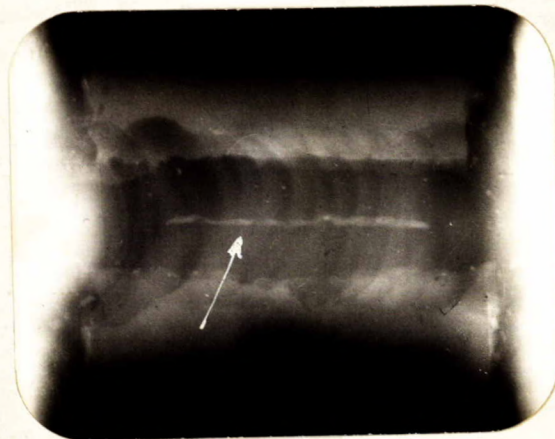
Figure 2.

The X-ray examination revealed a slag stringer in the root of the weld joining the ends of the strap. This strap joins the shaft ring to the pipe frame. The remainder of the welds on this strap are good and show no undercutting. The weld contours are smooth and the weld well positioned. The slag stringer noted above is probably the result of using too large an electrode in a narrow root gap.

PRINT OF AN EXOGRAPH OF A WELD JOINING THE
TWO ENDS OF THE STRAP JOINING THE SHAFT
RING TO THE PIPE FRAME.

Arrow points to slag trapped in the root of
the weld. See Figure 6.

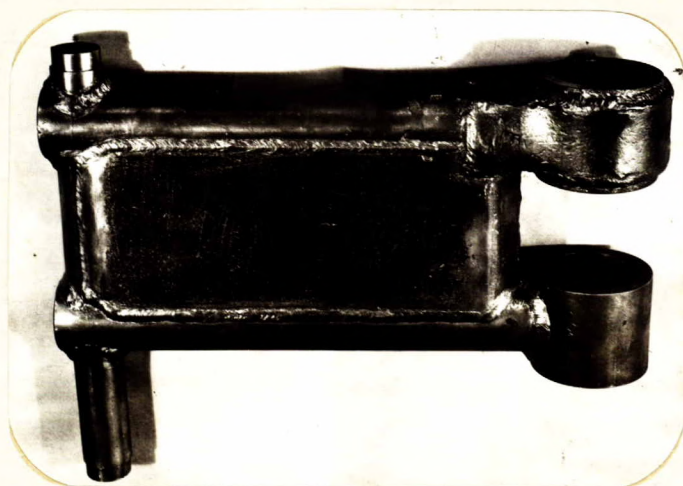
Figure 3.

(3). Figure 3 shows the general shape of the assembly as received. It will be noted that the stiffeners and spring sockets have been omitted (compare with Figure 5 of Investigation No. 1485) and that both fillet weld and strap methods of attaching the shaft ring to the pipe frame have been employed for purpose of comparison.

PHOTOGRAPH OF THE ASSEMBLY AS RECEIVED.

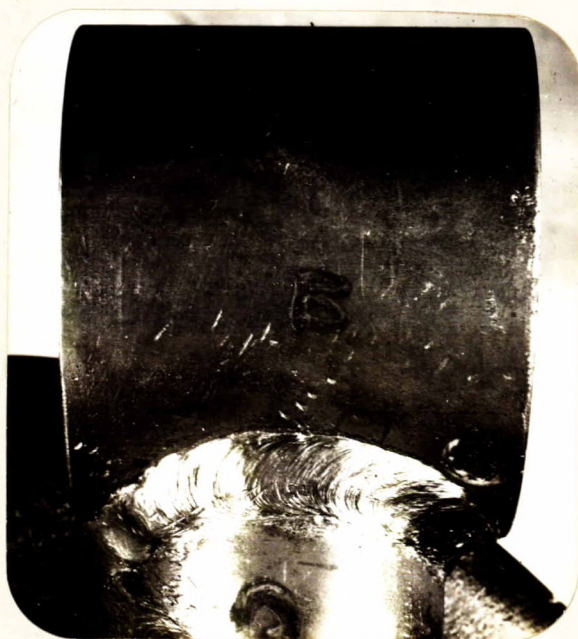
Figure 4.

PHOTOGRAPH OF FILLET WELD JOINING
SHAFT RING TO PIPE FRAME.

Note smooth, regular contour of weld.

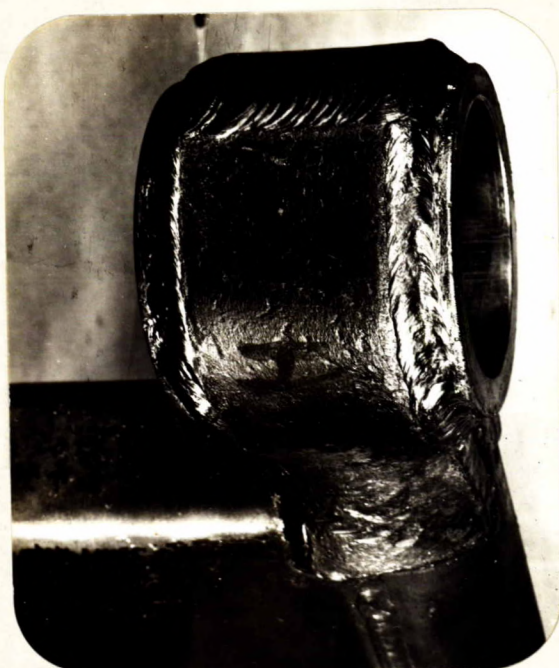
Figure 5.

PHOTOGRAPH OF A FILLET WELD
JOINING STRAP TO SHAFT RING.

Note absence of undercutting and that
weld extends to top of the strap material.

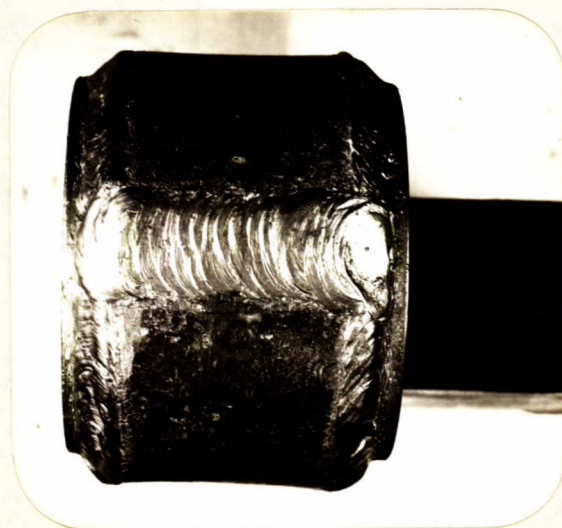
Figure 6.

PHOTOGRAPH OF WELD JOINING
ENDS OF STRAP MATERIAL.

Note regular and smooth weld contour.

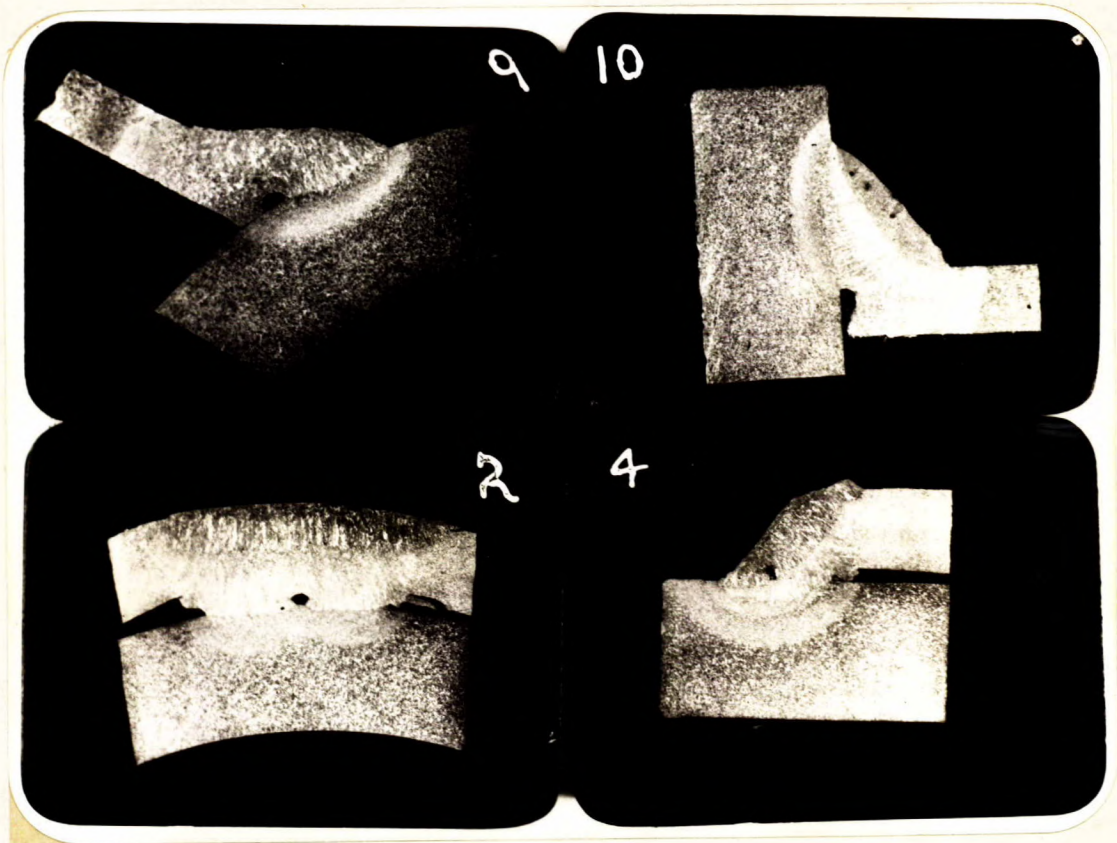
Figure 7.

SECTIONS OF VARIOUS WELDED JOINTS.

Sections 9 and 10, from fillet weld joining shaft ring to pipe frame. Section 9, through area in which beads from two electrodes have been joined. Note slag trap at root of weld. Section 10, from same weld for comparison--weld smooth, penetration fair.

Section 2, from weld joining ends of strap material. The exograph of this weld is shown in Figure 2. Note slag trapped in root of weld.

Section 4, a typical section of fillet weld joining strap material to shaft ring. Contour and penetration good. Small gas inclusion.

It is our opinion that if the standard of welding exemplified by this assembly is maintained it should prove satisfactory. It is understood, of course, that precautions should be taken to eliminate the two defects found in the shaft ring welds.

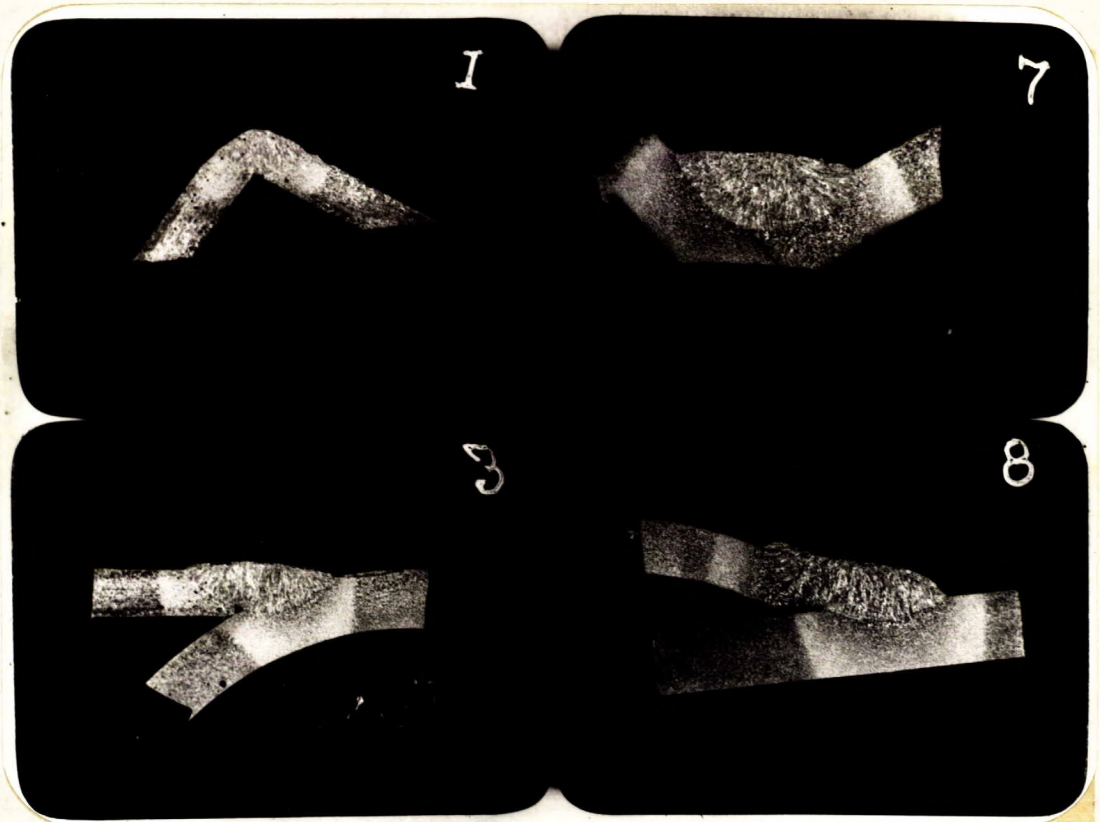
Figure 8.

All sections other than those referred to above have the following characteristics: Very good fit-up, fair penetration, economical use of weld metal, and smooth weld contour. A comparison of these with similar samples (of the same number) in Investigation No. 1485 reveals a great improvement in the welding technique.

SECTIONS OF VARIOUS WELDED JOINTS.

Note good fit-up, fair penetration, economical use of weld metal, and smooth weld contours.
