O T T A W A October 7th, 1943.

R E P O R T
of the
ORE DRESSING AND METALLURGICAL LABORATORIES.

Investigation No. 1507.

Examination of Two Cracked Hoover
Propeller Hub Forgings.

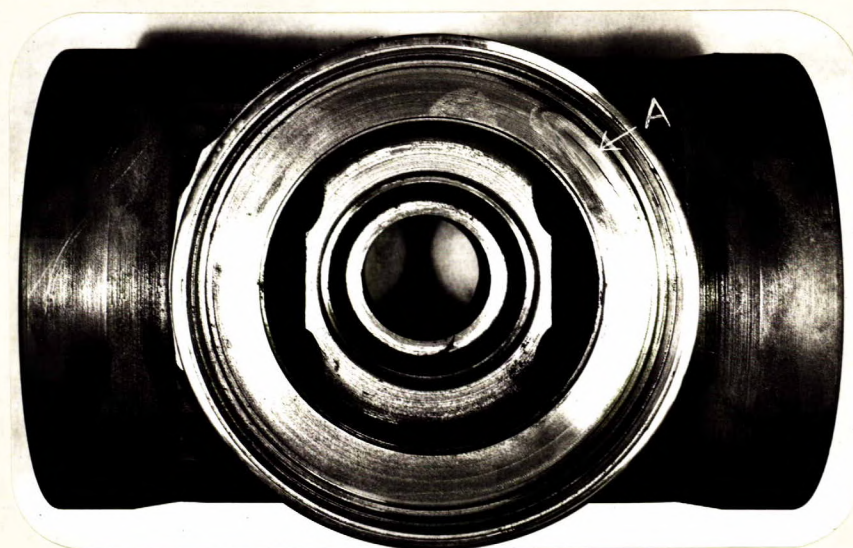
Figure 1 shows, at approximately $\frac{1}{4}$ size, a top view of one of the propellers "as received". The cracks had been previously marked by the R.C.A.F. Inspector and their presence was confirmed by the Magnaflux magnetic test. All cracks, except one, were located in the circular ring shown at "A" in Figure 1. This exceptional crack ran obliquely along the sides of the bored hole, about half-way from the top of the hub.

It was not possible to determine the point of commencement of cracking. The machining operation had taken away a good part of the crack.

SHOWING A PROPELLER HUB AS RECEIVED.

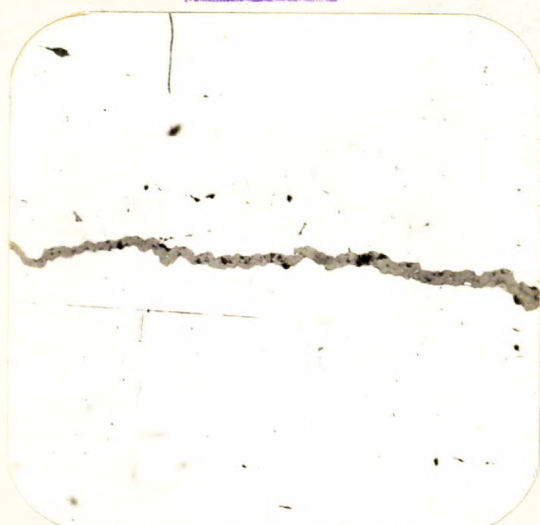
Figure 2.

All the cracks were sectioned and examined under the microscope in the unetched condition. Figures 2 and 3 show the appearance of one of the cracks, under the microscope. All the cracks found in the two hubs were analogous, each being filled completely with a similar one-phase, non-metallic inclusion. The shape of the crack-filling material definitely indicated it was not a silicate-type inclusion. Its blue colour suggested the possibility of its being a sulphide- or an oxide-type inclusion. Figure 4 shows the sample after being treated in a hydrogen atmosphere at 1100° F. The point to be noted is that the non-metallic inclusion has disappeared; this fact proves that the crack was previously filled with iron oxide (FeO).

X100, unetched.

SHOWING THE APPEARANCE OF THE
CRACK AND INCLUSION IN
THE "AS RECEIVED" MATERIAL.

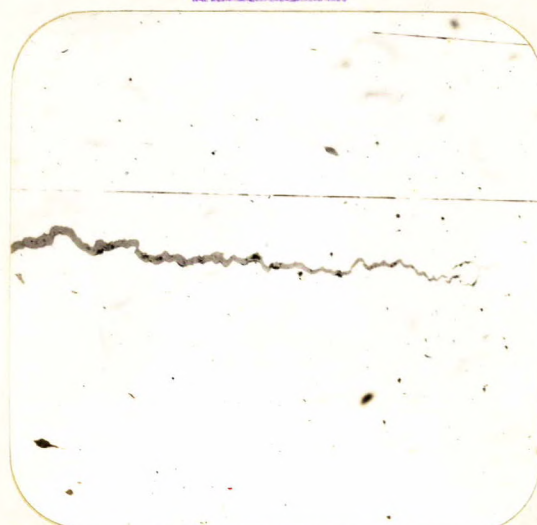
Figure 3.

X100, unetched.

SHOWING THE COMPLETE FILLING
OF THE CRACK, WITH THE
FeO INCLUSION IN THE
"AS RECEIVED" MATERIAL.

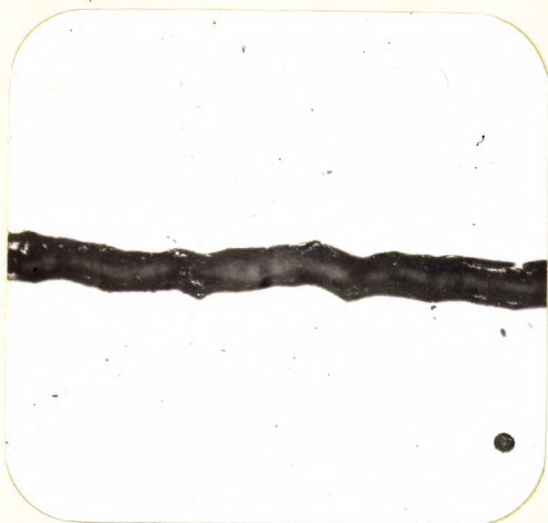
Figure 4.

X100, unetched.

SHOWING THE DISAPPEARANCE OF
THE INCLUSION AFTER TREATING
IN A HYDROGEN ATMOSPHERE
AT 1100° F.

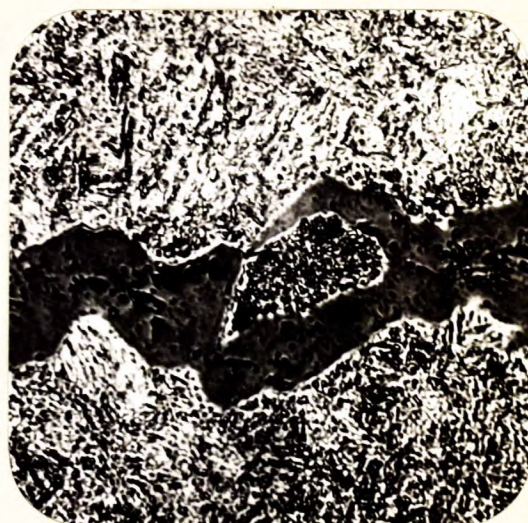
Figure 5.

Figure 5 shows the condition of the steel along the crack. Note the very slight amount of decarburization and the particle of steel entirely surrounded by the iron oxide.

The fact that the steel grain surrounded by the iron oxide eliminated the possibility of the oxide originating in the formation of the ingot. This argument was reinforced by the fact that no such heavy inclusion could be found in the steel, the cracks being confined to the surface of the machined hub. Figure 6 shows the general microstructure of the steel.

X1000, picral etch.

SHOWING THE CONDITION OF
THE STEEL ALONG THE
INCLUSION AND SLIGHT
DECARBURIZATION IN THE
"AS RECEIVED" MATERIAL.

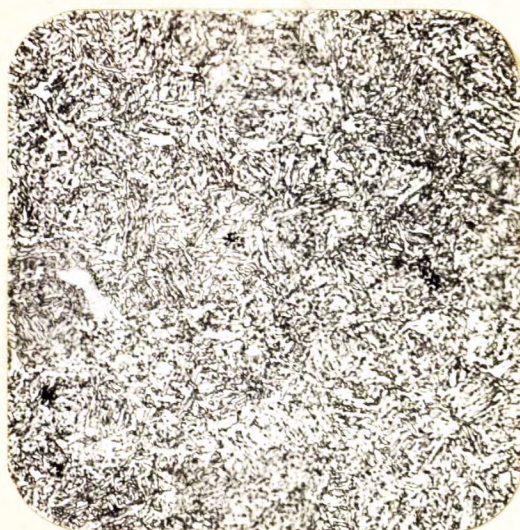
Figure 6.

X500, picral etch.

SHOWING THE MICROSTRUCTURE
OF THE "AS RECEIVED"
MATERIAL.

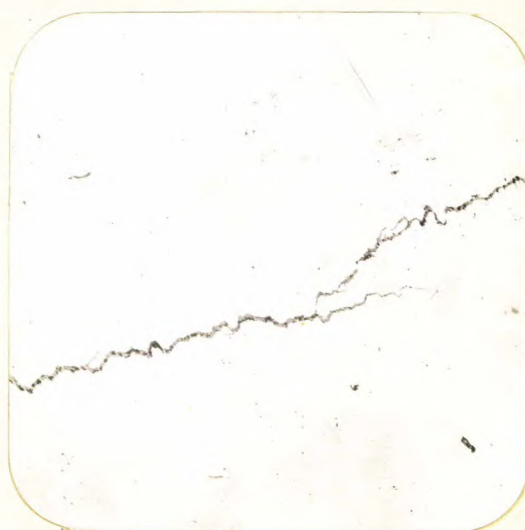
Figure 7.

It was then suggested that these cracks had formed on quenching and were oxidized during the tempering operation. However, doubt was expressed as to whether such a complete oxidation was possible. In order to check upon this statement, part of the hub was intentionally cracked by delaying the drawing after quenching in oil from 1525° F. The newly cracked specimen was drawn at 1100° F. for 5 hours. Figure 7 shows a part of the crack after the treatment. Note the complete

filling of the crack with the same type of inclusion as was found in the "as received" material. Figure 8 shows the same sample after etching. Note again the slight decarburization.

X100, unetched.

SHOWING AN ARTIFICIALLY
MADE AND OXIDIZED
CRACK.

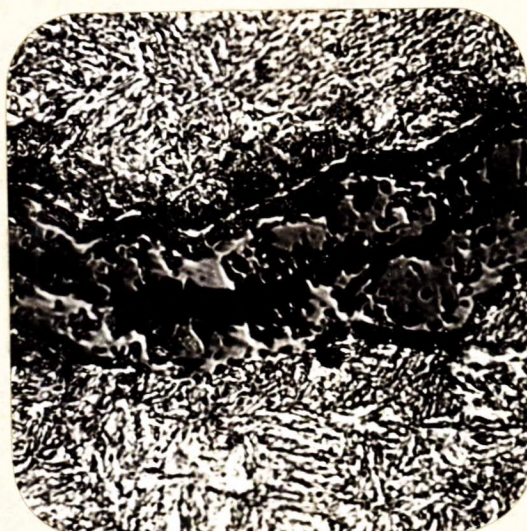
Figure 8.

X1000, picral etch.

SHOWING THE MICROSTRUCTURE AND
EXTENT OF DECARBURIZED ZONE
ALONG THE ARTIFICIALLY MADE
AND OXIDIZED CRACK.
