Investigation No. 1508.

Metallographic Examination of a Broken Ranger
Engine Crankshaft Damper Plate.

Bureau of Mines
Division of Metallic
Minerals
-
Ore Dressing
and Metallurgical
Laboratories

O T T A W A October 2nd, 1943.

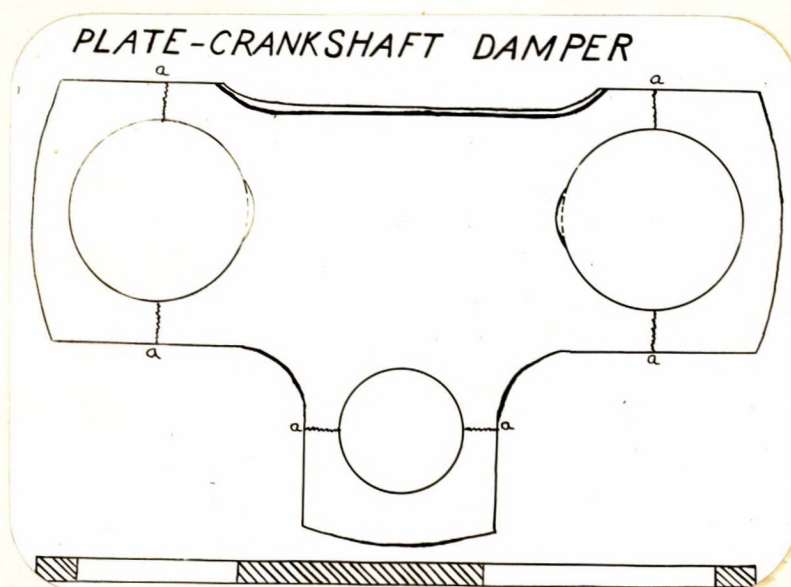
Figure 1.

The fracture, which appeared to be of the duplex type, took place at "aa" in each of the three large holes in the plate (see Figure 1).

The duplex nature of the fracture indicates that failure has been produced by the action of alternating stresses. The chemical composition requirements were found to have been met. The examination showed that the steel had been case-hardened to the specified degree, with the case and core having the specified hardness. The coarse martensitic structure indicated that the part had been quenched from well above the upper critical temperature (i.e., probably from the carburizing temperature) and had received no subsequent refinement heat treatment. The presence of grain boundary carbides is produced as a result of too intense carburization (in the absence of subsequent diffusion heat treatment) and is a definite defect, which would certainly lower the fatigue properties of the steel. Changing the carburizing conditions, or holding above the upper critical of the case for a period in a neutral atmosphere, will eliminate these weakening carbides.

The part failed in fatigue, and failure very probably was due to the presence of grain boundary carbides.

Better results might have been secured had the part been double-quenched, but adjustment of the carburizing conditions, or else the introduction of a diffusion heat treatment in order to effect elimination of free carbides, is definitely recommended. It is also considered that shot-blasting of the part is in order, as this treatment, if properly carried out, should definitely improve the fatigue strength.

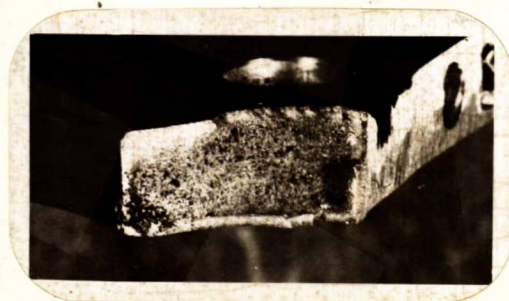
There was, however, no way of telling which section broke first. Cracks were observed in the case at one of the fractures. The fractures definitely revealed the case-hardened outer zone. One of the fractures is illustrated in Figure 2.

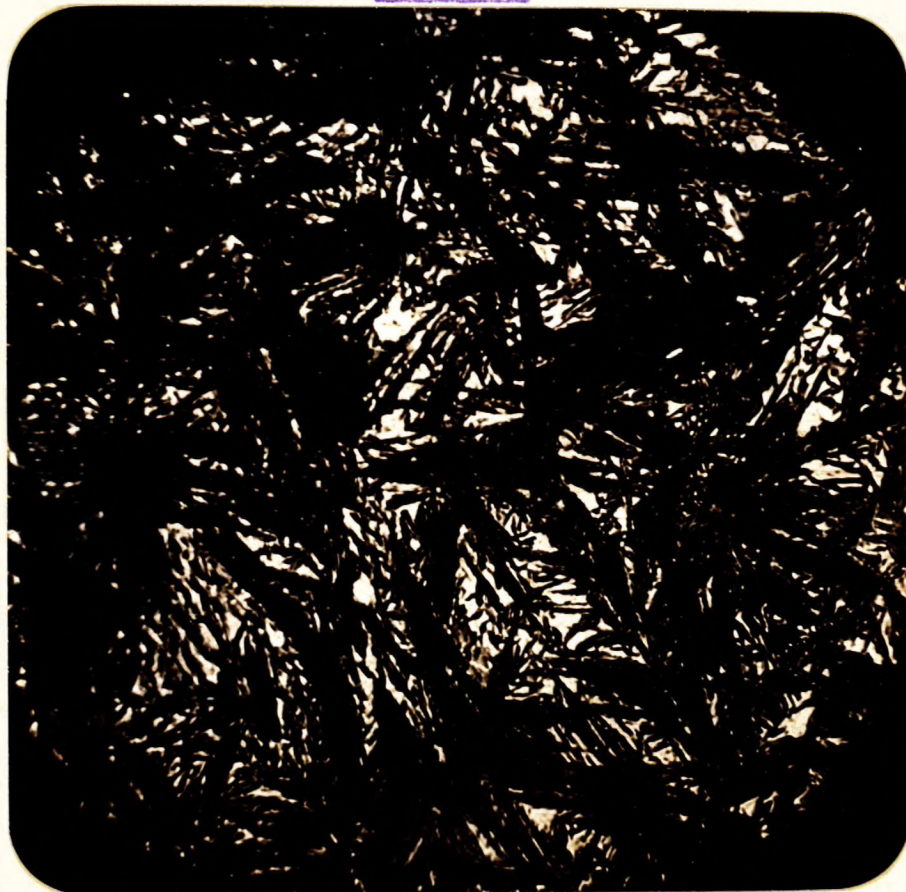
Figure 3.

Specimens cut from the plate were mounted in bakelite, polished, and examined under the microscope in the unetched condition. The steel was found to be fairly clean. The sample was next etched in a solution of 2 per cent nitric acid in alcohol and re-examined. Figure 3 is a photomicrograph, at X1000 magnification, showing the nital-etched structure of the case, which was revealed as coarse martensite. At the

extreme outer case, and especially at the corners, there was evidence of the presence of cementite (the iron carbide phase).

X1000, etched in 2
per cent nital.

STRUCTURE OF CASE.

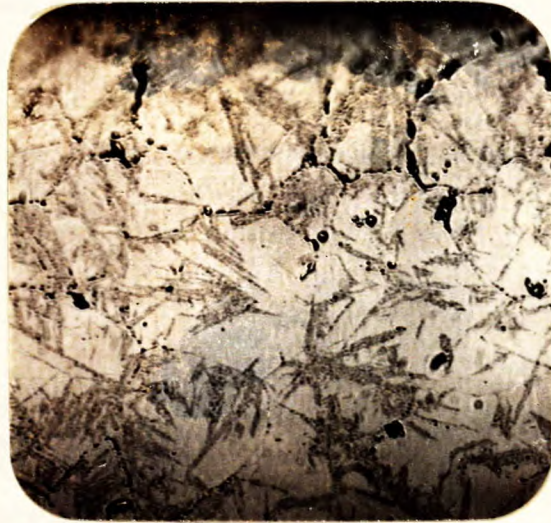
Figure 4.

To check for the presence of carbides, the specimen was re-polished and re-etched in Murakami's reagent. Figure 4, a photomicrograph at X500 magnification, shows the structure obtained. The black etching areas along the grain boundaries are carbides.

X500, etched in
Murakami's solution.

SHOWING GRAIN BOUNDARY CARBIDE.

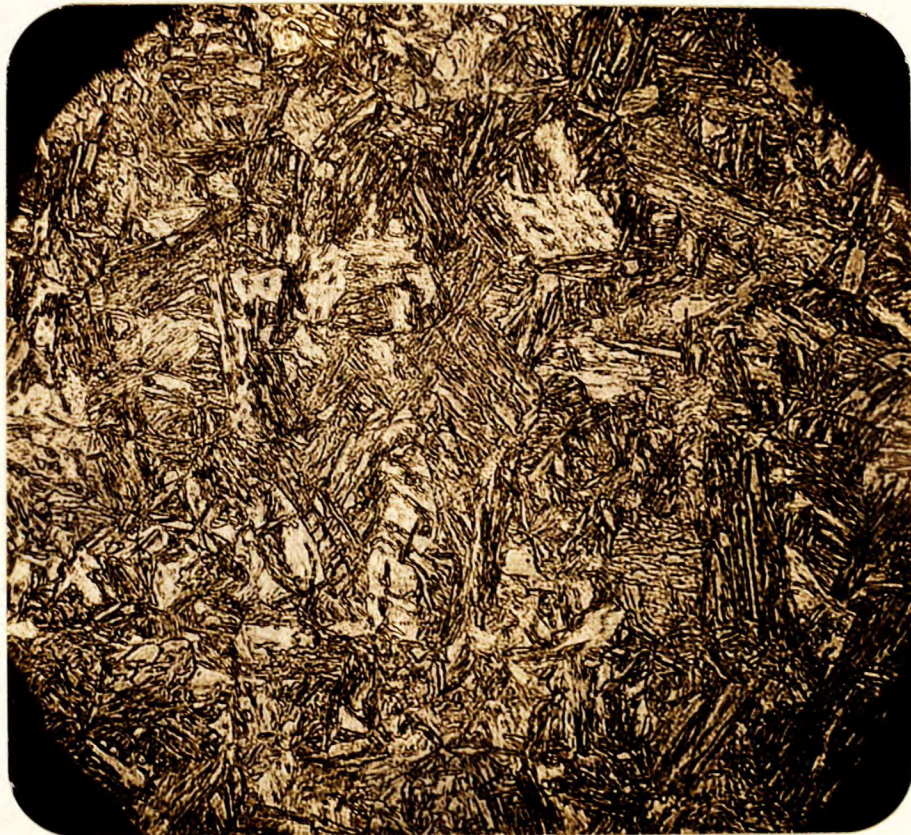
Figure 5.

Figure 5 is a photomicrograph, at X500 magnification, showing the nital-etched structure of the core. No free ferrite was observed in the core.

X500, etch in 2
per cent nital
STRUCTURE OF CORE.
