R E P O R T  
of the  
ORE DRESSING AND METALLURGICAL LABORATORIES.

Investigation No. 1515.

Examination of Four Manganese Steel Castings  
from the Sorel Steel Foundries Limited,  
Sorel, Quebec.

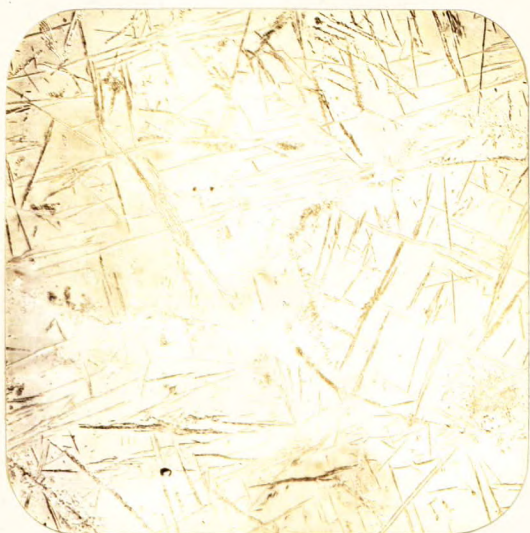
Figure 2.

CASTING NO. 1.

The presence of such large amounts of free carbides in Castings Nos. 1, 3, and 4 would have a marked embrittling effect and consequently would lead to failure under heavy impact loads. In order to get these carbides in solution the casting must be heated to the proper solution temperature (1900° F.+), and to retain them in solution the casting must be quenched rapidly in cold water. The nature of the carbides in the various castings would indicate that Steel No. 1 has escaped heat treatment and Steel No. 3 has probably been quenched from too low a temperature. Steel No. 4 has been quenched too slowly.

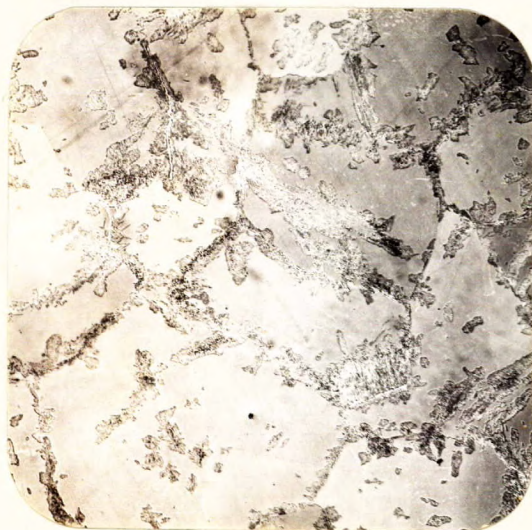
Figure 4.

CASTING NO. 3.

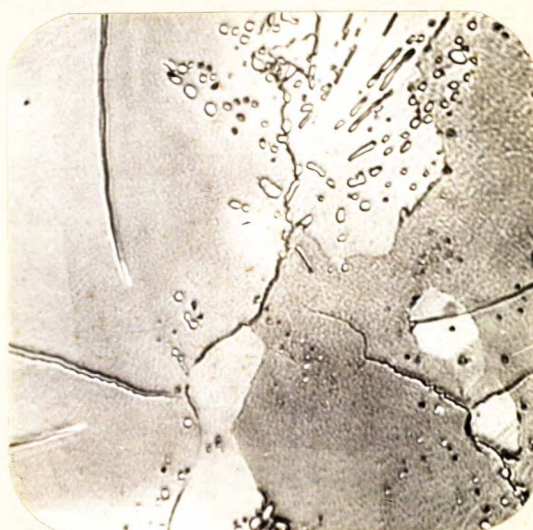
Figure 5.

CASTING NO. 4.
