ORE DRESSING AND METALLURGICAL LABORATORIES.

Investigation No. 1516.

Examination of Two Aircraft Forgings,
Part No. HP-1225.

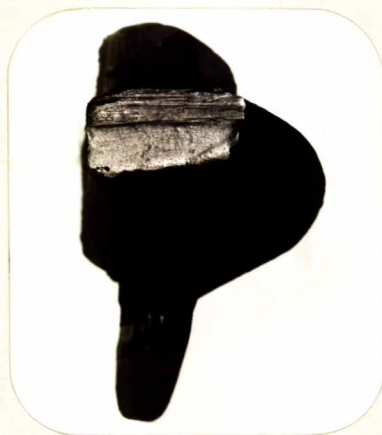
Figure 1.

Both ends of each forging were notched and broken open. The fracture, in all cases, had an appearance intermediate between silky and woody. Figure 1 is a photograph of a typical fracture.

UPPER HALF OF BREAK IS SAW-CUT
NOTCH; LOWER HALF IS FRACTURE.

If severe burning of this sample had occurred, the fracture test would be expected to show a rather coarse crystalline break. Since this was not the case and since the microscopic examination gave negative results, it is concluded that the parts were not burned in forging. In the absence of any incipient fusion, overheating in forging is of no importance, for grain size and structure are only influenced by the temperature at which the forging was finished; moreover, grain size and structure are refined by subsequent heat treatment operations.

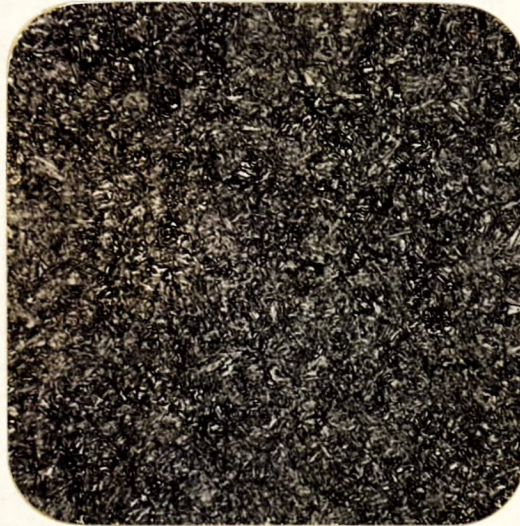
Figure 2.

Samples were removed from both ends of each forging, mounted in bakelite, and polished. Examination of the metal in the unetched and etched conditions failed to reveal positive evidence of incipient fusion or grain boundary oxidation. The structure, as shown at 250 diameters in Figure 2, is a uniform tempered martensite.

MICROSTRUCTURE OF FORGINGS.

A small forging lap, about 0.02 inch deep and 3/8 inch long, was noticed, incidentally, in one of the parts.
