ORE DRESSING AND METALLURGICAL LABORATORIES.

Investigation No. 1520.

Investigation of a Heat of 17-Pdr. A.P. Shot
Which Showed a High Percentage of Cracks
after Heat Treatment.

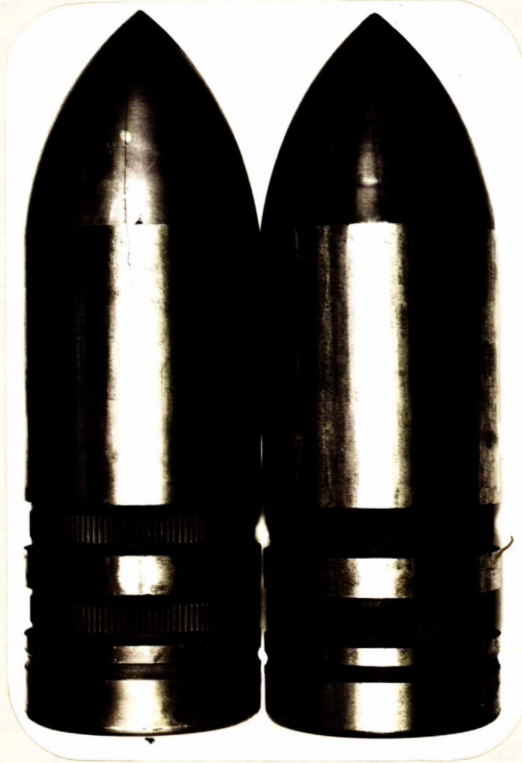
Unfortunately it was not stated whether the 12 shot sent for examination were taken from an "oil-quenched" lot or from a "water- and oil-quenched" lot. It is believed that the two shot which showed "typical cracks" were taken from an oil-quenched lot, since this type of crack is supposedly common to this type of heat treatment. The cracks may be seen in the photograph, Figure 1.

PHOTOGRAPH OF SHOT, DEPICTING
"TYPICAL" CRACKS.

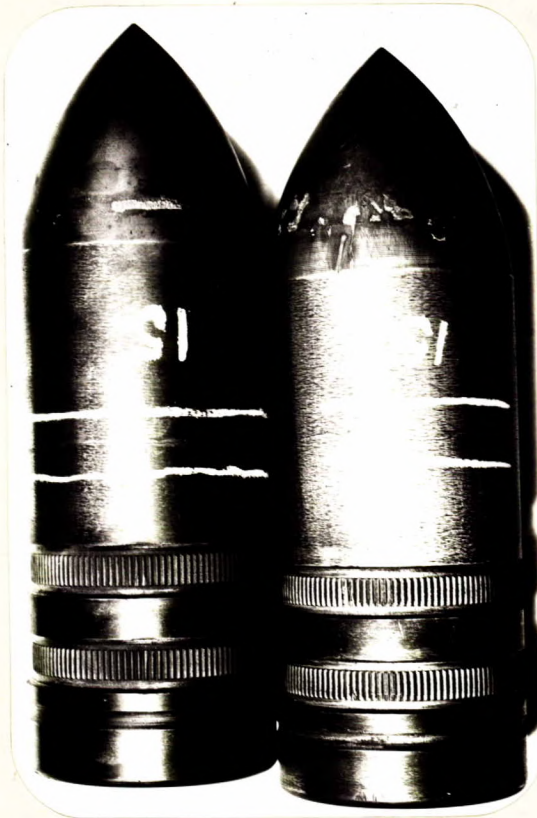
Figure 2.

Figure 2 shows the kind of circumferential cracks which developed in four of the twelve shot after etching 15 minutes.

CIRCUMFERENTIAL CRACKS DEVELOPED BY 1:1
HCl ETCHING FOR 15 MINUTES.

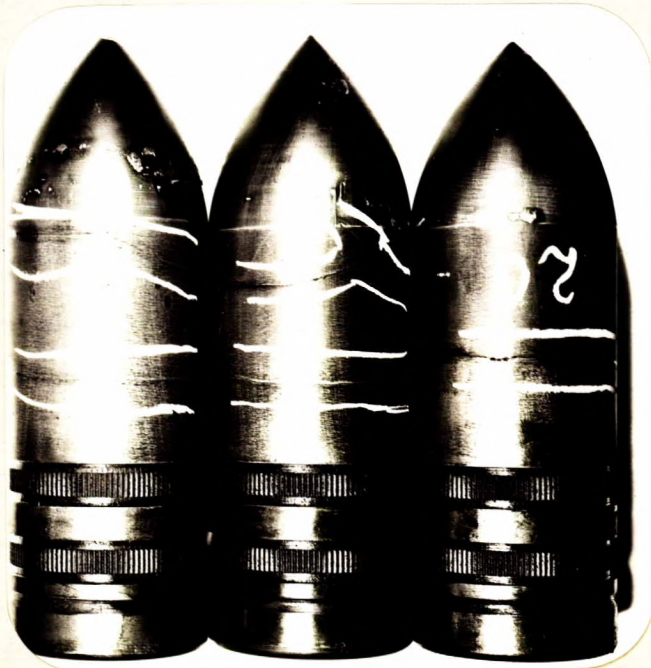
Figure 3.

Figure 3 shows the kind of circumferential cracks which developed in three of the twelve shot after etching for 20 minutes.

CIRCUMFERENTIAL CRACKS DEVELOPED BY 1:1
HCl ETCHING FOR 20 MINUTES.

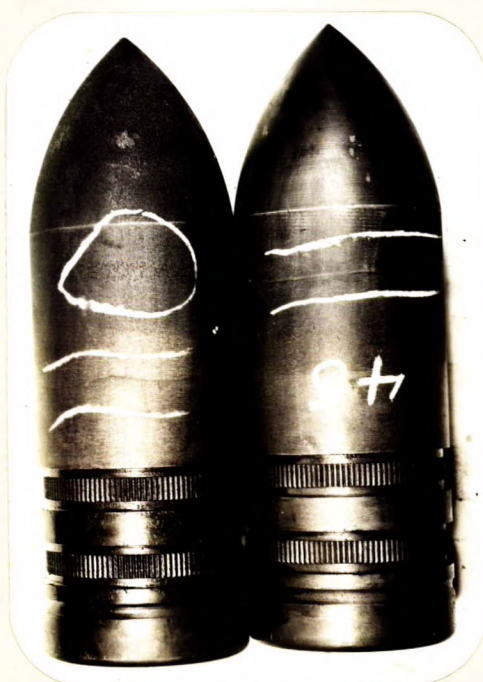
Figure 4.

Figure 4 shows the kind of circumferential cracks which developed in two of the twelve shot after etching for 45 minutes. None of the shot cracked longitudinally, which indicates that all twelve shot came from a lot which had been partially water-quenched and then oil-quenched, since this type of crack is common to that heat treatment.

CIRCUMFERENTIAL CRACKS DEVELOPED BY 1:1
HCl ETCHING FOR 45 MINUTES.

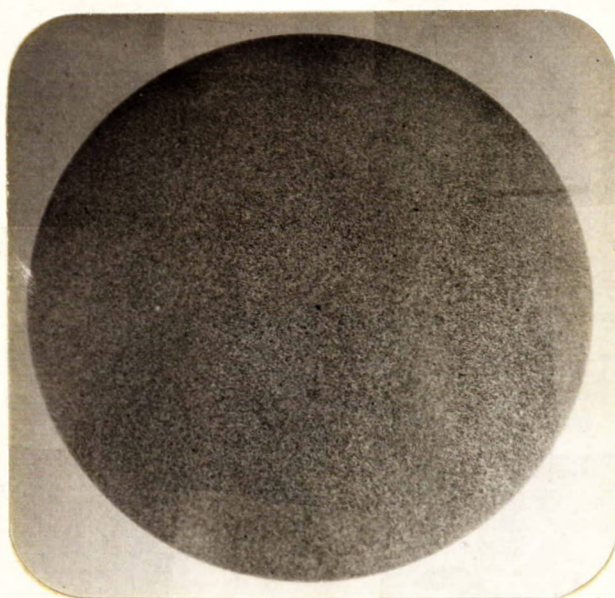
One of the six unheat-treated shot was ground and etched on the cross-section in a 10 per cent solution of ammonium persulphate. The etched surface is shown in Figure 5.

MACRO-ETCHED SURFACE.

The cross-section was then reground and etched in 50 per cent boiling hydrochloric acid for half an hour. The etched surface was similar to that in Figure 5, showing that the steel is quite sound.
