ORE DRESSING AND METALLURGICAL LABORATORIES.

Investigation No. 1523.

Examination of Six Malleable Iron
Universal Carrier Track Links.

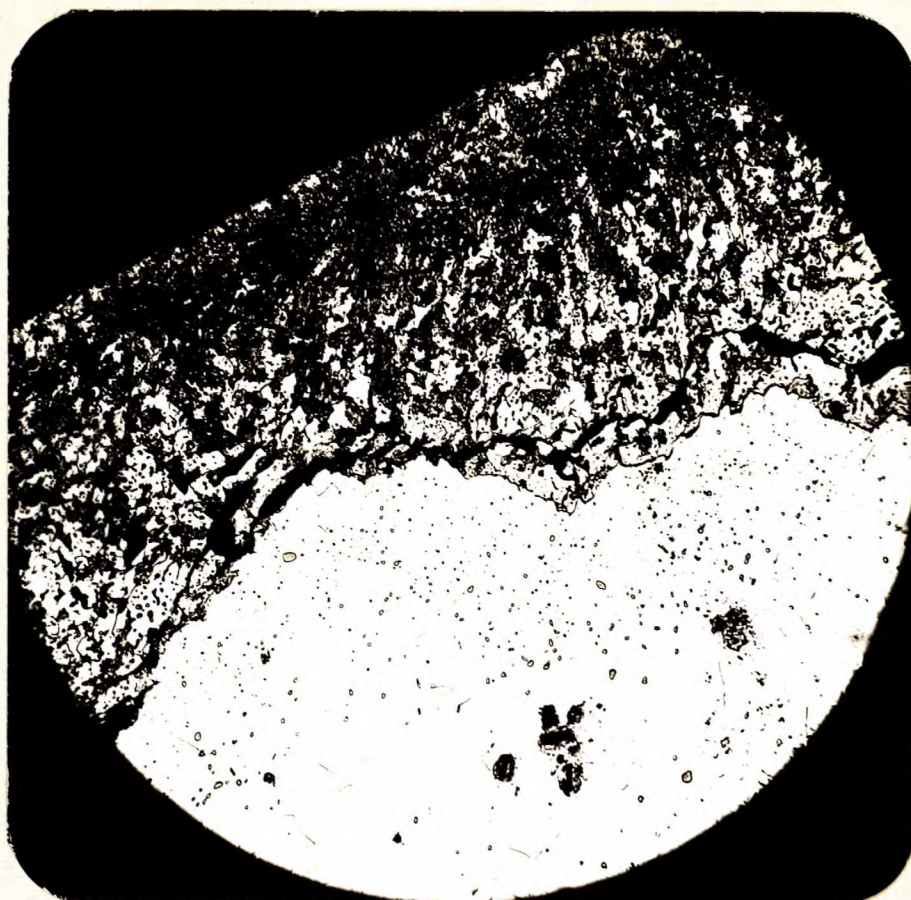
Figure 1.

Microscopic examination revealed that the links had typical structures at the surface, i.e., an outer cyanide layer backed by an area of ferrite. (See Figure 1).

X200, nital etch.
CASE AND FERRITE AREA.

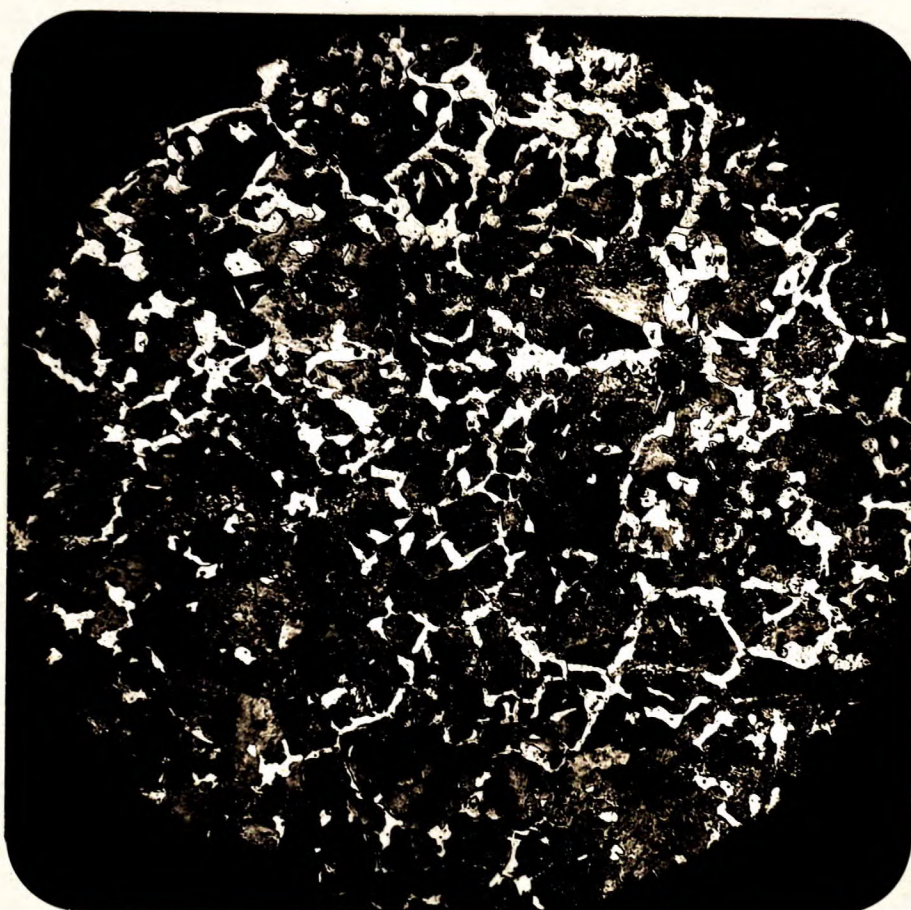
Figure 2.

The structure of the remainder of the eye-hole wall and the grouser was also typical, consisting of a zone of mixed ferrite and pearlite bordering an area composed of temper carbon in a background of pearlite containing small particles of cementite. These structures are shown in Figures 2 and 3.

X200, nital etch.
ZONE OF MIXED FERRITE AND PEARLITE.

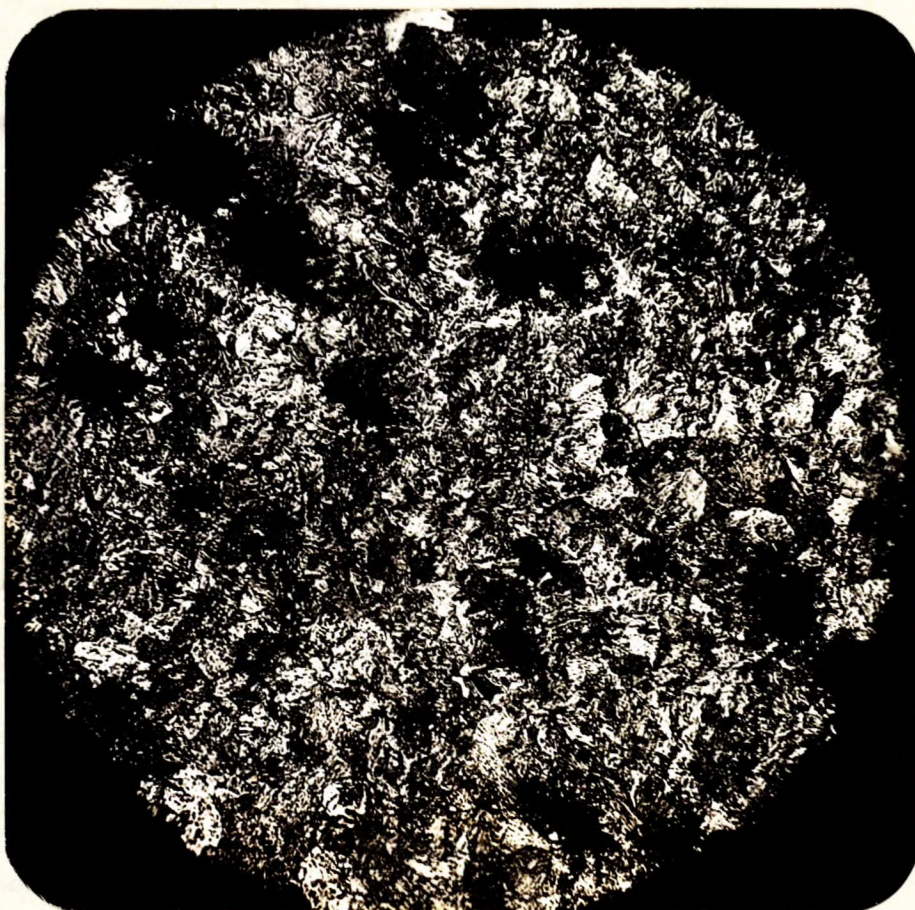
Figure 3.

X200, etched in 2 per cent nital.

TEMPER CARBON IN BACKGROUND OF PEARLITE
AND SMALL PARTICLES OF CEMENTITE.
