ORE DRESSING AND METALLURGICAL LABORATORIES.

Investigation No. 1527.

Examination of a Steel Generator Shaft
Which Failed Prematurely in Service.

November 5th, 1943.

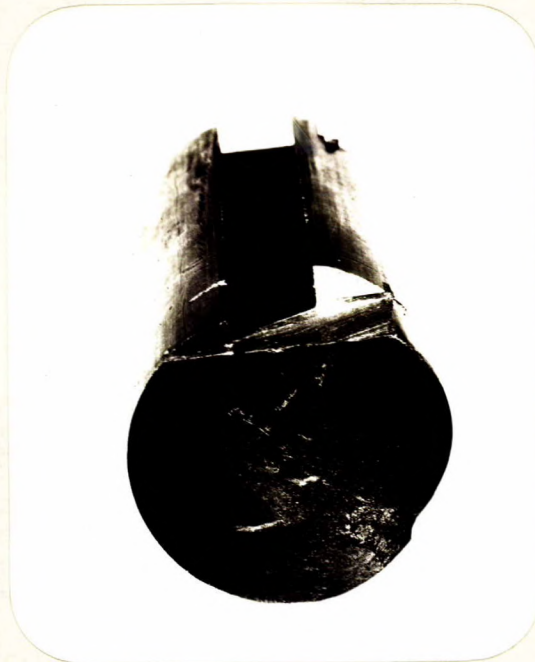
Figure 1.

Note: Some samples for microscopic examination were removed before this photograph was taken.

The fracture appears to be of the duplex fatigue type but its exact nucleus was not ascertainable.

onto this end of the shaft. Since the metal near the failure had dark tempering colours, the temperature employed in this operation must have been fairly high. The keyway in the part (see Figure 1) apparently is an additional insurance against slip.

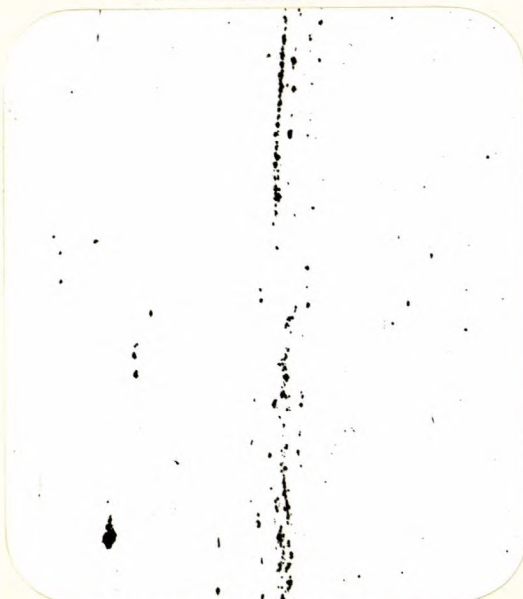
Figure 2.

Figure 2, a photomicrograph of the unetched steel near the point of failure, shows that it is very dirty. After an etch of 2 per cent nitric acid in alcohol had been applied, the structure was seen to consist of pearlite and ferrite (see Figure 3).

X100, unetched.

The sharp changes of section characterizing the keyway in this shaft would result in stress concentrations. Large inclusions present in the metal would have a similar effect.

than at present (possibly 250-275 V.H.N.). This hardness is mentioned because it is understood that machining is to be done after heat treatment. The inclusion content of the steel should be lessened.

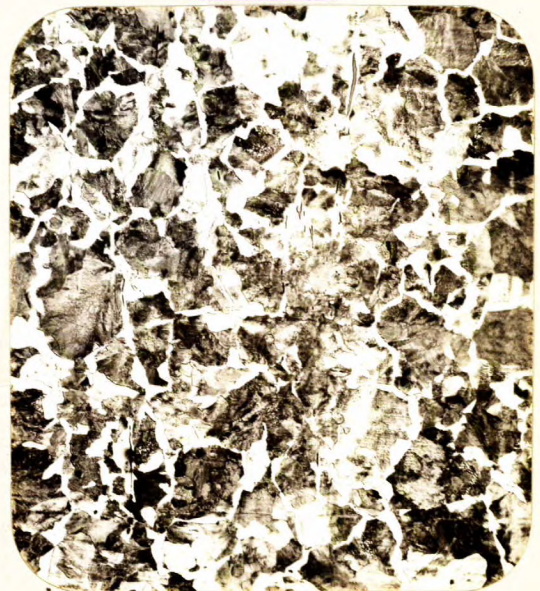
Figure 3.

X100, etched in 2 per cent nital.

Microscopic examination (by revealing the presence of considerable areas of ferrite) definitely shows that the part was normalized (air cooled) rather than quenched and drawn. Since this air-cool heat treatment left the steel in a comparatively soft condition, its fatigue-resisting properties are at a practical minimum.

1. If a fully heat-treated, more highly alloyed steel is not available, the steel at present in use (SAE 5135) should be given a quench-and-draw heat treatment (with a quench following the draw), so that its final hardness is somewhat higher
