Investigation No. 1528.

Examination of a Cracked Mosquito
Aircraft Rudder Pedal Bar.

Bureau of Mines
Division of Metallic
Minerals

Ore Dressing
and Metallurgical
Laboratories

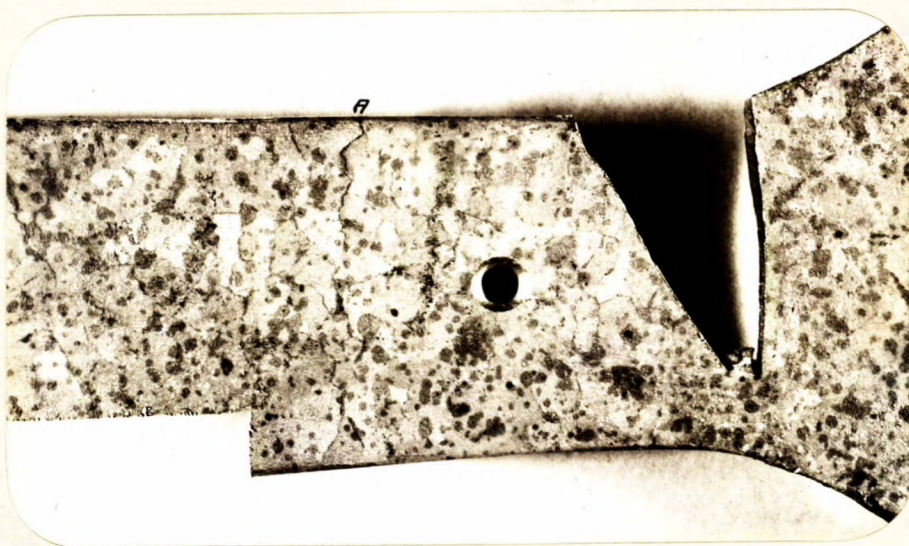
Part of the largest crack in the bar can be seen at A, in Figure 1.

(Approximately to size).
Note: Specimens were removed at cut areas prior to photographing.

A low-power binocular microscope disclosed the presence of numerous other fine intercrystalline cracks. The surface of the bar around many of these fine cracks was stained yellow. Some of these stains may be seen in Figure 1.

Since it is probable that the yellow stains on the surface of this pedal bar around some of the intercrystalline cracks were caused by electrolyte from the anodising operation

being retained in the cracks and later seeping out, cracks very likely were present before the anodising operation was completed. These cracks could have been formed in cooling from the casting temperature or (and) the solution heat treatment.

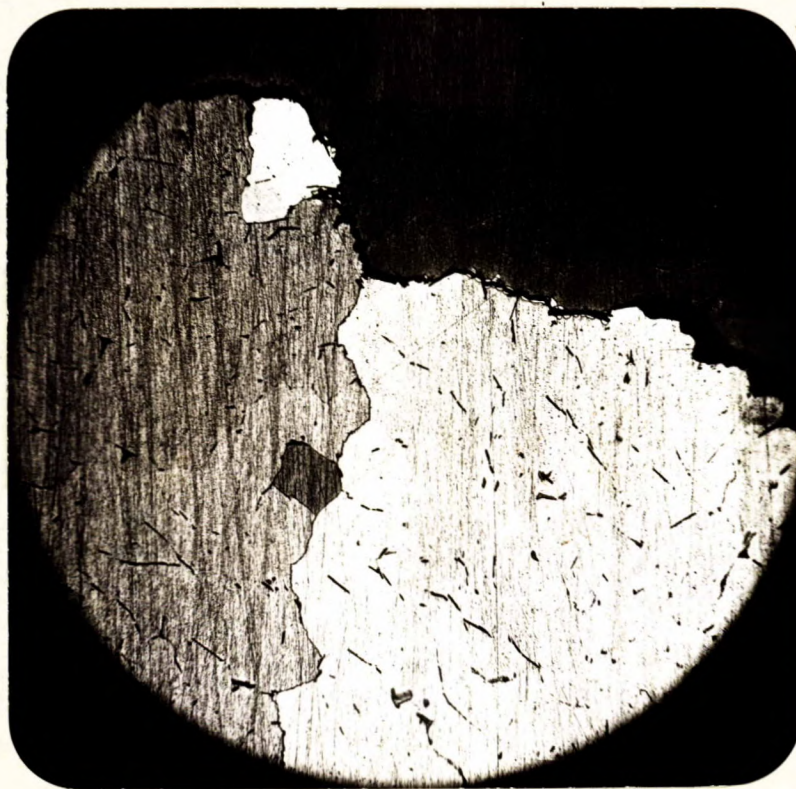
Figure 2.

A copper-aluminium eutectic constituent was segregated along a few preferred grain boundaries. A second constituent, evidently aluminium-copper-iron, was seen in the grains and on the grain boundaries. Figures 2 and 3, photomicrographs at 100 and 250 diameters respectively, illustrate these points.

X100, Keller's etch.

Note intercrystalline crack. Copper-aluminium eutectic (white globular constituent) is segregated on preferred grain boundaries. Aluminium-copper-iron is black oblong constituent.

The coarse grains present, accompanied by this preferential segregation, indicate that this part was cast from too high a temperature. In this regard W. C. Devereux* states:

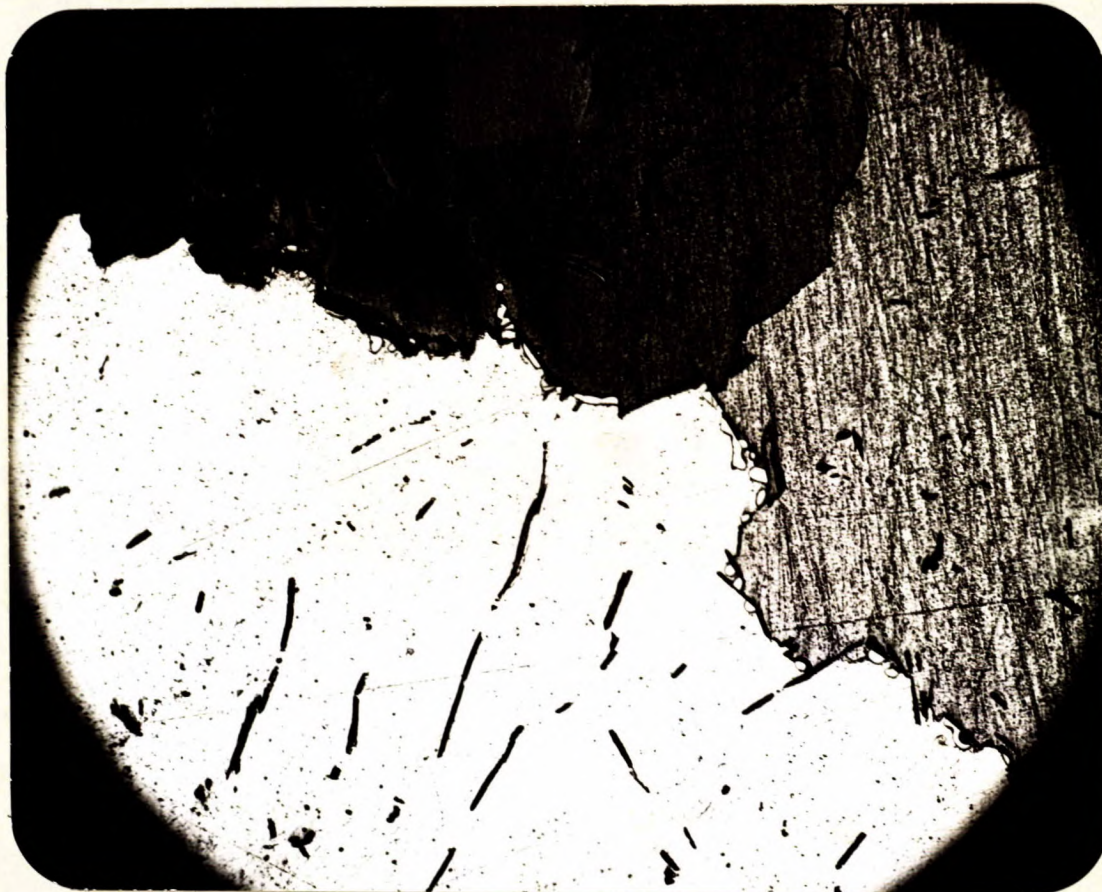
Figure 3.

X250, Keller's etch.

Note intercrystalline crack. Copper-aluminium eutectic (white globular constituent) segregated along preferred grain boundaries, and aluminium-copper-iron (black oblong constituent) on the grain boundaries and in the grains.
