Investigation No. 1529.

Examination of Two Broken Shafts
from Two Double-Worm Speed Reducers
Used in Operating a Peatty Naval Training
Tilting Platform.

Examination of Two Broken Shafts from Two Double-Worm Speed Reducers Used in Operating a Peatty Naval Training Tilting Platform.

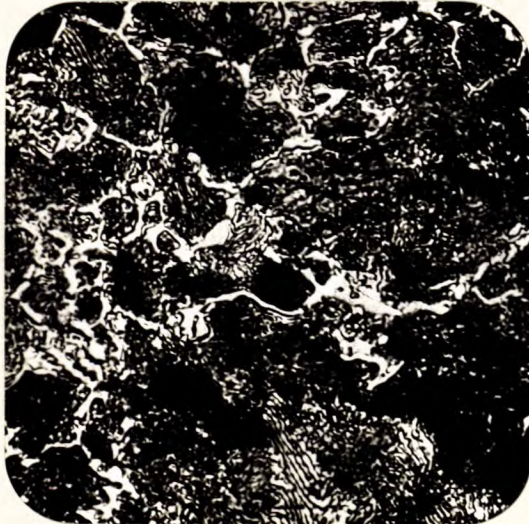
Figure 1.

Specimens were cut from each shaft near the point of failure and prepared for microscopic examination. The steels of the two shafts were examined under the microscope in the unetched condition and found to be fairly clean. Figures 1 and 2 are photomicrographs, at X1000 magnification, showing the nital-etched structure of the case of the shaft of Reducers Nos. 1 and 2 respectively. The samples were over-etched in order to make easier the identification of the free carbide particles. The background is pearlite, the iron-iron carbide eutectoid. This pearlite appears lamellar in certain areas which etch more lightly. Apart from these lamellar areas, all other white etching material is iron carbide. Figures 3 and 4 are photomicrographs at X100 magnification and show respectively the nital-etched structure of the core of the shaft of Reducers Nos. 1 and 2. Here the light areas are

X1000, etched in 2
per cent nital.

CASE, NO. 1 REDUCER SHAFT.

Hardness tests revealed that only the worm part of the shafting had been hardened in heat treatment. The soft case at the point of fracture would have relatively low fatigue strength and this fatigue strength would be further lowered by the presence of free carbides in the case (as revealed in the microscopic examination). The percentage of ferrite and pearlite in the core, and the lamellar nature of the pearlite in both case and core, both indicate a relatively slow cooling from well below the upper critical range. The coarseness of the pearlite and the general structure of the case of Shaft No. 1 indicate that the portion at the point of failure was cooled in the box as a final heat treatment. The low hardnesses of the case and core are also consistent with this assumption. In Shaft No. 2, greater fineness of structure, and higher hardness at the point of failure, indicate that this material was finally normalized. Assuming that both steels had the same inherent grain size and were carburized at the same temperature, one could assume from the greater fineness of structure of Shaft No. 2 that this steel was normalized subsequent to carburizing rather than removed from the box and cooled in air. If, however, these two steels had markedly different inherent grain sizes and carburizing temperatures, this assumption is not necessarily correct.

The presence of a soft, high-carbon case in the shaftings is considered to have been responsible for these premature failures under alternating stresses. It is considered that the steels should be used in the hardened

condition and that the carbon in the case should be as nearly the eutectoid composition as possible. As an alternative, a medium-carbon steel might be used. Shotblasting should also be considered.

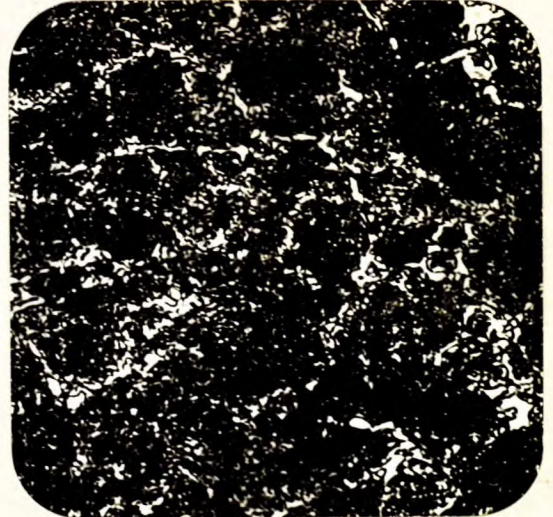
Figure 2.

X1000, etched in 2
per cent nital.

CASE, NO. 2 REDUCER SHAFT.

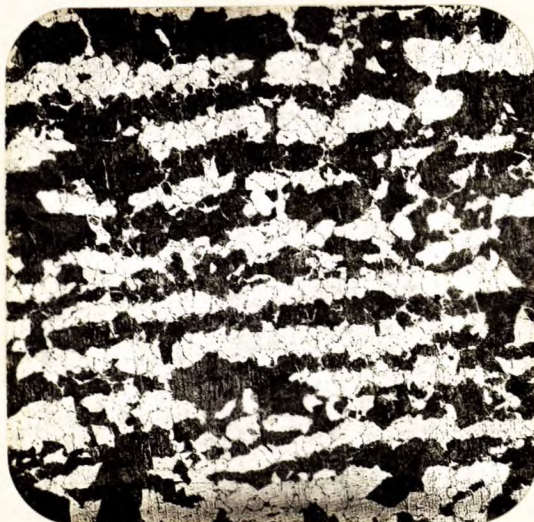
Figure 3.

ferrite (the iron constituent) and the dark etching material is pearlite.

X100, etched in 2
per cent nital.

CORE, NO. 1 REDUCED SHAFT.

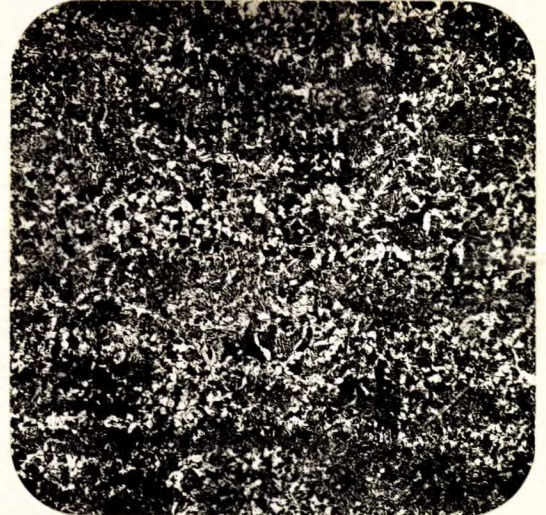
Figure 4.

X100, etched in 2
per cent nital.

CORE, NO. 2 REDUCED SHAFT.
