R E P O R T  
of the  
ORE DRESSING AND METALLURGICAL LABORATORIES.

Investigation No. 1532.

Examination of Welds Cut from Compressed Air  
Reservoirs, C Mk. 1A (E. Leonard & Sons, London, Ontario).

CANADA  
DEPARTMENT  
OF  
MINES AND RESOURCES  
Mines and Geology Branch  
O T T A W A November 13th, 1943.

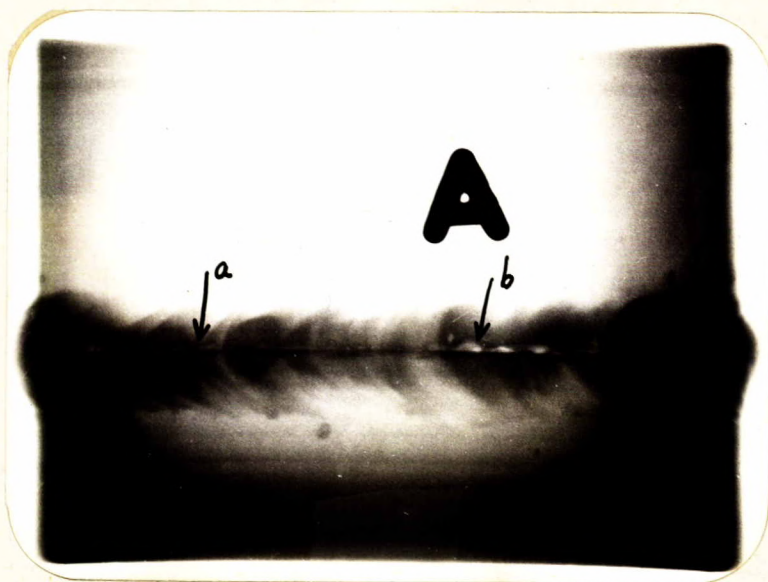
Figure 1.

As is shown by the exographs, the welding defects are numerous and of a serious nature. This is confirmed by the macro and micro samples. The defects found (see Figures 11 and 12) are lack of penetration, lack of fusion, entrapped slag, high piled-up welds, and improper alignment of edges to be welded.

SECTION A - TOP WELD.

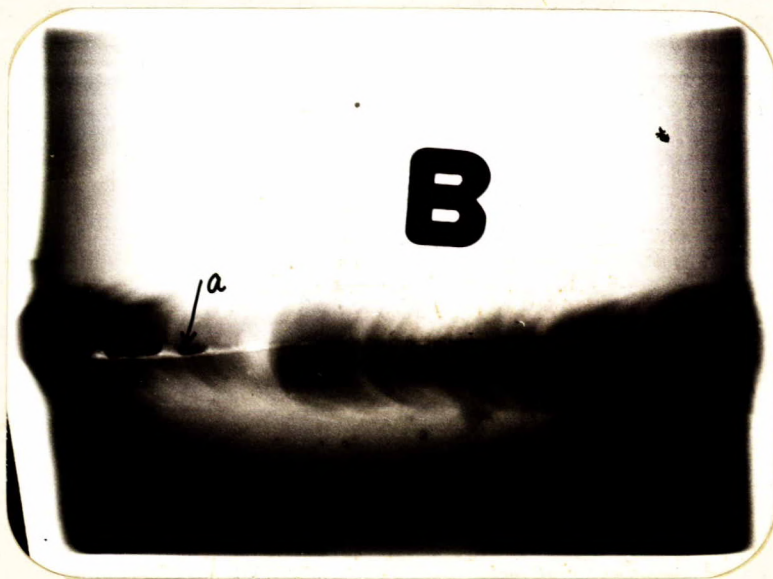
Figure 2.

Samples from the top weld show two passes (Sample C) and others from the same weld only one pass (Sample B). It would appear that this is the result of the use of a small diameter electrode in the root pass to secure improved penetration and to cope with variations in root gap. This points to an irregular technique varying considerably from that stated to be used.

SECTION B - TOP WELD.

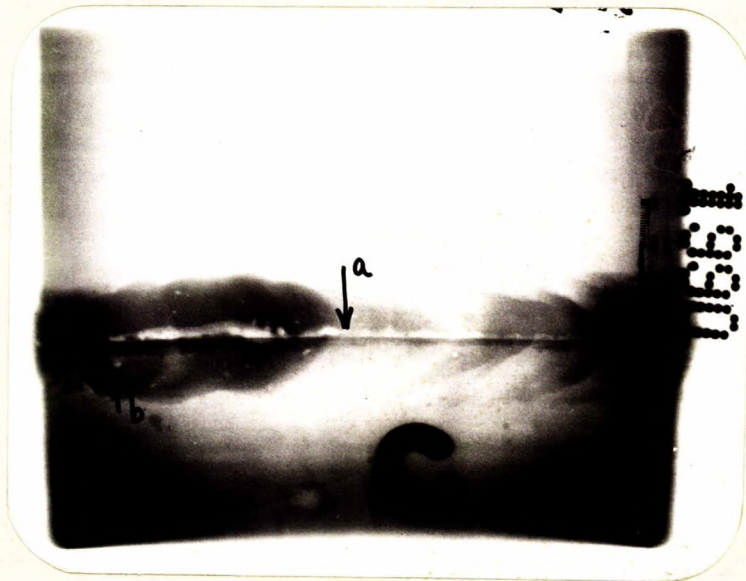
Figure 3.

SECTION C - TOP WELD.

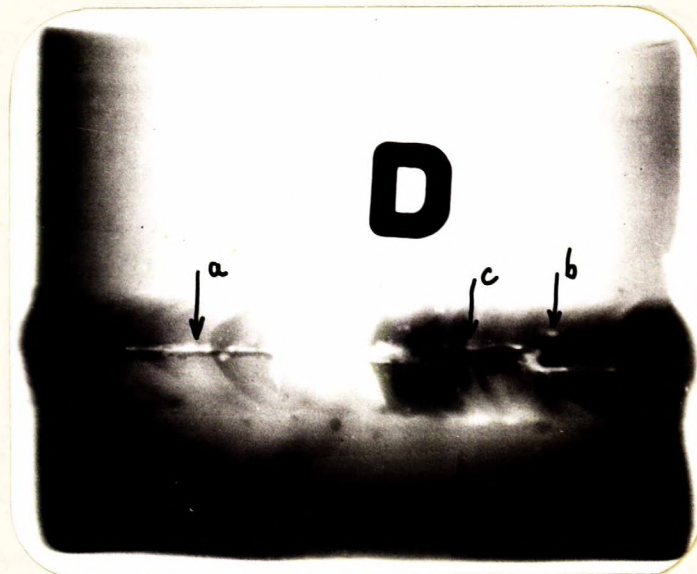
Figure 4.

SECTION D - TOP WELD.

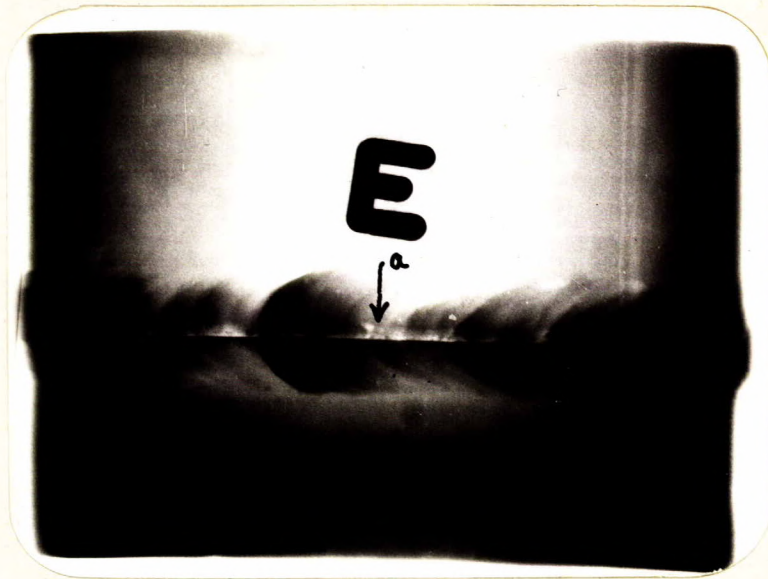
Figure 5.

SECTION E - BOTTOM WELD.

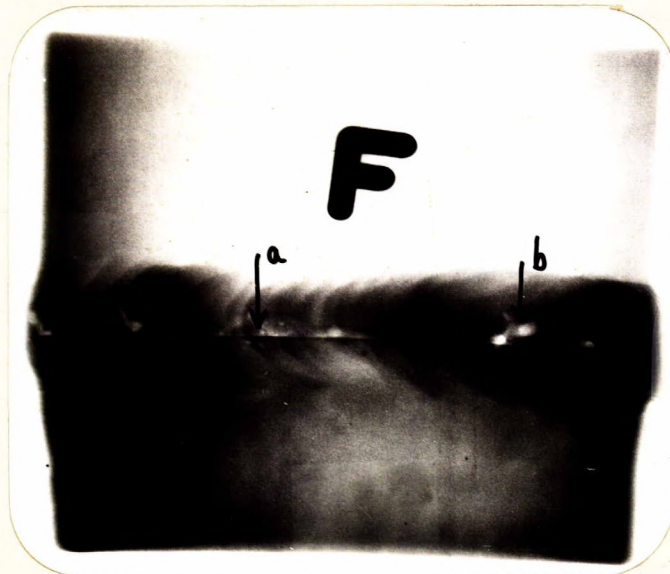
Figure 6.

SECTION F - BOTTOM WELD.

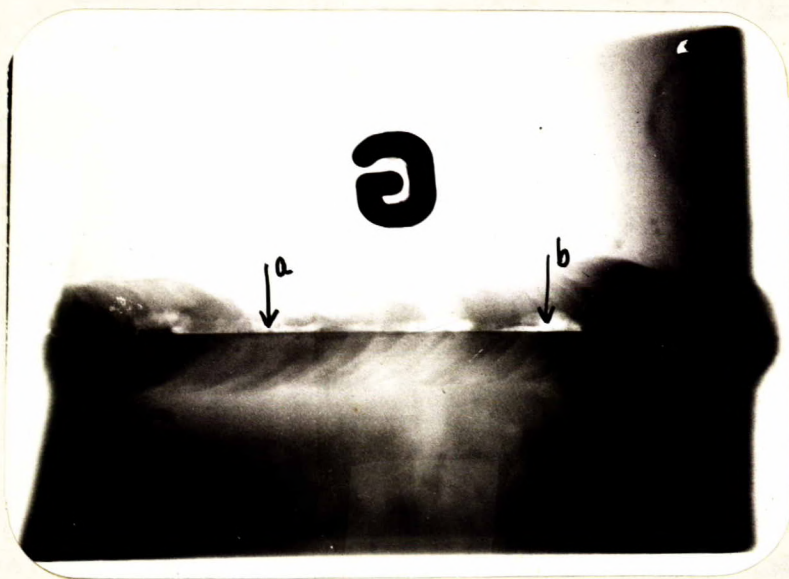
Figure 7.

SECTION G - BOTTOM WELD.

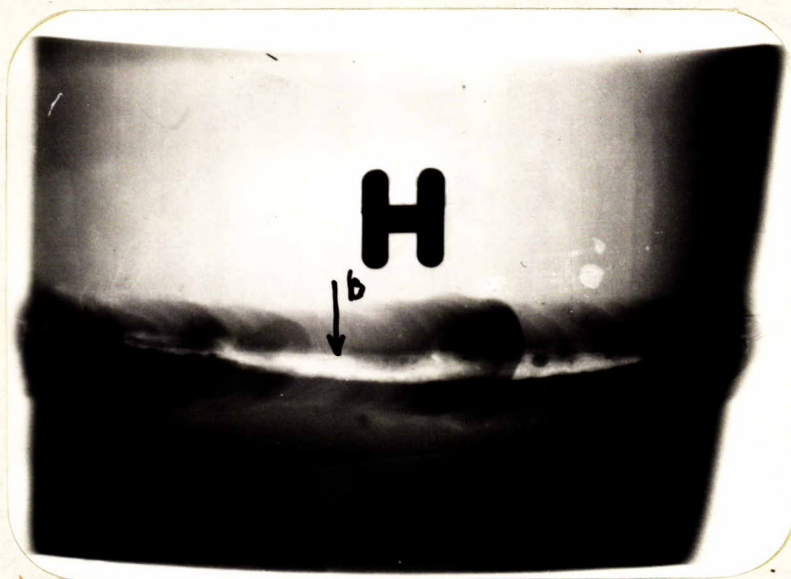
Figure 8.

SECTION H - BOTTOM WELD.

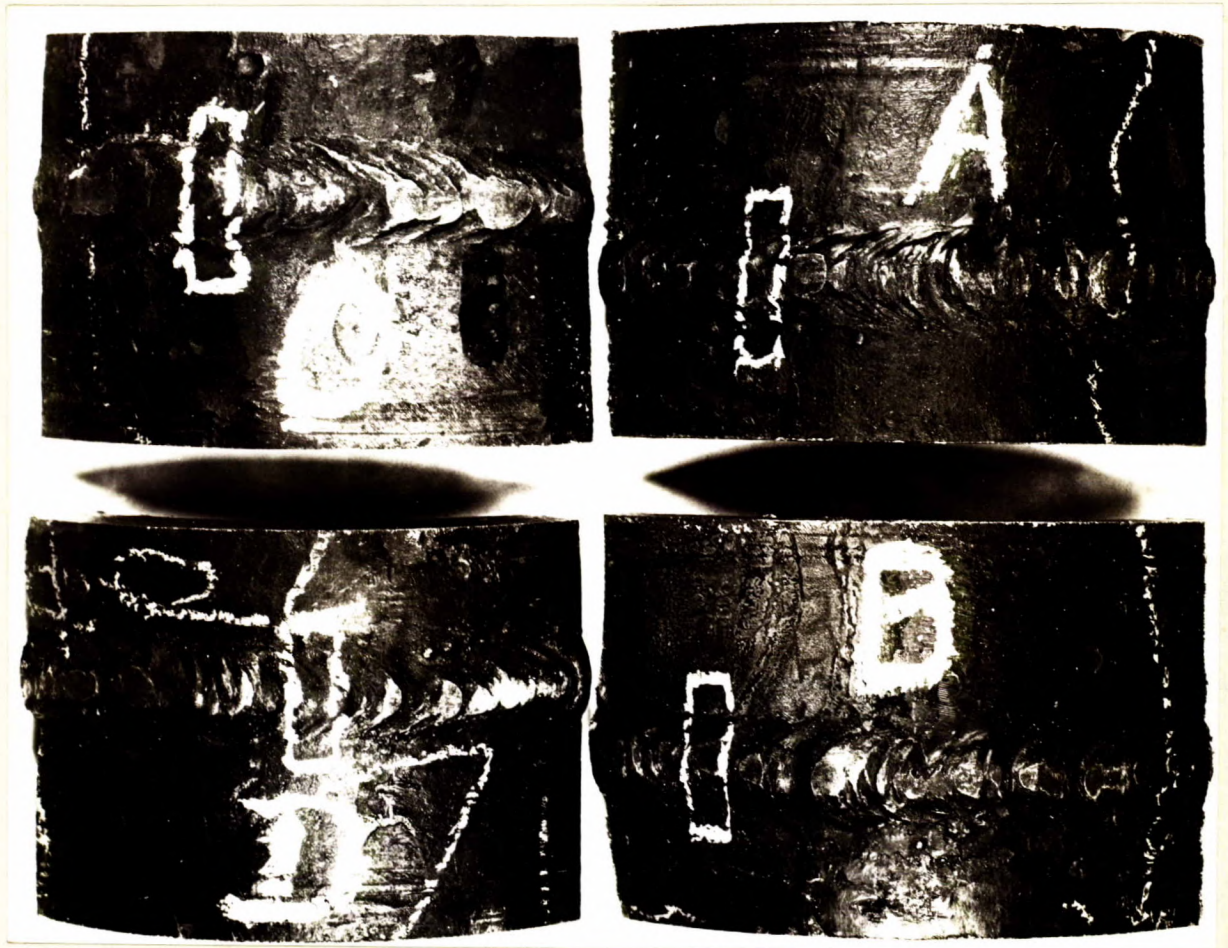
Figure 9.

High piled-up welds are common, apparently in an attempt to mask defects known to be present or to provide additional strength. It is a common belief that this added weld metal enhances the strength of the weld, whereas the complete reverse is actually the case.

SAMPLES A, B, C, and D - TOP WELD AS RECEIVED.

Note high piled-up welds. White rectangles indicate areas from which macro samples were machined.

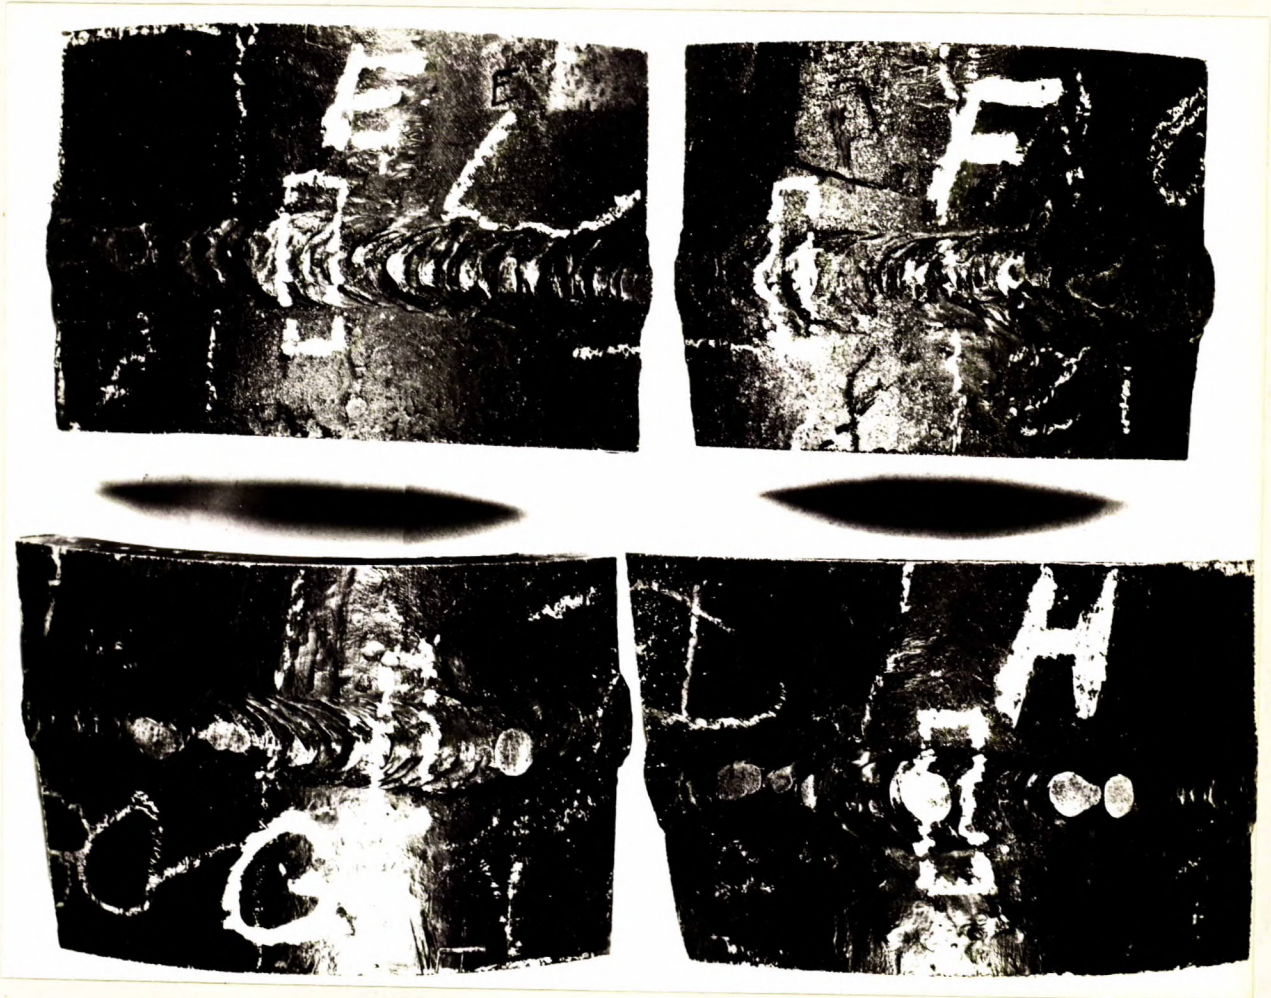
Figure 10.

SAMPLES E, F, G and H - BOTTOM WELD AS RECEIVED.

Note high piled-up welds. White rectangles indicate areas from which macro samples were machined.

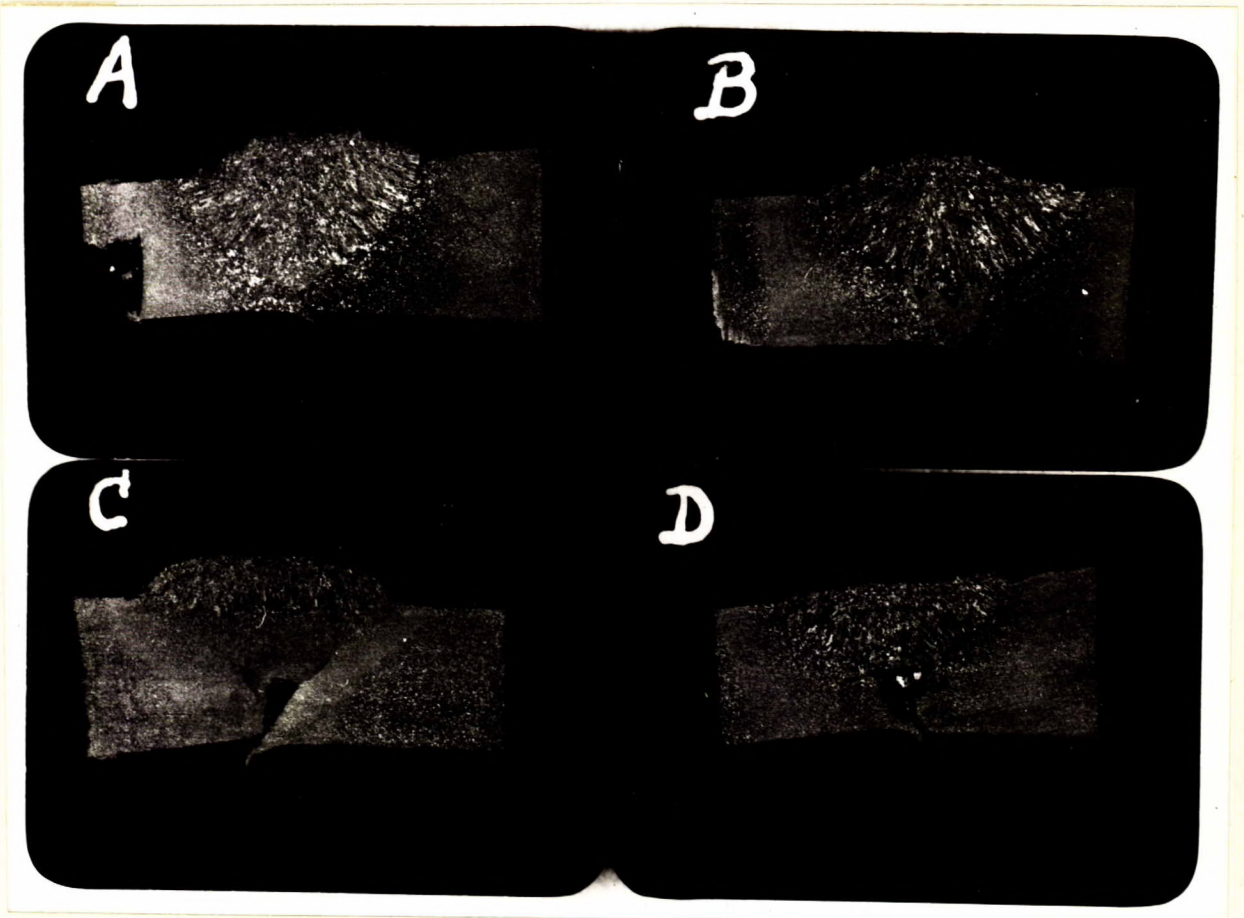
Figure 11.

In the majority of cases the penetration secured does not exceed 50 per cent, the figure being based on the thickness of the thinnest section. This is the result of ignoring the specified 1/8" root gap. As shown by the macro samples, the root gap has varied from zero to 1/8". Where the

proper root gap has been used the specified angle of bevel (60° included angle) had been ignored. The function of the 1/8"-root gap is to permit complete penetration of the molten weld metal.

MACRO SAMPLES OF TOP WELD.

Note incomplete penetration, slag inclusions,  
and lack of fusion. Note also varying  
number of passes.

1. The edge preparation specified, if followed, would permit production of a good weld. It is recommended that these instructions be rigidly followed.

5. Every effort should be made to secure the specified root gap to permit complete penetration.

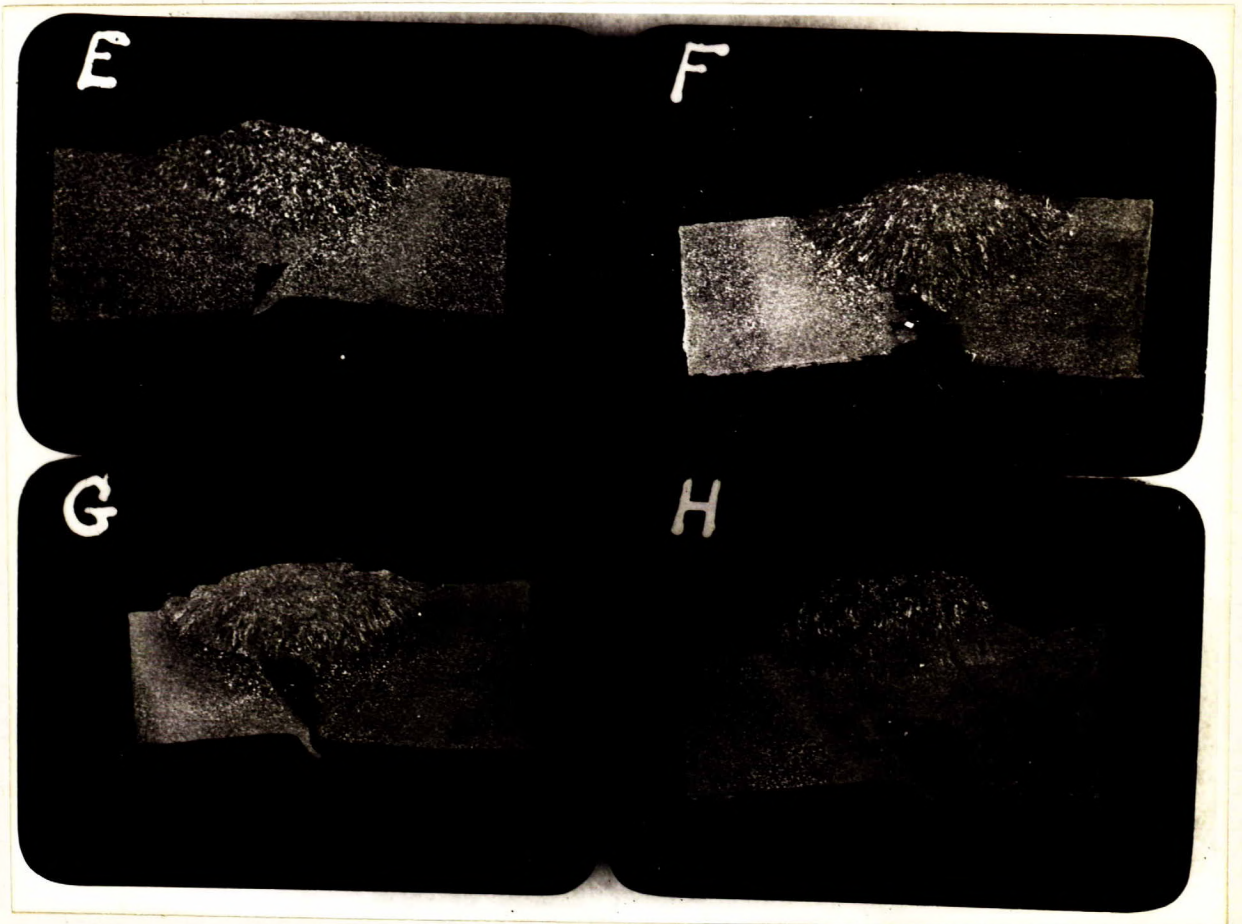
Figure 12.

MACRO SAMPLES OF BOTTOM WELD.

Note incomplete penetration, slag inclusions,  
and lack of fusion. Note also variations  
in root gap.

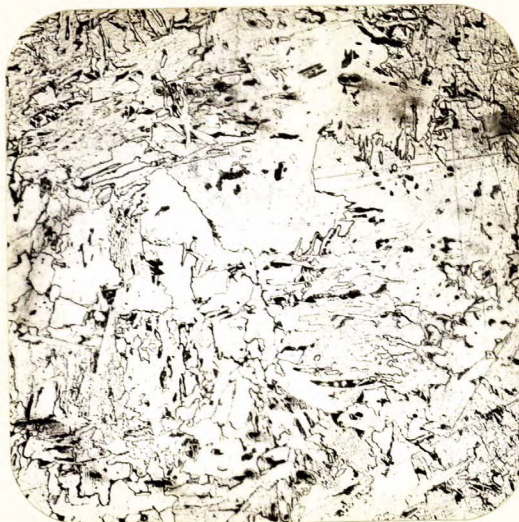
Figure 13.

(4) Figure 13 shows the coarse-grained structure adjacent to weld in Sample A, and Figure 14 is the banded structure of the tube remote from the weld of Sample A. Figure 15 is the fine-grained structure adjacent to weld of Sample C. Figure 16 is a typical normalized structure of the tube remote from the weld of Sample C.

Although all samples were stated to have come from the same reservoir (No. 712), it is apparent from the microstructures that such is not the case. Some have been removed from a normalized reservoir and some from "as-welded" reservoirs.

SECTION A; COARSE-GRAINED STRUCTURE ADJACENT TO WELD.

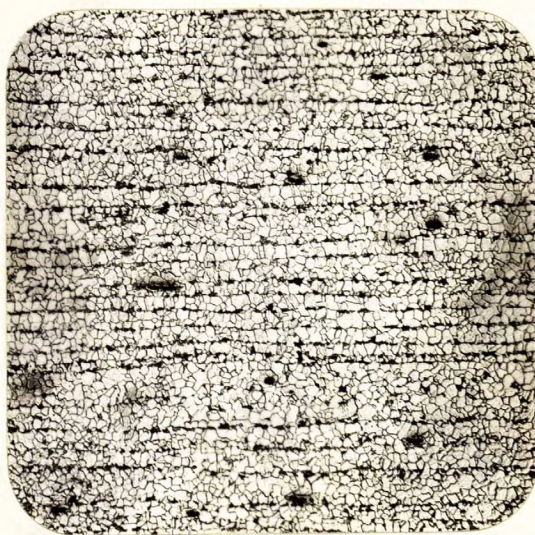
Figure 14.

SECTION A; FINE-GRAINED BANDED STRUCTURE TYPICAL  
OF HOT-ROLLED STEEL IN AREA REMOTE FROM WELD.

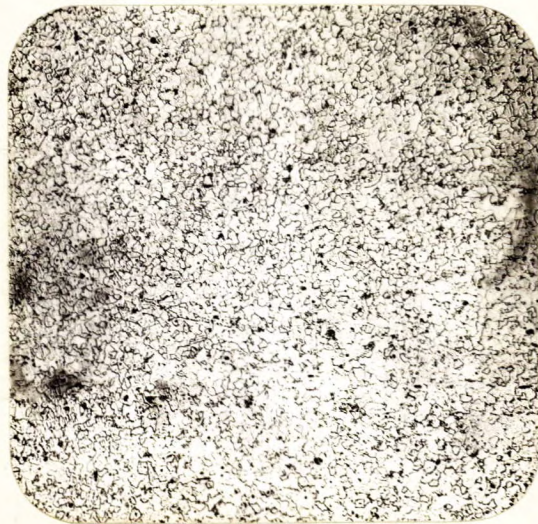
Figure 15.

SECTION C; FINE-GRAINED STRUCTURE ADJACENT TO  
WELD, INDICATING NORMALIZING TREATMENT.

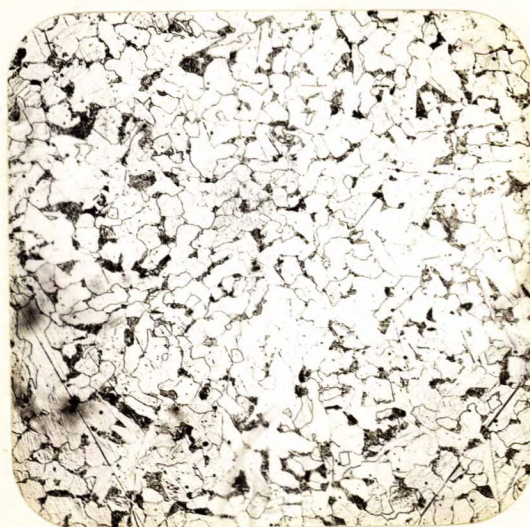
Figure 16.

SECTION C; NORMALIZED STRUCTURE OF PIPING  
REMOTE FROM WELD.

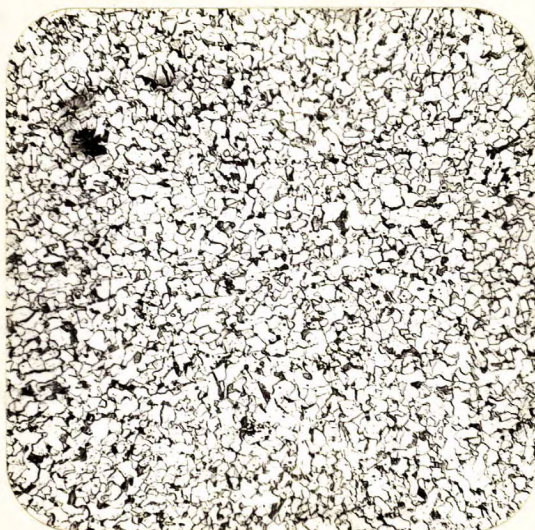
Figure 17.

(5) A micro sample from weld of Sample A was normalized at 1600° F. for 30 minutes in spent carburizer. Figure 17 shows the structure in the same area as Figure 13, after normalizing. Figure 18 shows the structure in the same area as Figure 14, after normalizing. Note the change brought about by normalizing.

SECOND SECTION FROM SAMPLE A; STRUCTURE OF PIPING  
ADJACENT TO WELD AFTER NORMALIZING AT 1600° F.  
FOR 30 MINUTES.

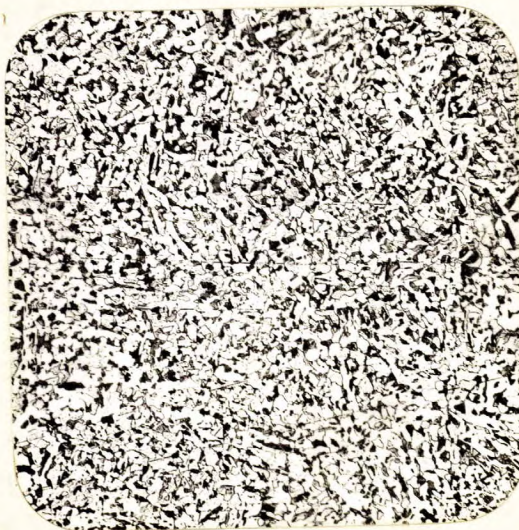
Figure 18.

SAME SAMPLE AS ABOVE; STRUCTURE OF PIPING REMOTE  
FROM WELD AFTER NORMALIZING AT 1600° F.  
FOR 30 MINUTES.
