November 17th, 1943.

Investigation No. 1534.

Examination of a Broken Rear Drive
Worm Gear from an F.W.D. Truck.

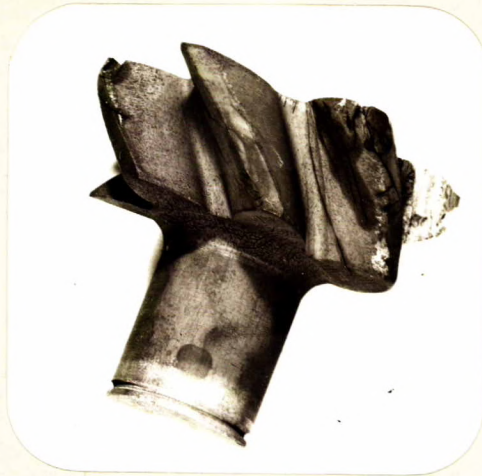
The following characteristics were observed in the gear "as received". On each tooth of the gear, cracks starting at the root and spreading along only one side of the tooth could be seen. This condition is shown in Figure 1. In some instances, as Figure 2 shows, these cracks resulted in the tearing off of the case surface at the top of the gear.

The cracks on one side only of the gear teeth are characteristically of a fatigue nature. This result is due to the fact that a piece subjected to alternating stresses apparently never fails by compression. A gear tooth really acts as a cantilever beam, with a tension and a compression side. The stress oscillates from zero to a maximum on each side as the gear tooth is loaded and unloaded. The alternation of stress finally produces failure on the tension side.

SHOWING HOW CRACKING OCCURRED ONLY
ON ONE SIDE OF THE GEAR TEETH.

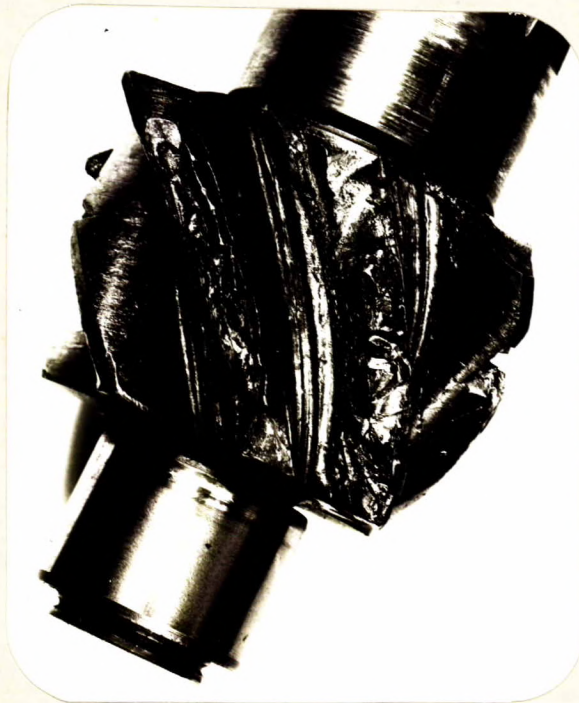
Figure 2.

SHOWING THE GEAR "AS RECEIVED".

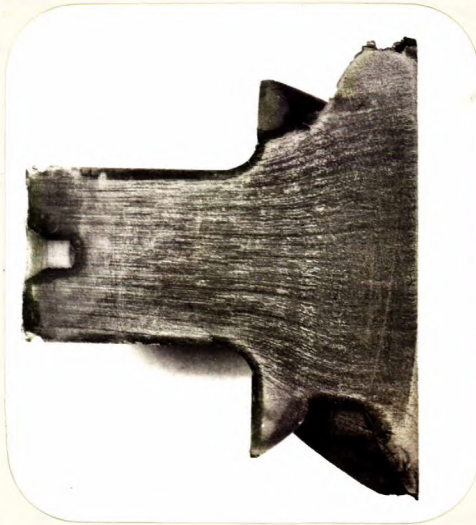
Figure 3.

A section of the gear was etched in a hot 50 per cent solution of hydrochloric acid to show the direction of flow lines. Figure 3 shows the result.

Etched in 50 per cent HCl.
SHOWING THE DIRECTIONS OF THE FLOW LINES.

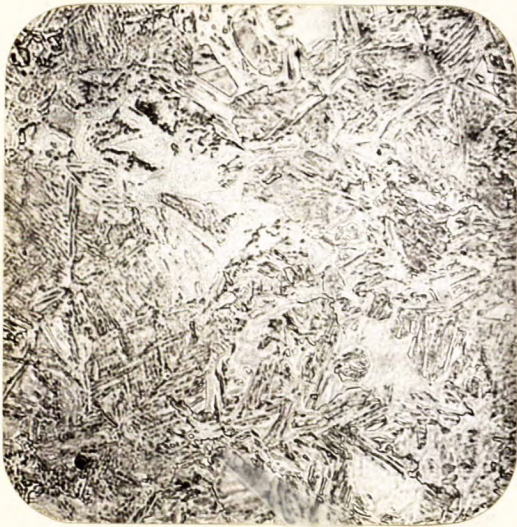
Figure 4.

The microstructure of the core consists of ferrite and a low-carbon martensite, as can be seen in Figure 4, taken at X500 magnification.

X500, picral etch.
SHOWING THE STRUCTURE OF
THE CORE, i.e., MARTENSITE
AND FERRITE.

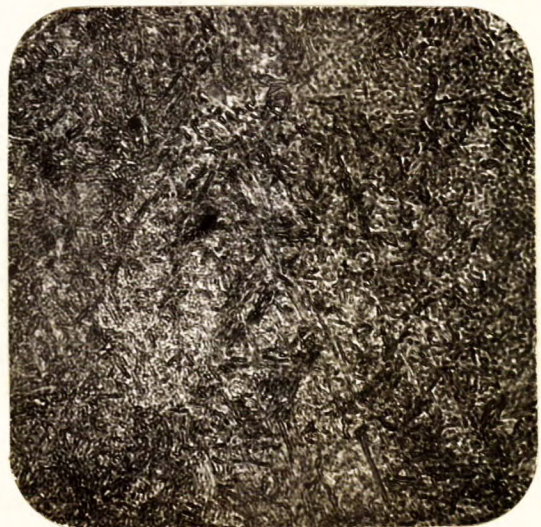
The microstructure of the case is an undrawn martensite with a few imbedded free carbides. This constituent (i.e., martensite) etches slowly, yielding a brown colour, as seen under the microscope. The microstructure, at 500 diameters, is shown in Figure 5. The acicular nature of the structure is shown in Figure 6, at X1500 magnification. The McQuaid-Ehn grain size was also determined, and this is shown in Figures 7 and 8. The grain size is 7. Note the evidence of abnormality.

The presence of free carbides in the case indicates a high carbon content; also, the slow etching of the case points to a lack of tempering. Both the free carbides in the case (which could have been eliminated by a diffusion heat treatment) and the lack of drawing (which promotes the retention of internal stresses induced by grinding) lower the fatigue

X500, picral etch.
SHOWING THE STRUCTURE OF
THE CASE, i.e., MARTENSITE
AND FREE CARBIDES.

1. In view of the fact that the manufacturing and all heat treatment practice prior to the tempering are correct, it appears that good service may be expected from these gears provided that a complete stress relief be given in the drawing operation.
2. If failures of stress-relieved gears are occurring, a change to a homogeneous-type steel, such as SAE 4340, SAE 4640 or SAE 3145, is recommended.

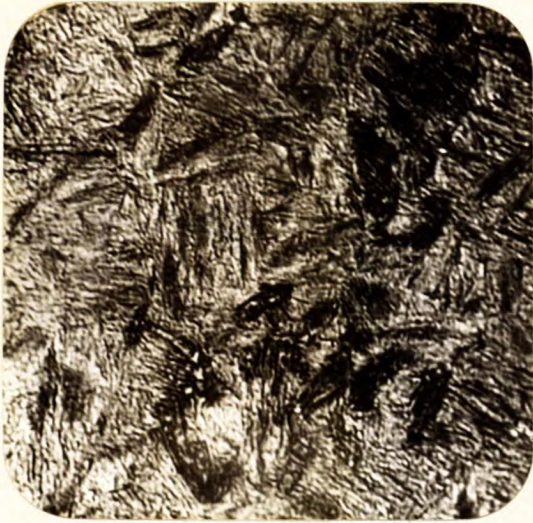
Figure 6.

X1500, picral etch.

SHOWING THE ACICULAR
STRUCTURE OF THE CASE.

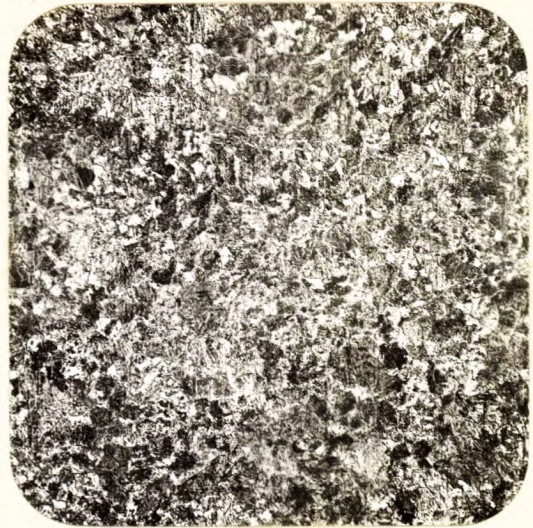
Figure 7.

X100, nital etch.

MCQUAID-EHN TEST SHOWING
GRAIN SIZE NO. 7.

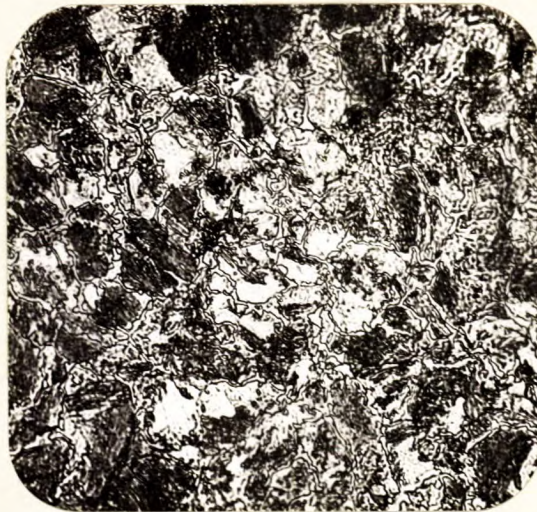
Figure 8.

The abnormality of the steel as shown by the McQuaid-Ehn test might also be a contributing factor to failure because of the soft spots developed on quenching this type of steel. However, the hardness tests have not detected these soft areas.

X500, nital etch.

SHOWING THE ABNORMALITY
OF THE STEEL.

Note the ferrite segregated along
the carbide grain boundaries.

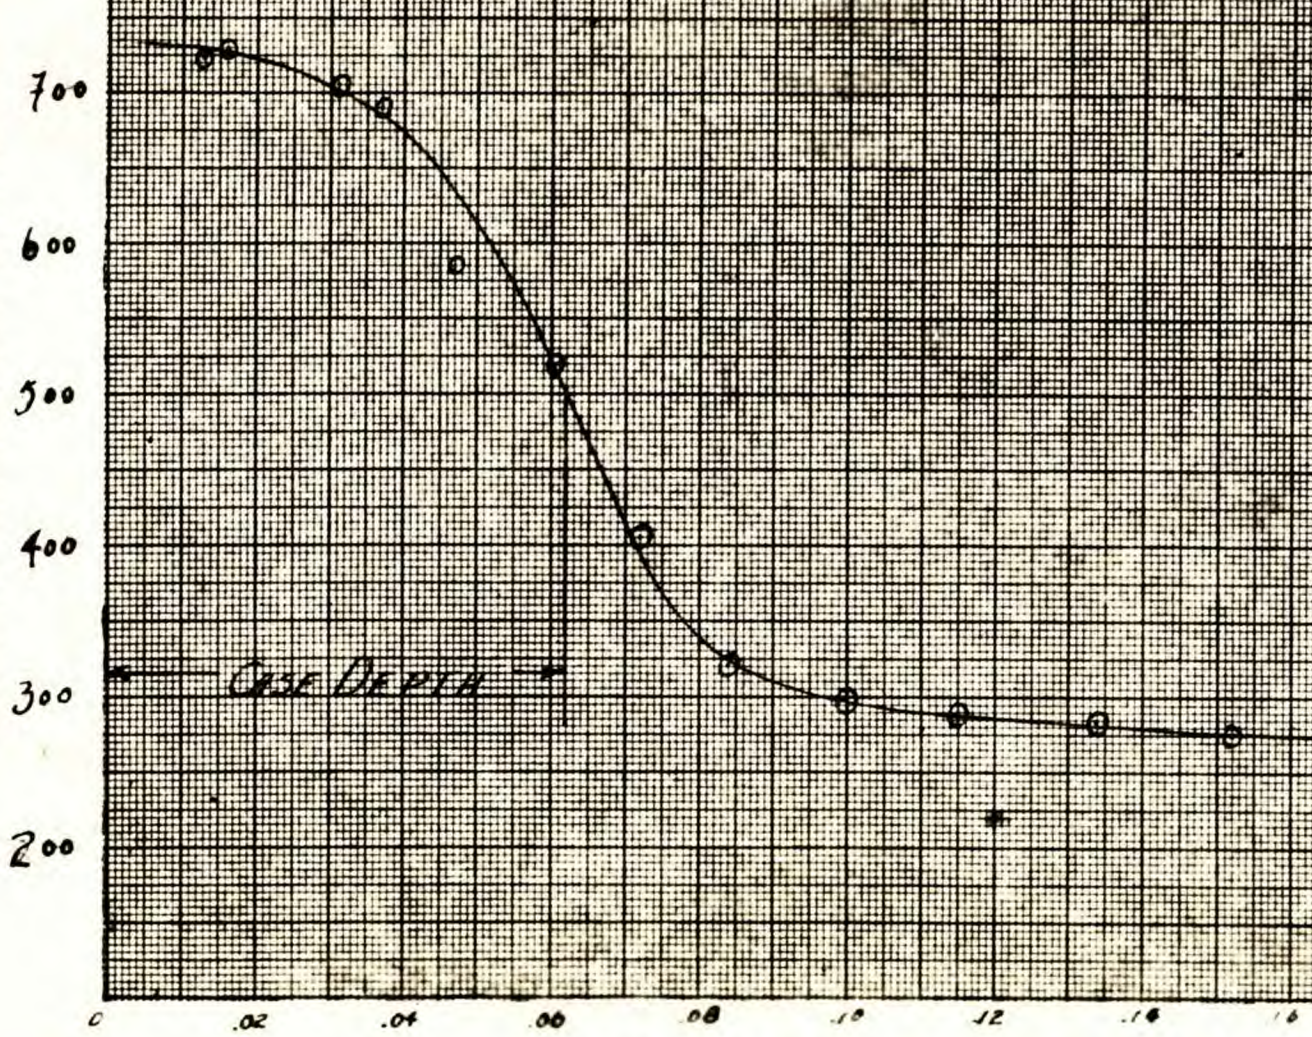
DEPTH-HARDNESS RELATIONSHIP ON A TOOTH OF A
BROKEN WORM GEAR

A hardness survey was also made on the cross-section of a gear tooth. Using the Vickers machine, hardness readings ranging from 736 V.H.N. (62 Rockwell 'C') to 275 V.H.N. (core hardness) were recorded. The results of this survey are shown graphically in the chart, Page 10. As a criterion of case thickness, a hardness level of 500 V.H.N. is taken. In the present example the case thickness is 0.062 inch.

In the present case, the case hardness is on the high side of the range and the core hardness is on the low side. However, the present core hardness is probably the highest which one could expect from a 0.15 carbon medium alloy steel. In any event, the low core hardness is not considered to have been the cause of failure.

The case depth found does not exceed the value given by Schenck.
