R E P O R T  
of the  
ORE DRESSING AND METALLURGICAL LABORATORIES.

Investigation No. 1535.

Examination of Two 6-mm. Armour Plates  
Which Cracked on Bending.

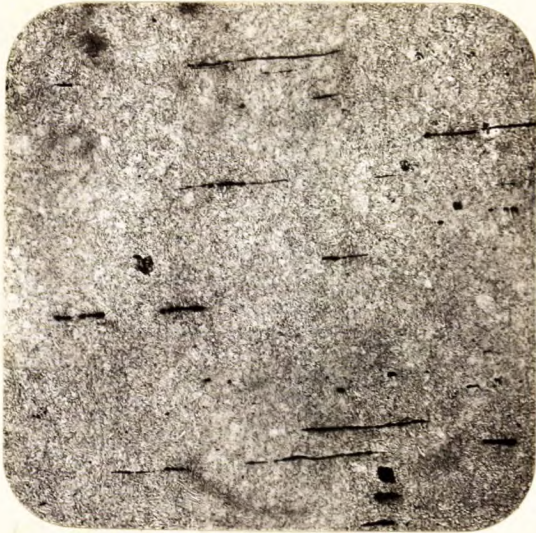
Figure 1.

Sections of the plates were examined under the microscope and both steels were found to be very dirty. The inclusions were elongated and of a bluish-grey colour, indicating that they are of the sulphide type. Figures 1 and 2 show, for each plate, at X100 magnification, typical examples of these inclusions as revealed after a light picral etch. The microstructures of the

Although the hardness of the plates definitely contributed to the cracking, the prime cause is believed to be steel dirtiness.

The inclusions were proven to be sulphur-bearing. However, they are not believed to be straight manganese or iron sulphide, because of the lack of correlation between the sulphur content and the number of inclusions found. Most probably the inclusions are sulphide containing silicates.

X100, light picral etch,  
SHOWING AN INCLUSION PATTERN  
IN AEDB LOT NO. 817 SPECIMEN.

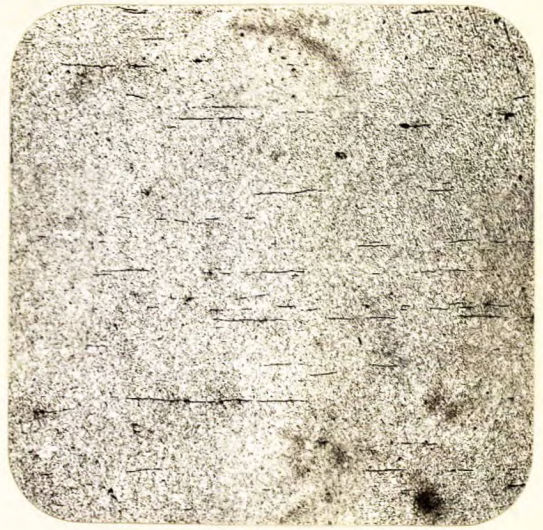
Figure 2.

X100, light picral etch,  
SHOWING AN INCLUSION PATTERN  
IN AEDB LOT NO. 818 SPECIMEN.

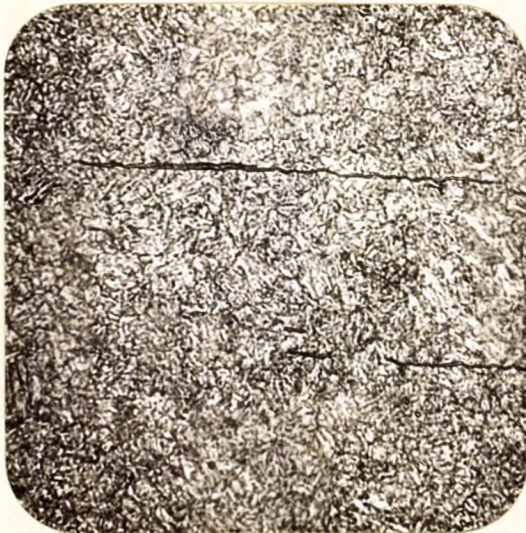
Figure 3.

plates after a longer picral etching are shown in Figures 3 and 4.

X500, picral etch,  
SHOWING THE MICROSTRUCTURE  
OF AEDB LOT NO. 817.

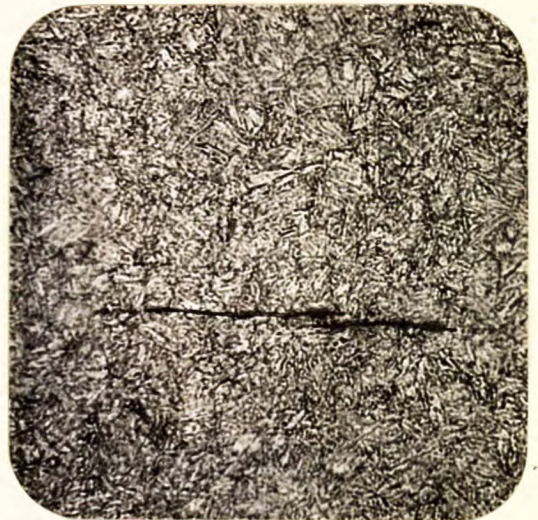
Figure 4.

X500, picral etch,  
SHOWING THE MICROSTRUCTURE  
OF AEDB LOT NO. 818.

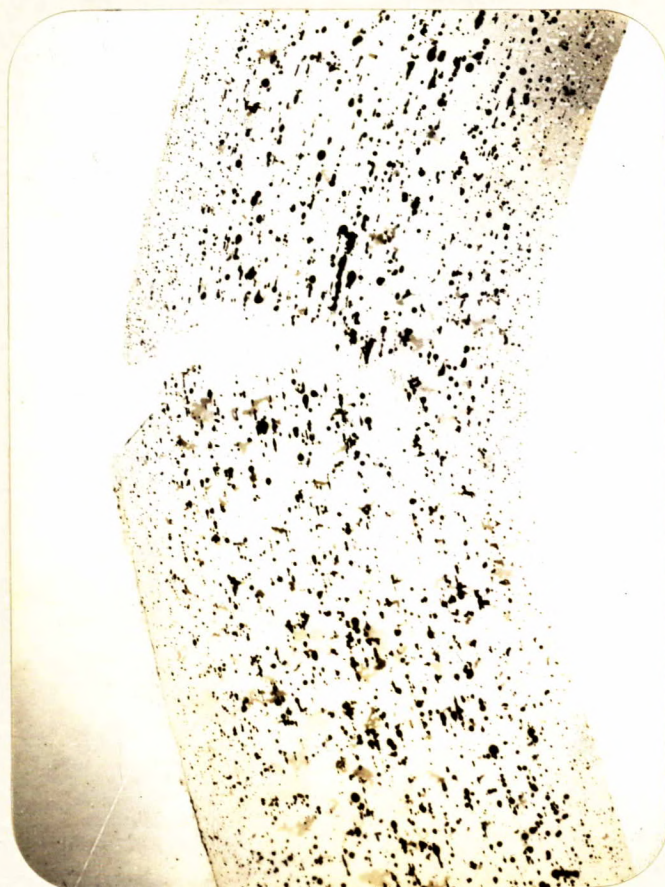
Figure 5.

Figure 5 shows an enlargement of a sulphur print, taken on one of the plates, which definitely confirms that the inclusions are of the sulphide type.

A SULPHUR PRINT OF A SECTION  
OF AEDB LOT NO. 817.

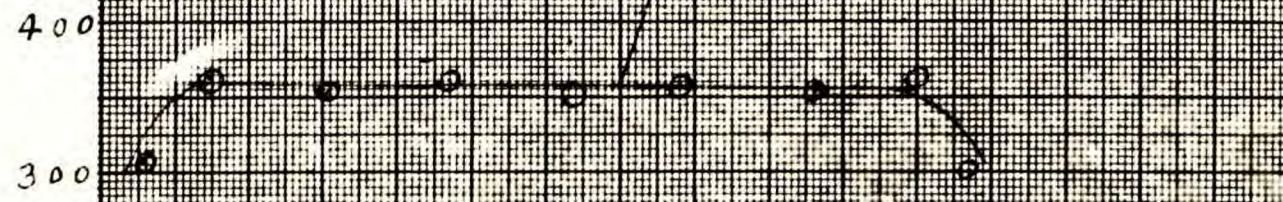
A.E.D.B. LOT NO. 817

Cross-sectional hardness surveys were made with the Vickers hardness tester, using a 10-kilogram load. The results are shown, in chart form, on Page 6.
