ORE DRESSING AND METALLURGICAL LABORATORIES.

Investigation No. 1536.

Examination of a Set of Broken Valve Springs
for Kermath Seachief IV Marine Engine.

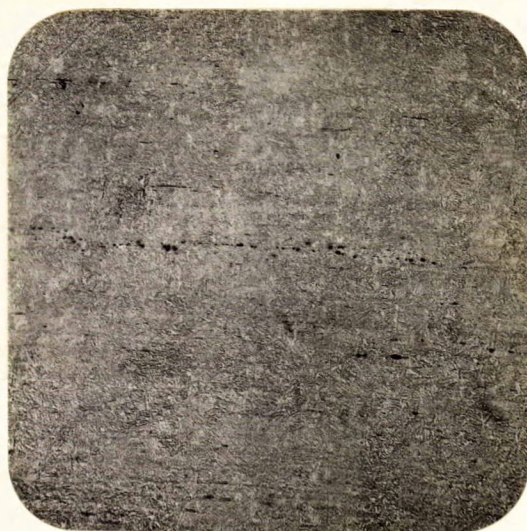
Figure 1.

Longitudinal sections of the springs were examined under the microscope. Quite a number of inclusions, both in cluster groups and elongated, were found. Figure 1 shows this condition.

inclusions and surface irregularities. Both may act as stress raisers and considerably lower the fatigue strength, as the notch sensitivity of this hard type of steel is quite high. Indeed, the detrimental inclusions are only those which happen to be at the surface of the steel, but the probability of their occurrence at this location is quite high on account of the number found in the steel.

The inclusions and irregularities of the surface are believed to be the cause of failure. Shotblasting of the surface would most certainly improve the spring performance.

PHOTOMICROGRAPH SHOWING AN EXAMPLE
OF THE TWO TYPES OF INCLUSIONS.

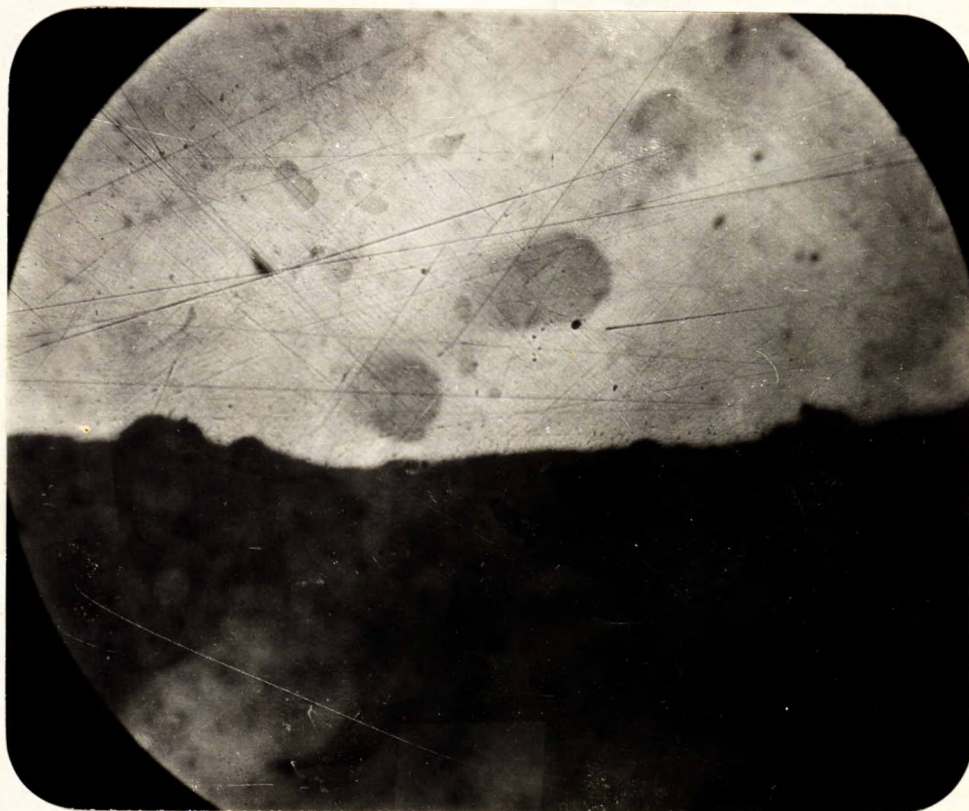
The edge of the spring was also examined and was found to be rough. This condition is shown in Figure 2.

SHOWING SURFACE IRREGULARITIES.

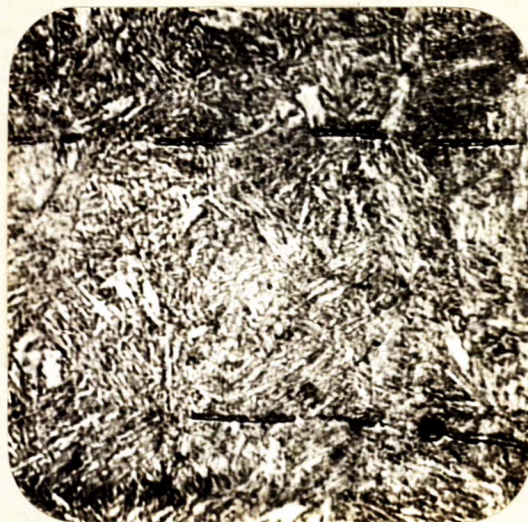
Figure 3.

Figure 3, a photomicrograph at X1000 magnification, shows that the structure of the spring is a uniform tempered martensite.

The hardness and structure of the steel are normal.

PHOTOMICROGRAPH SHOWING THE MICROSTRUCTURE
AND SOME ELONGATED INCLUSIONS.
