ORE DRESSING AND METALLURGICAL LABORATORIES.

Investigation No. 1538.

Examination of a Broken High  
Strength Brass Cap Square.

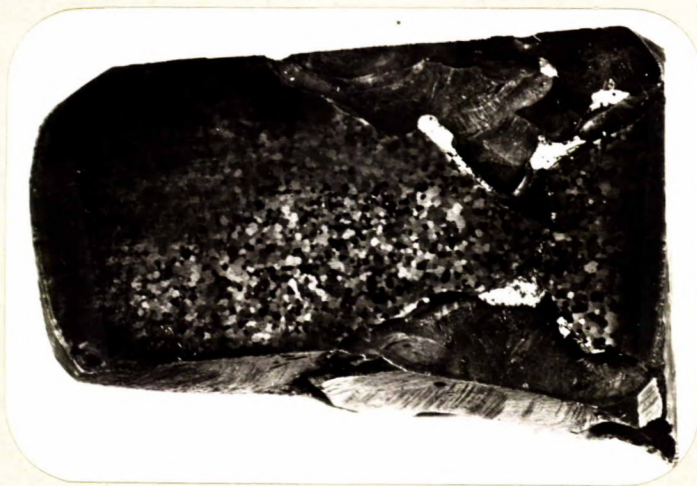
Figure 1.

very poor joining of the previously broken parts (see Figure 1).

It should be observed that the "Vickers Standard Materials" specification states the following for this material: "NOT TO BE SOLDERED."

BRAZED JOINT AT FORMER BREAK.

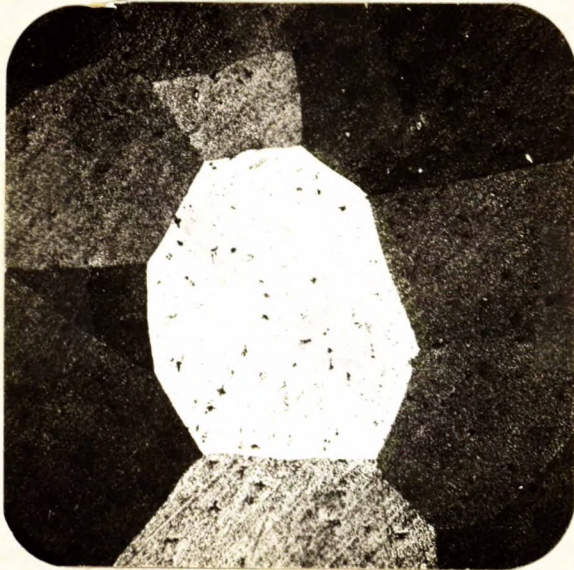
Figure 2.

Microscopic examination of the material adjoining the actual fracture showed structure normal for a  $\beta$ -type manganese bronze (Figure 2). The microstructure of the brazed joint is shown in Figure 3.

X100, FeCl<sub>3</sub> etch.  
STRUCTURE CLOSE TO  
THE FRACTURE.

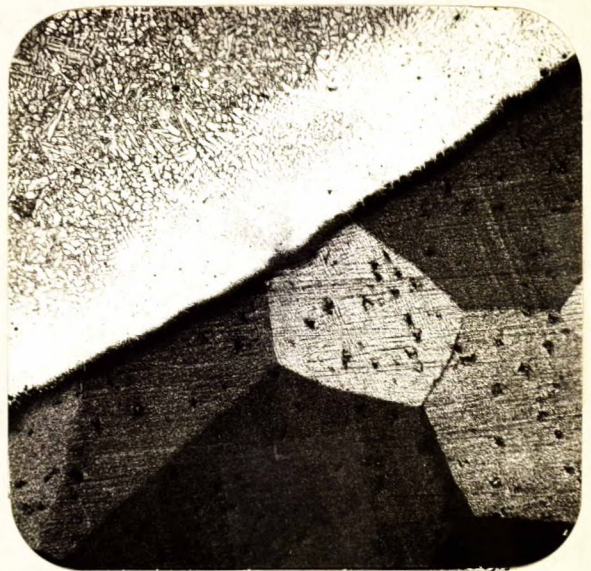
Figure 3.

X100, FeCl<sub>3</sub> etch.  
BRAZED JOINT.
