R E P O R T
of the
ORE DRESSING AND METALLURGICAL LABORATORIES.

Investigation No. 1540.

Further Examination of Welds Cut from Compressed Air
Reservoirs, C Mk. 1A (E. Leonard & Sons, London, Ontario).

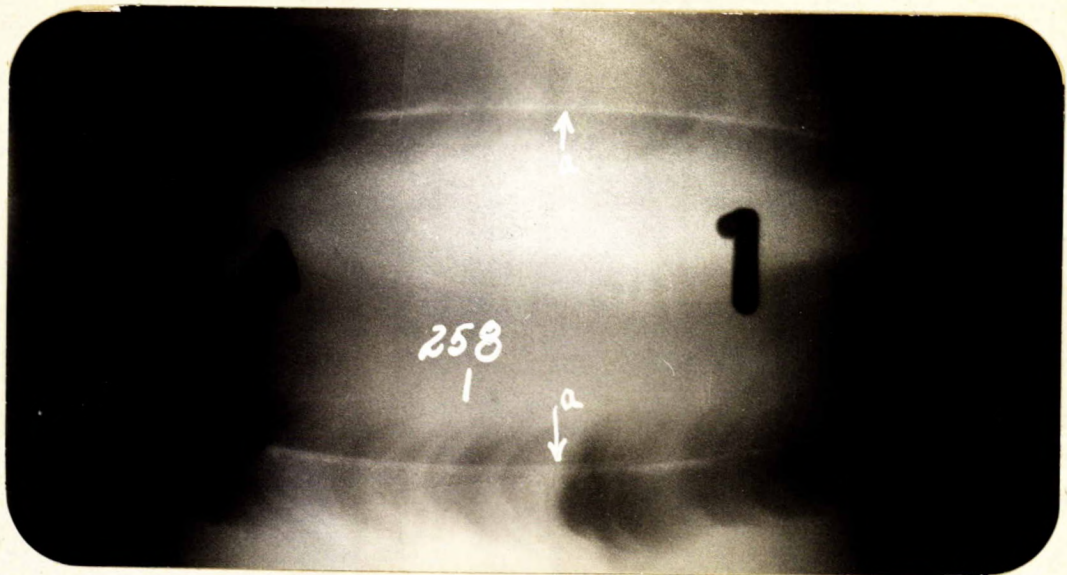
Figure 1.

GROUP 1: RESERVOIR NO. C 258, WELD 1.

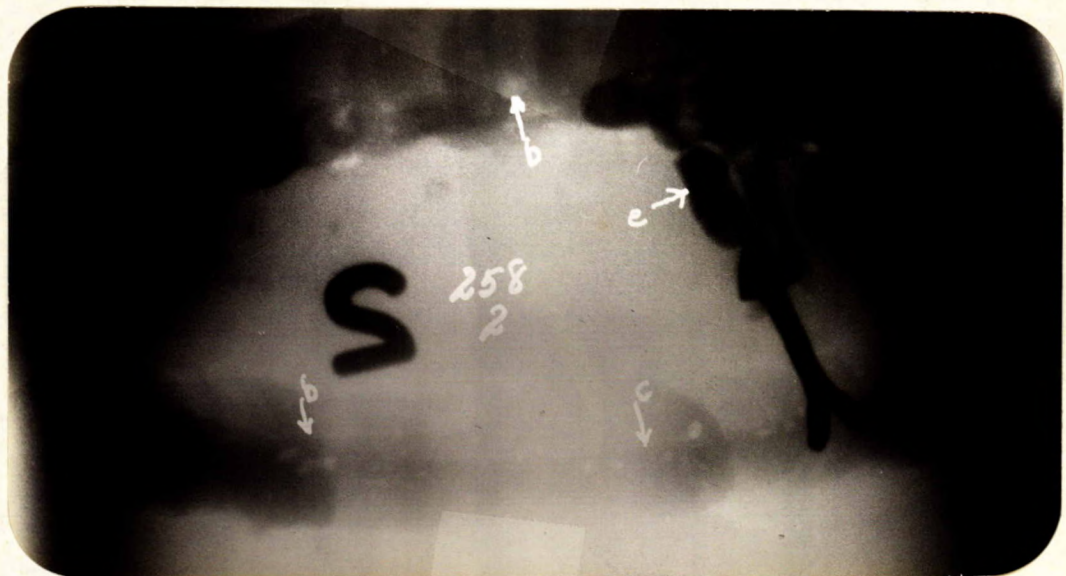
Figure 2.

GROUP 1: RESERVOIR NO. C 258, WELD 2.

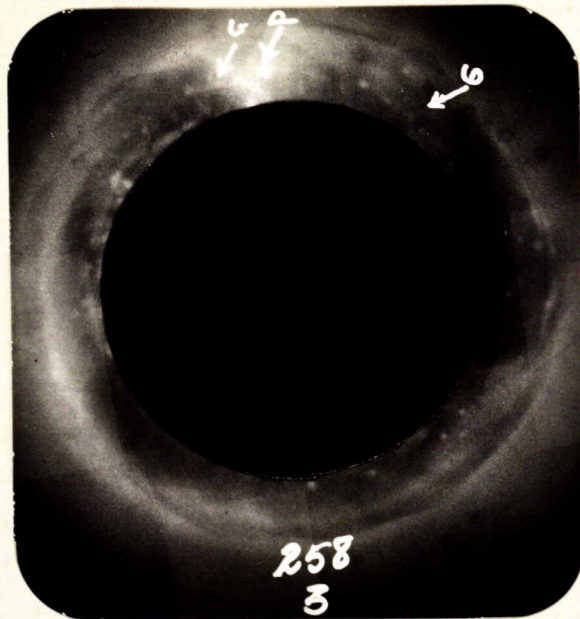
Figure 3.

GROUP 1: RESERVOIR NO. C. 258, WELD 3.

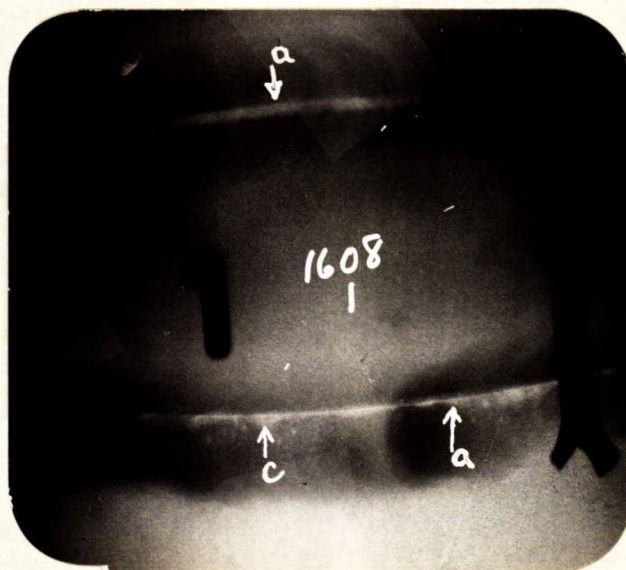
Figure 4.

GROUP 1: RESERVOIR NO. C 1608, WELD 1.

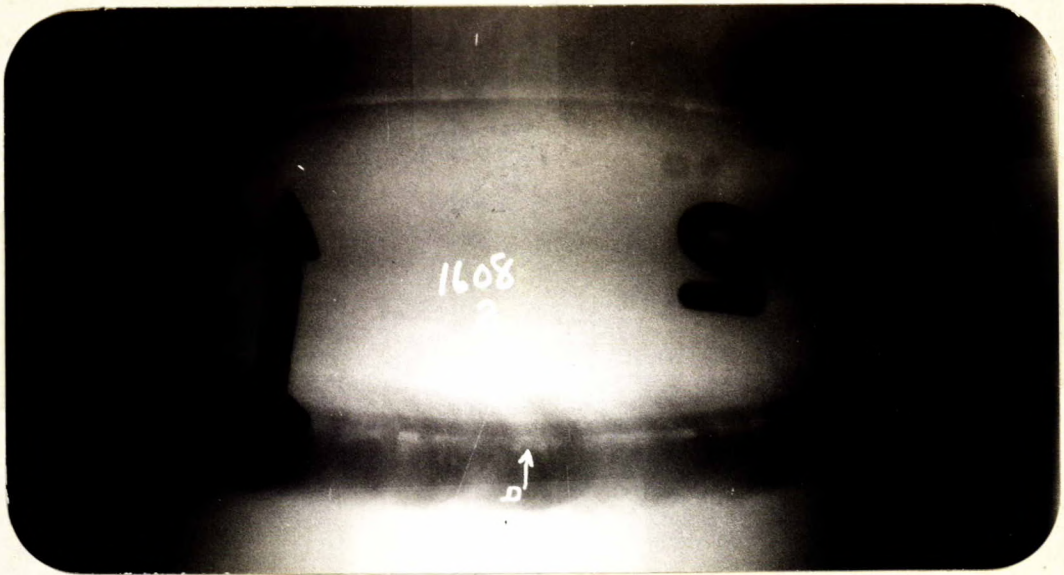
Figure 5.

GROUP 1: RESERVOIR NO. C 1608, WELD 2.

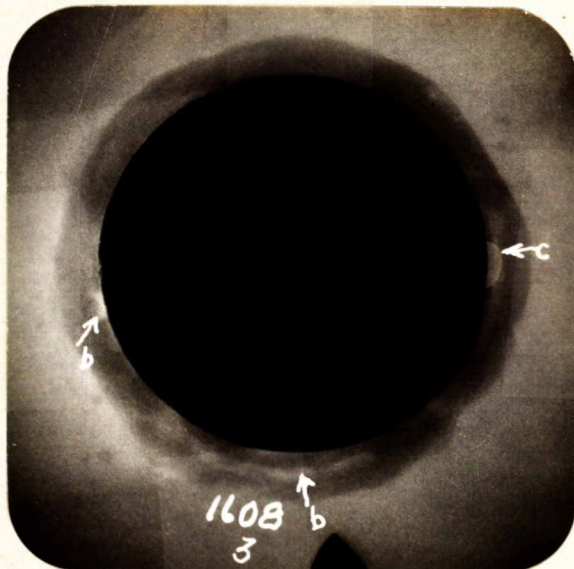
Figure 6.

GROUP 1: RESERVOIR NO. C 1608, WELD 3.

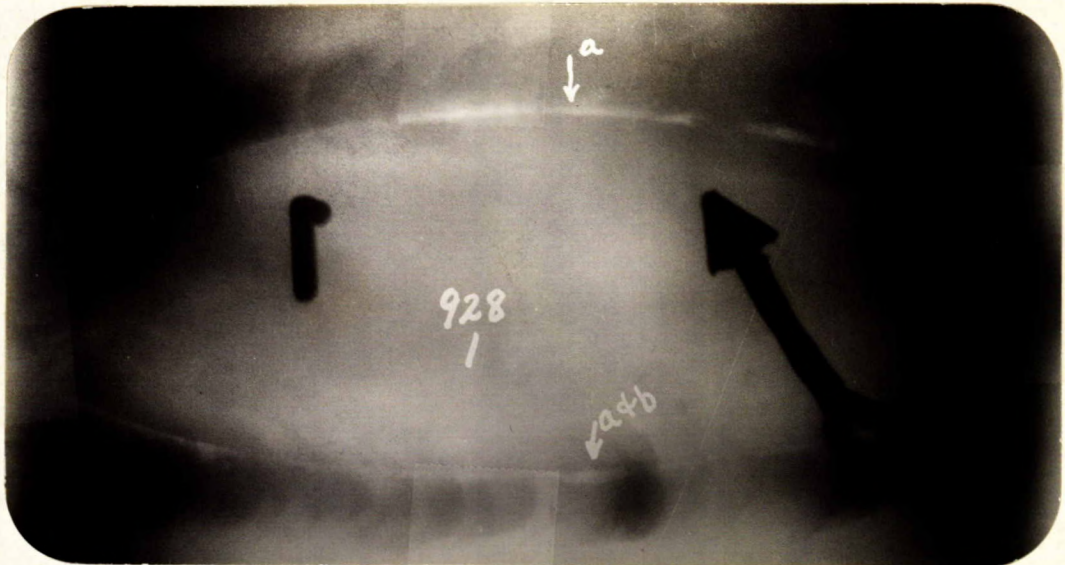
Figure 7.

GROUP 2: RESERVOIR NO. C 928, WELD 1.

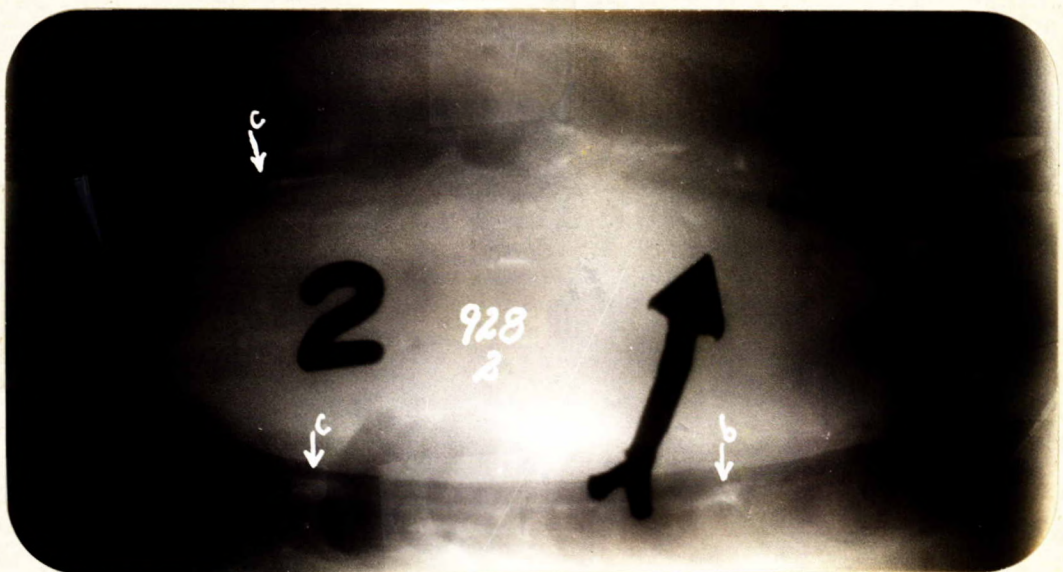
Figure 8.

GROUP 2: RESERVOIR NO. C 928, WELD 2.

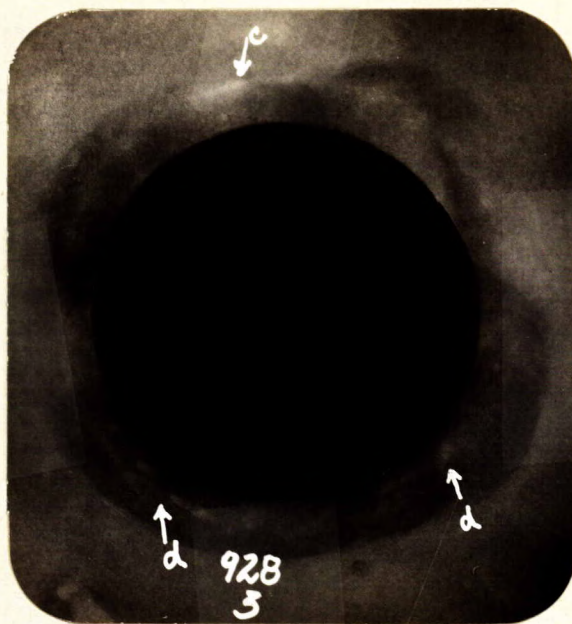
Figure 9.

GROUP 2: RESERVOIR NO. C 928, WELD 3.

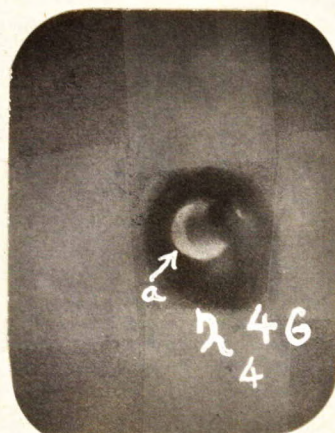
Figure 10.

Of the twenty cylinders examined, three show a fourth weld which is a plug weld in the base of the reservoir. This weld is not shown on the drawing or referred to in the specification. As shown by Figures 10, 16, and 21, this weld exhibits the same types of defects as all the other welds and should not be permitted.

GROUP 2: RESERVOIR NO. C 246, WELD 4.

5. Plug welds (present, although not allowed in specification or drawing) show the same defects as the other welds and their use should be rigorously forbidden.

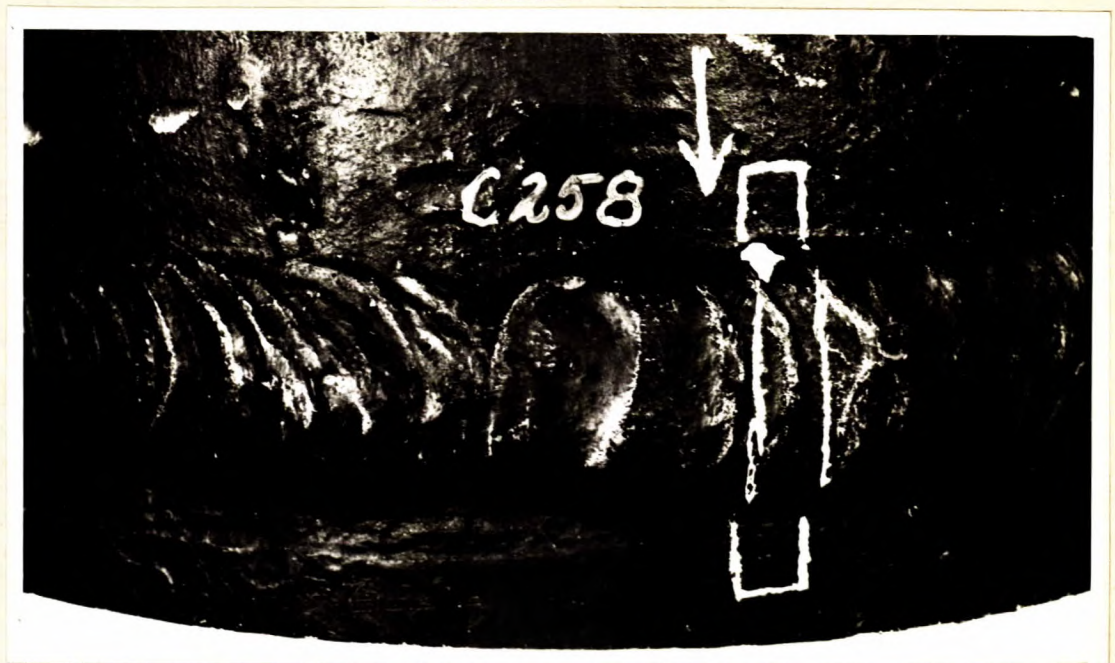
Figure 11.

GROUP 1: RESERVOIR NO. C 258, WELD 2.

Photograph of outside of weld. Arrow points to a high piled-up weld. White rectangle shows location of micro sample.

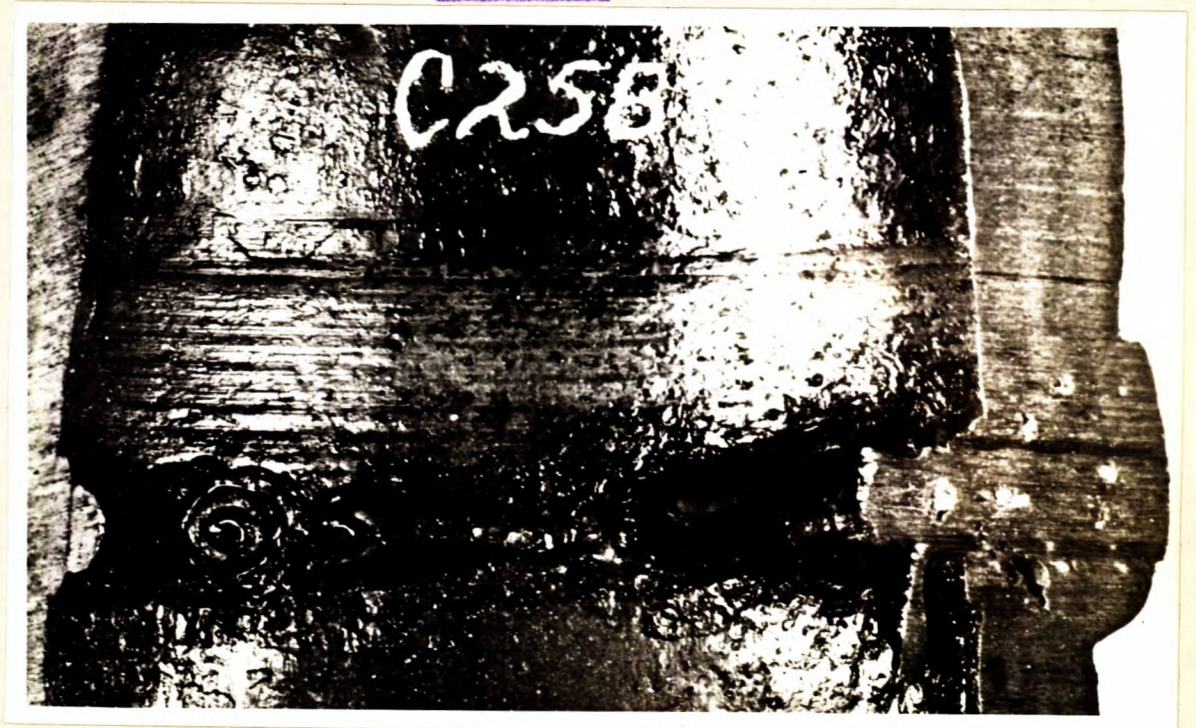
Figure 12.

GROUP 1: RESERVOIR NO. C 258, WELD 2.

Photograph of inside of weld shown above. Note weld metal icicles and porosity at right cut edge.

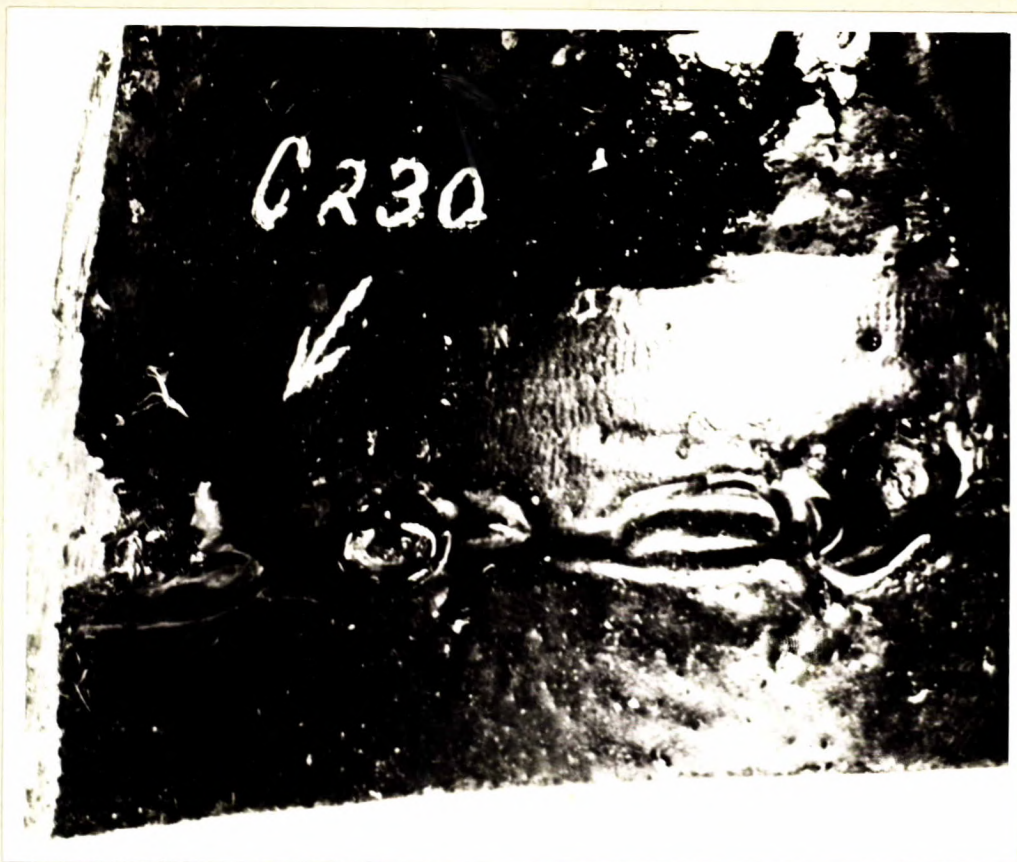
GROUP 1: RESERVOIR NO. C 230, WELD 1.

Photograph of inside of weld. Arrow points to weld metal icicles.

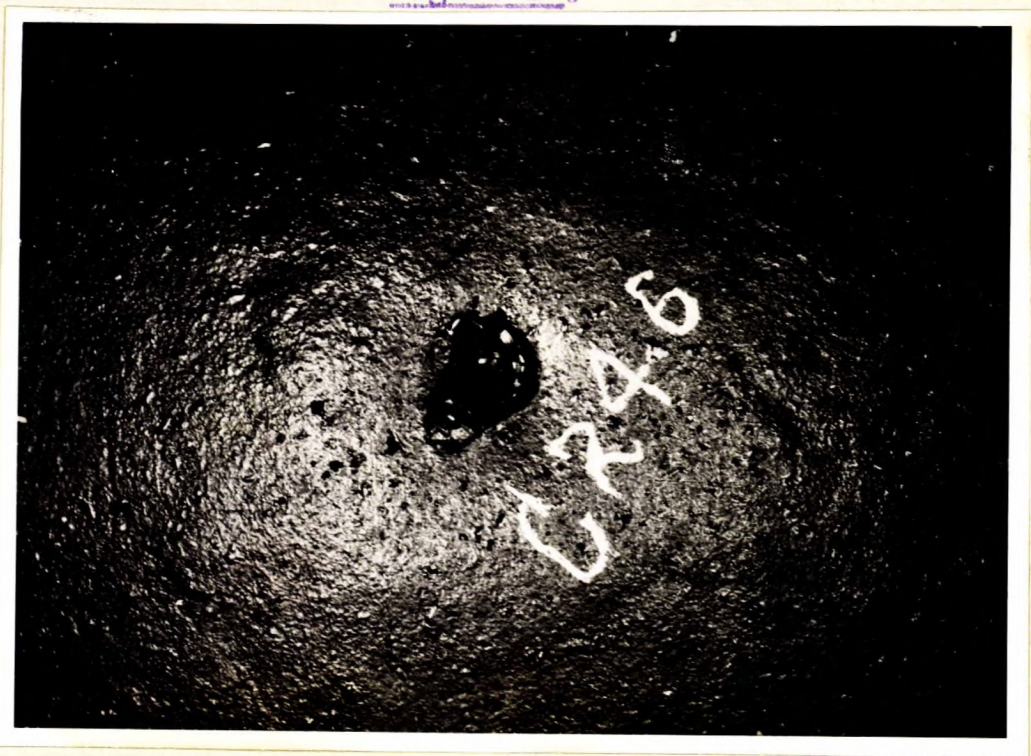
Figure 16.

GROUP 2: RESERVOIR NO. C 246, WELD 4.

Photograph of end plug weld. Note shrinkage cavity in centre of weld; depth, approximately 3/16 inch.

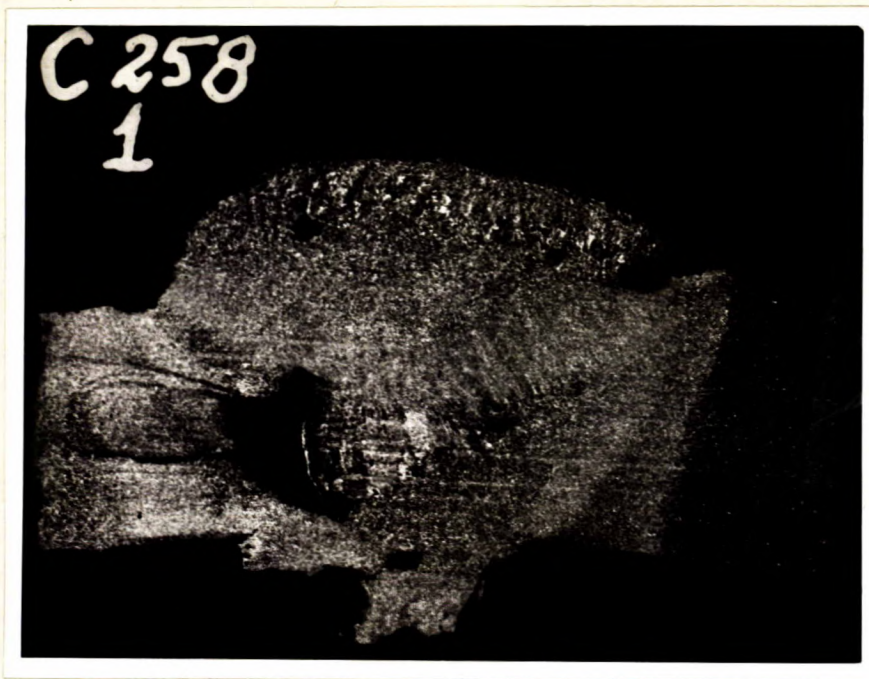
Figure 17.

GROUP 1: RESERVOIR NO. C 258, WELD 1.

Note undercutting, high piled-up weld, scattered porosity, slag entrapment, lack of fusion, and weld metal icicles. Note also wide root gap. A three-pass weld.

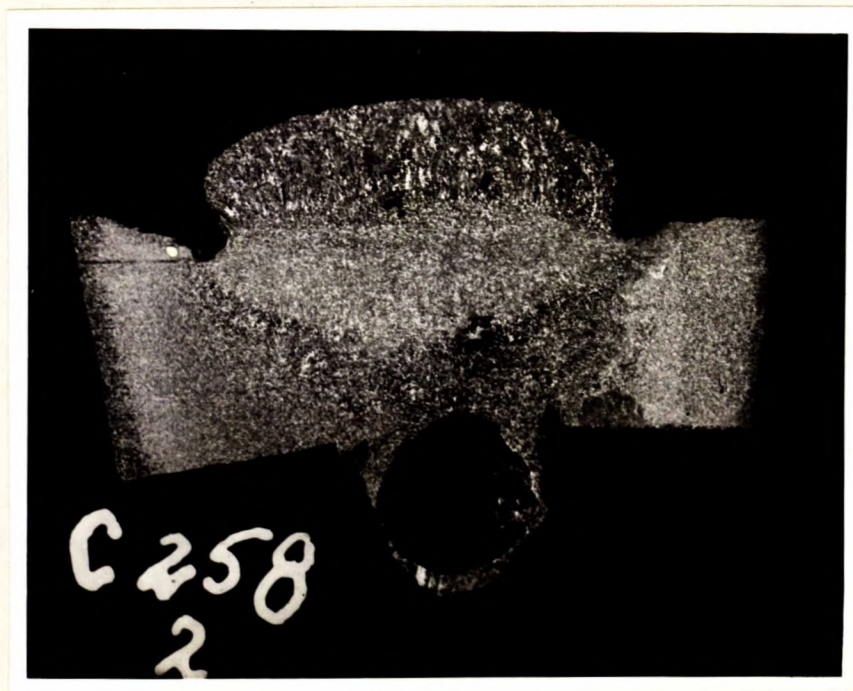
Figure 18.

GROUP 1: RESERVOIR NO. C 258, WELD 2.

Note high piled-up weld, severe undercutting, porosity, weld metal icicles, and wide root gap. A three-pass weld.

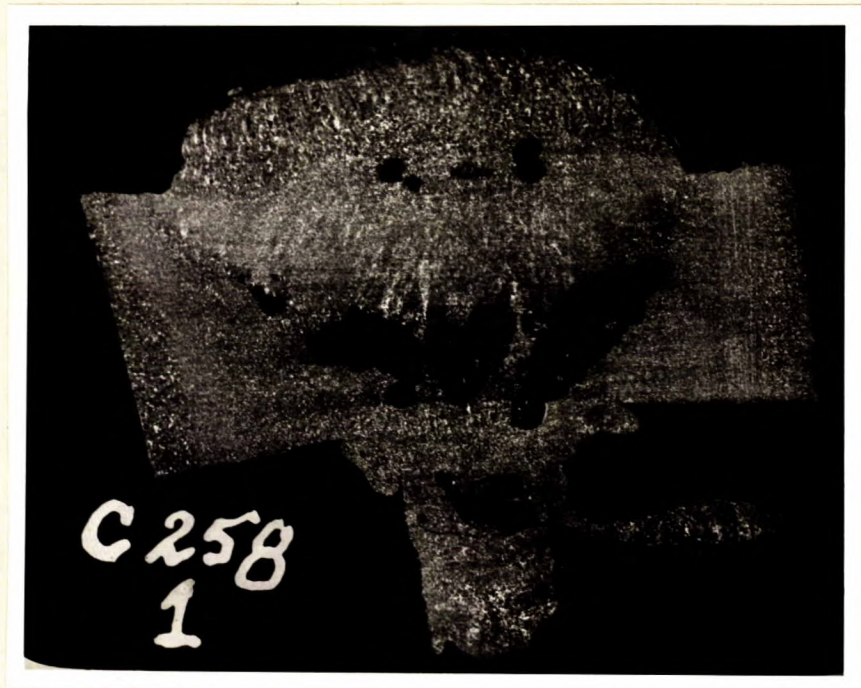
Figure 19.

GROUP 1: RESERVOIR NO. C 258, WELD 1.

Note high piled-up weld, excessive porosity and slag, lack of fusion, weld metal icicle, and wide root gap. A three-pass weld.

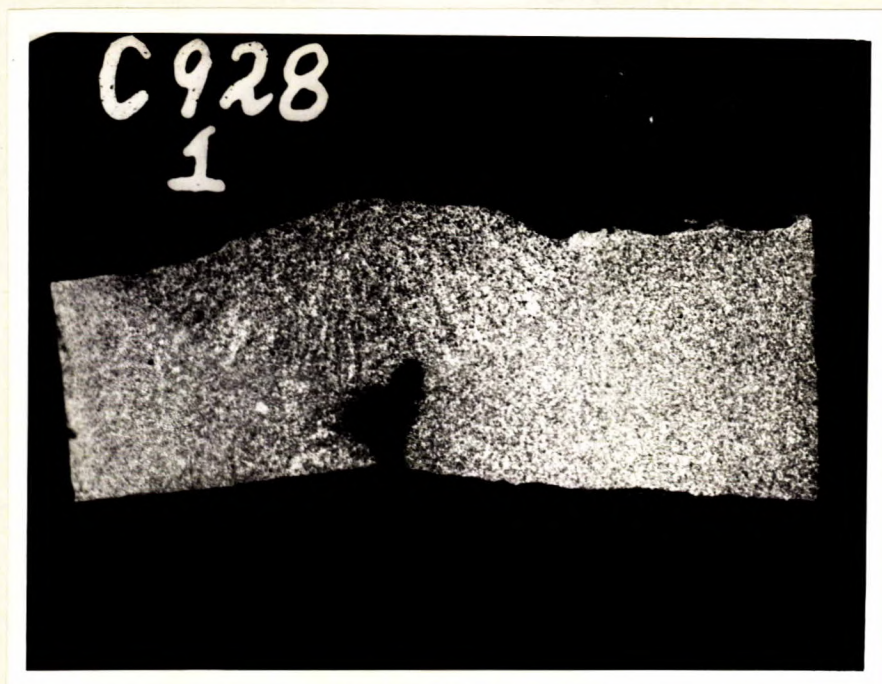
Figure 20.

GROUP 2: RESERVOIR NO. C 928, WELD 1.

Note lack of penetration; also narrow root gap. A one-pass weld.

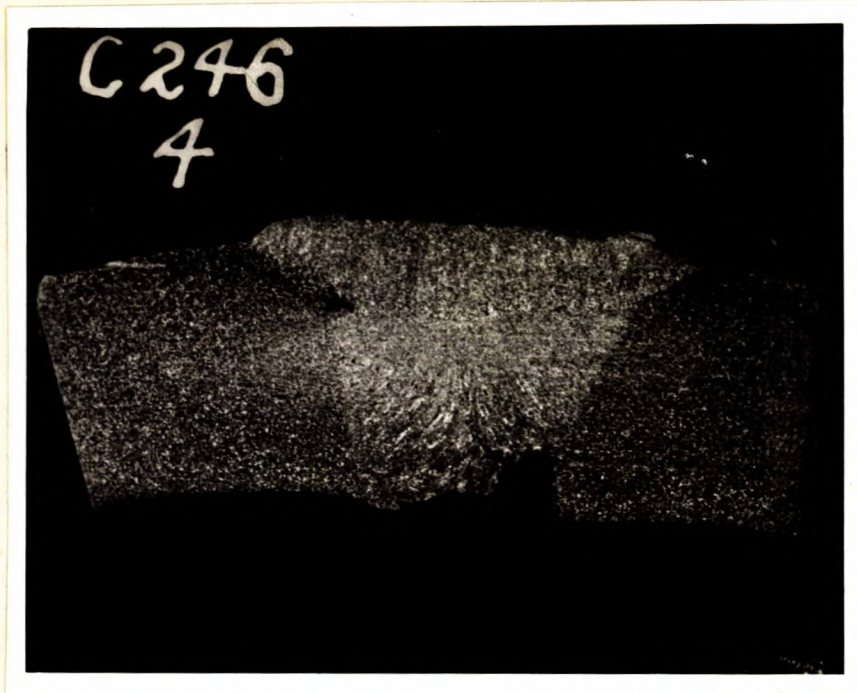
Figure 21.

X3.5, etched in 5 per cent nital.
GROUP 2: RESERVOIR NO. C 246, WELD 4.
Note slag entrapped and lack of penetration.
A two-pass weld.

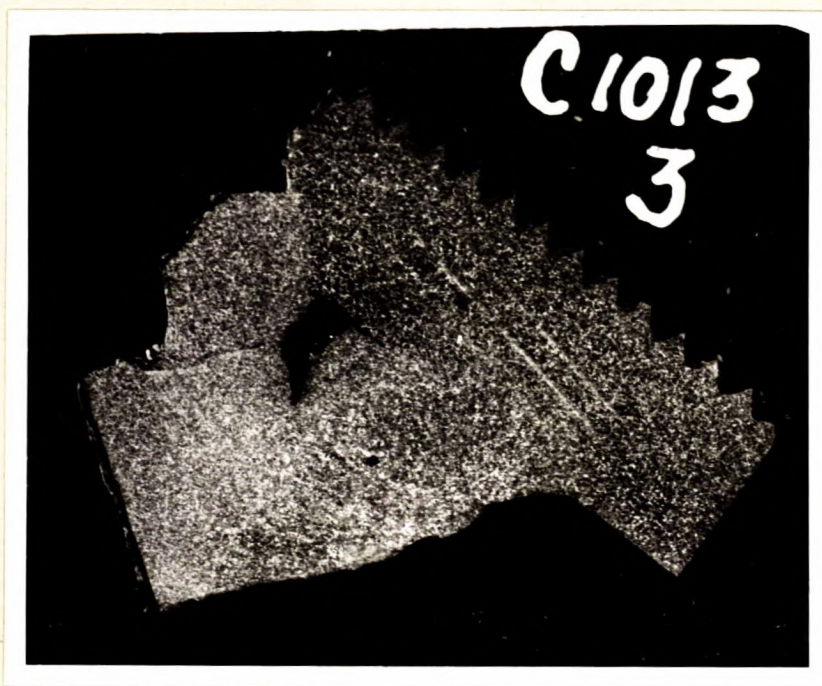
Figure 22.

X3.5, etched in 5 per cent nital.
GROUP 2: RESERVOIR NO. C 1013, WELD 3.
Note lack of penetration and also slag
entrapment. A three-pass weld.

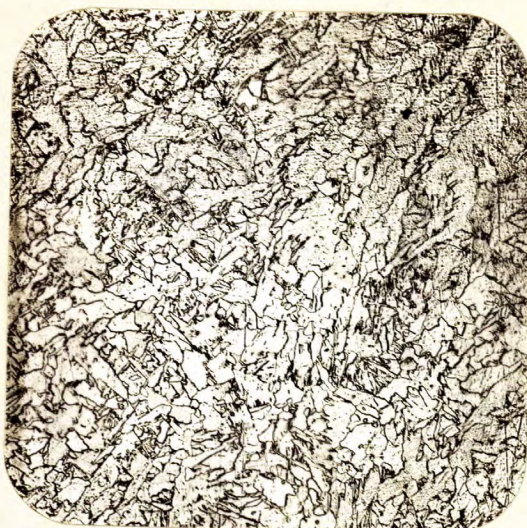
Figure 23.

(4) The above sections were examined under the microscope. It was found that some had been normalized after welding and some had not. Figure 23 shows a structure of weld metal of a section which has not been normalized. Figure 24 shows a structure of weld metal of a normalized section. Note the considerable difference between these structures.

According to specification, all reservoirs are to be normalized after welding. As in our previous examination, some reservoirs were found to be normalized and some were in the "as-welded" condition.

STRUCTURE OF WELD METAL OF
AN UNNORMALIZED RESERVOIR.

7. If the reservoirs submitted for examination are representative of reservoirs going into use, accurate checks should be made to ensure that all are normalized as required by specification. Two investigations have shown that not all reservoirs are being normalized.

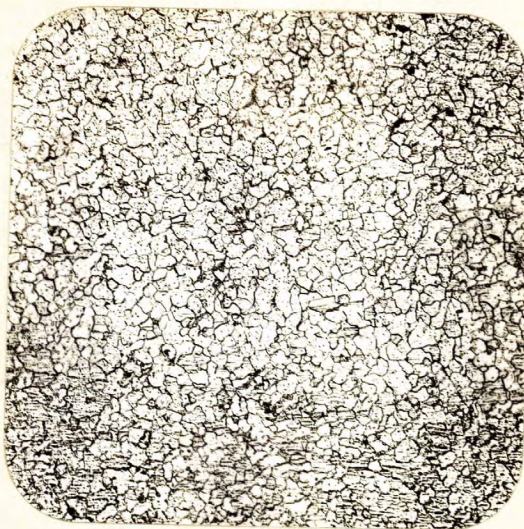
Figure 24.

STRUCTURE OF WELD METAL
OF A NORMALIZED RESERVOIR.
