O T T A W A November 26th, 1943.

R E P O R T
of the
ORE DRESSING AND METALLURGICAL LABORATORIES.

Investigation No. 1542.

Examination of Studs Flash-Welded to Armour Plate.

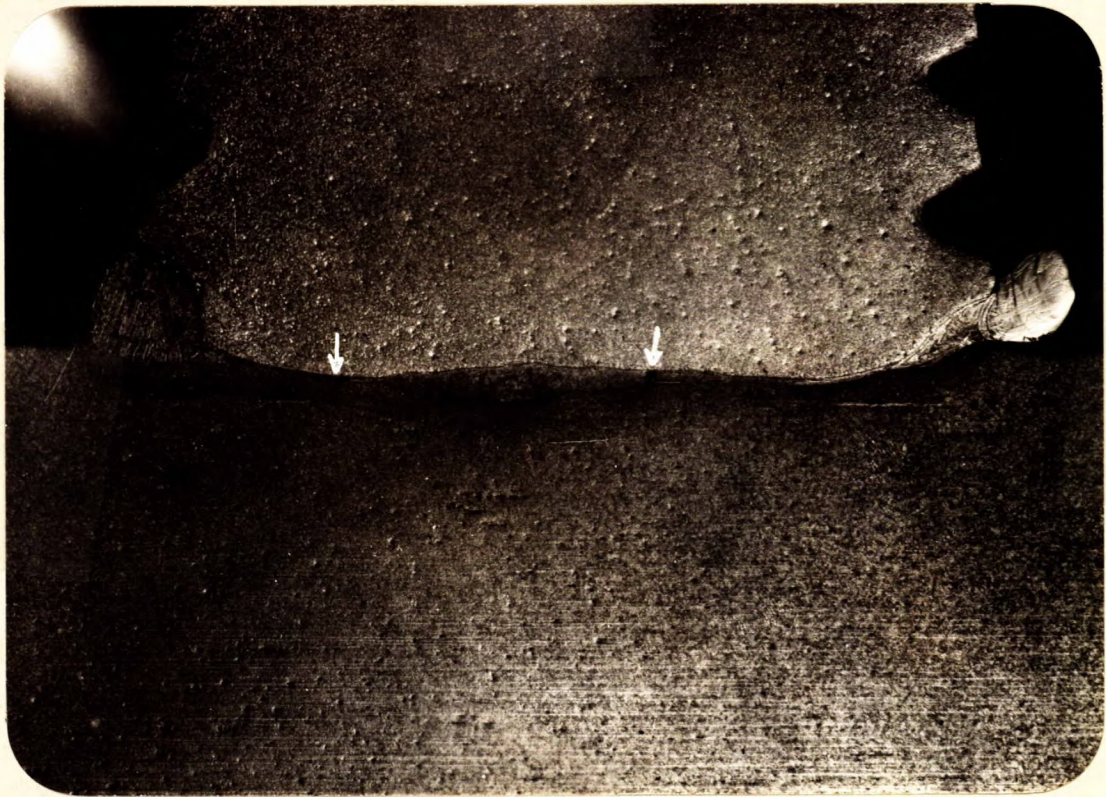
Figure 1.

- (3) Micro specimens were machined through the centre of the remaining stud and armour plate and also from the location of the stud used in the above impact test. Figure 1 shows the weld area of the untested stud and Figure 2 the weld area of the tested stud.

Micro-examination of the fusion zone of the untested stud shows two very small areas of entrapped slag. In our

opinion they are too small to seriously weaken the weld but they do indicate that care must be taken to avoid greater slag inclusions. To minimize this danger, both the end of the stud and the surface of the armour plate should be ground down to clean metal.

FUSION AND HEAT-AFFECTED ZONES OF UNTESTED STUD.

Note small penetration and narrow heat-affected zone.
Note also ejection of molten metal at right edge.
Arrows point to small slag inclusions at fusion line.

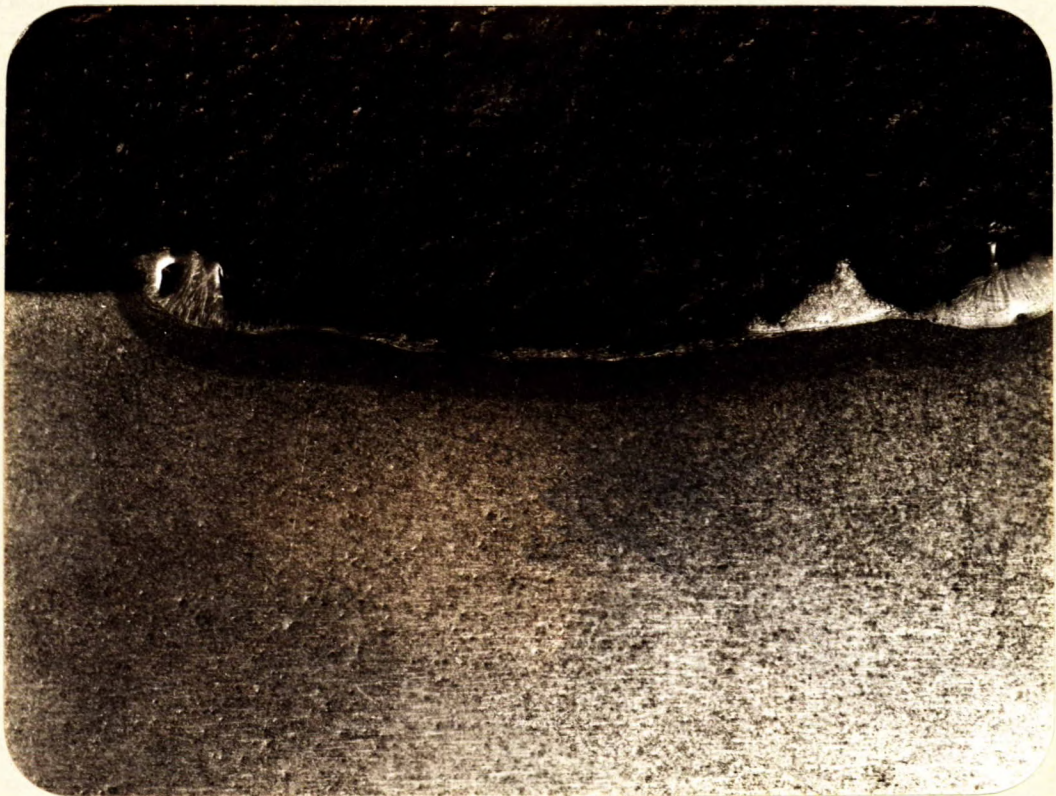
Figure 2.

FUSION AND HEAT-AFFECTED ZONE OF TESTED STUD.

Note small penetration and narrow heat-affected
zone. Note that failure occurred in the stud
material just above the fusion line.

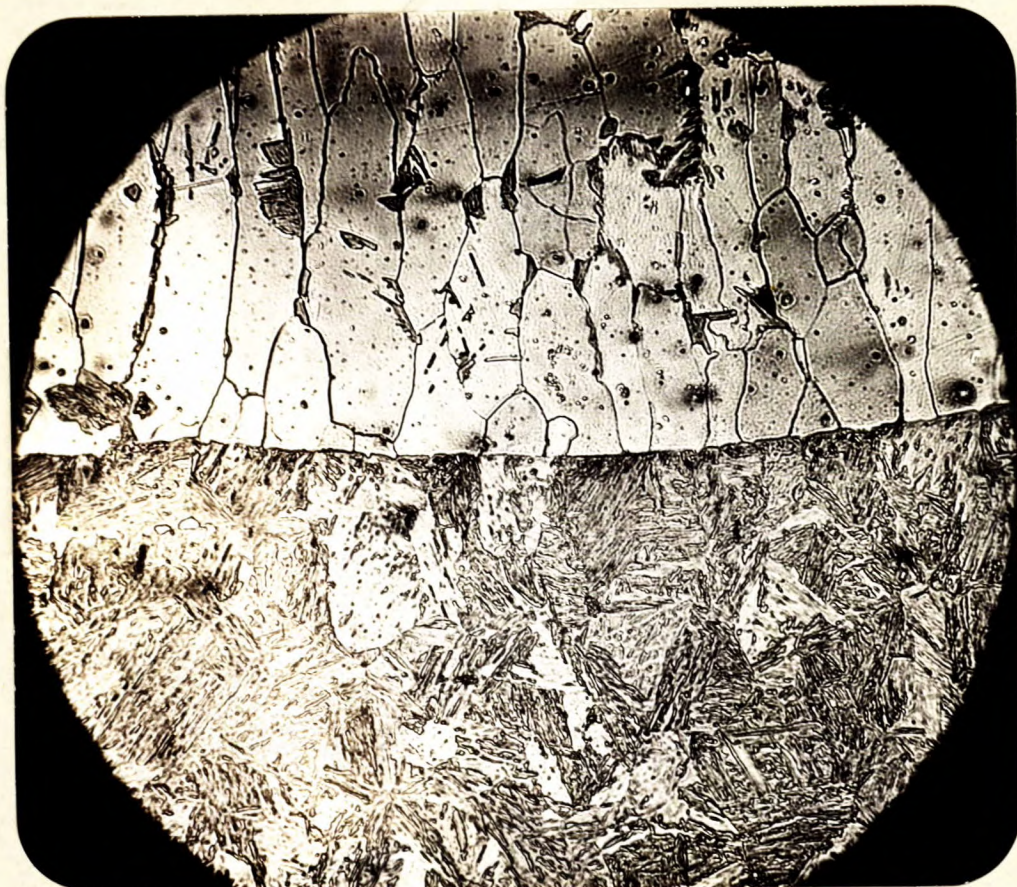
Figure 3.

- (4) Both specimens were examined under the microscope. Figure 3 illustrates the typical structure of the junction of the stud and armour plate. Figure 4 shows the typical structure of heat-affected zone of the untested stud. Note the micro-

FUSION ZONE OF UNETCHED STUD.

Note good bond secured.

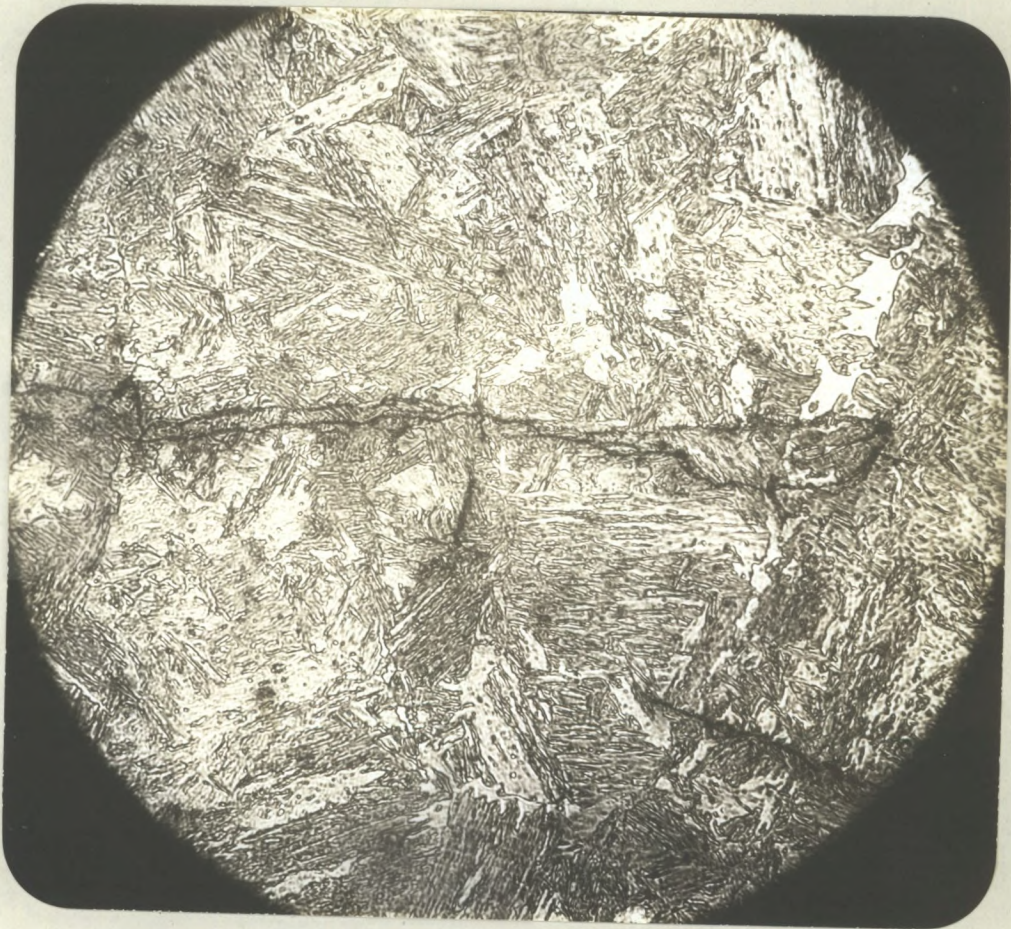
Figure 4.

cracks in this area. Figure 5 is the narrow transition zone between the heat-affected zone and the unaffected plate metal. Figure 6 shows the structure of the armour plate.

It is interesting to note that the relatively soft heat-affected zone of the untested stud has fine hairline cracks which are typical "hard" cracks, frequently found in areas of high hardness under welds. A close examination of the harder heat-affected zone of the tested stud failed to reveal any such cracks. It is probable that the cracks found formed immediately after welding, and the subsequent surge of current cannot be expected to eliminate them.

4. The weld with a low hardness in the heat-affected zone showed typical 'hard' cracks in that zone. These are the result of a brittle structure produced by the welding operation, the hardness being lowered by a subsequent drawing.

HEAT-AFFECTED ZONE OF UNTESTED STUD.

Highly tempered martensite and some ferrite
(white constituent). Note transgranular
'hard cracks'.

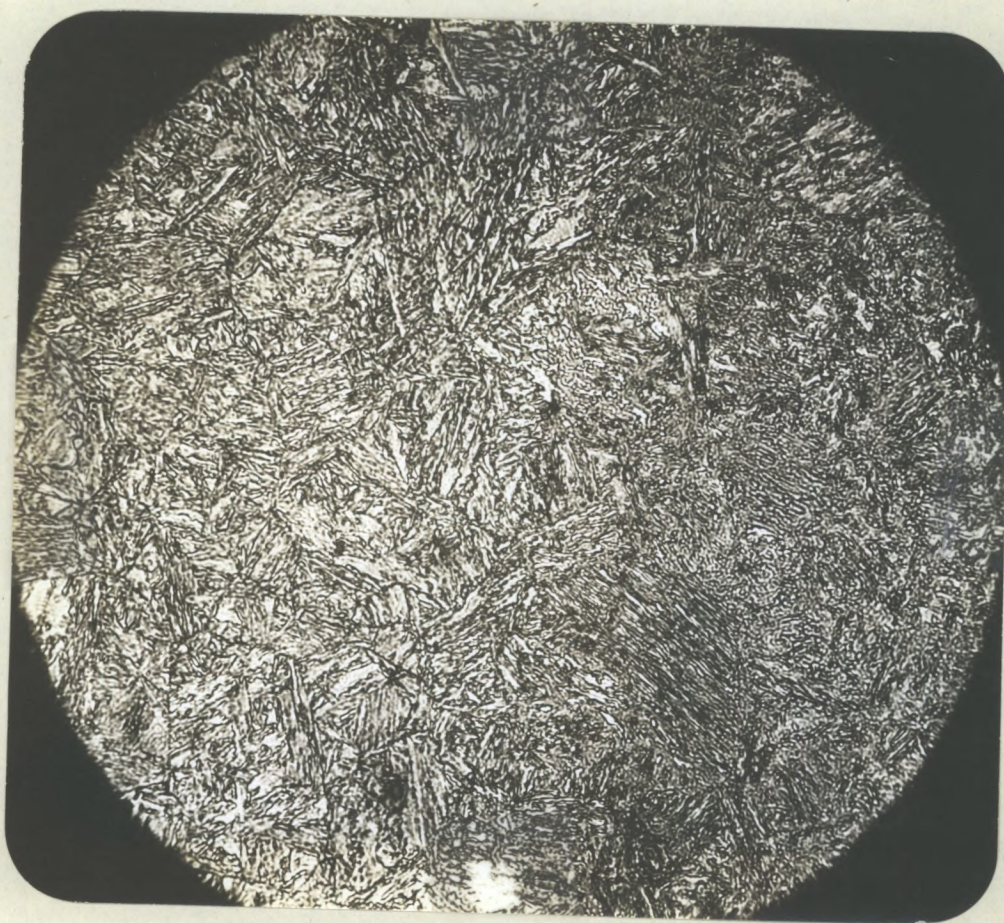
Figure 5.

TRANSITION ZONE OF UNTESTED STUD.

Nodular martensite of heat-affected zone -
fine pearlite and ferrite in transition
zone - tempered martensite of unaffected
armour plate.

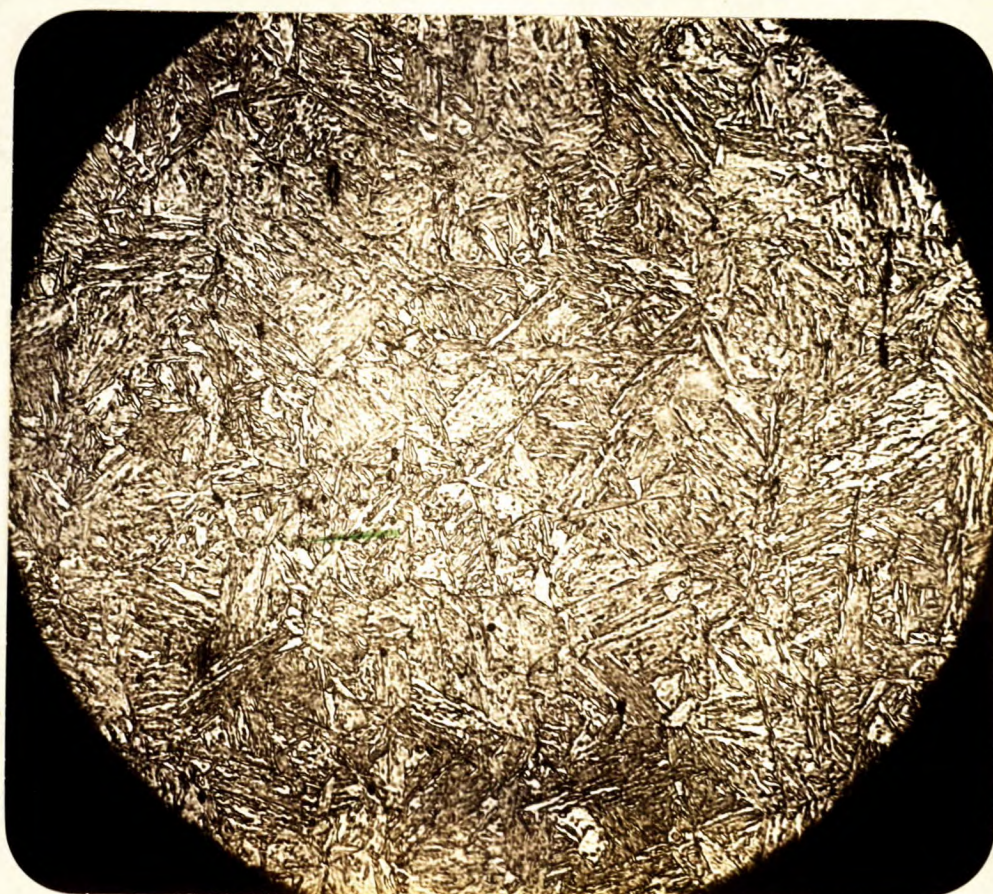
Figure 6.

TEMPERED MARTENSITIC STRUCTURE OF ARMOUR PLATE.

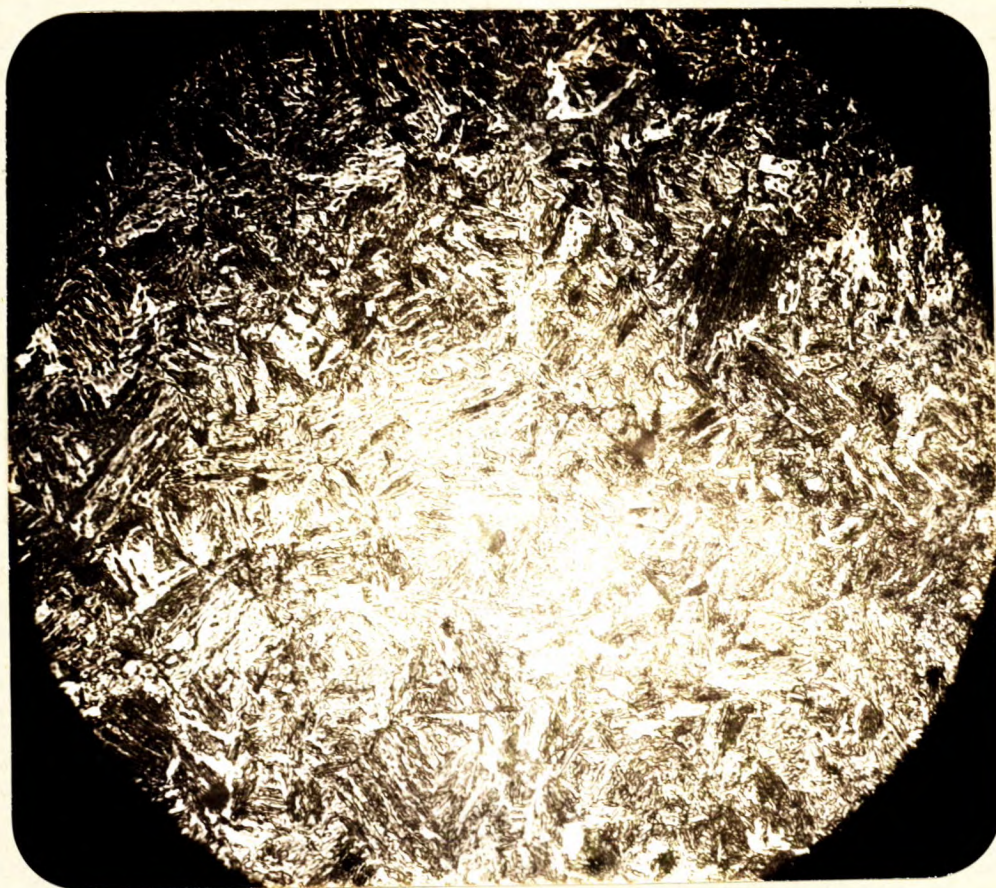
Figure 7.

Figure 7 shows the structure of the heat-affected zone of the armour plate of the tested stud. Note the difference of structures of the heat-affected zones. Figure 8 illustrates the structure of the low-carbon stud material.

Both micro-examination and hardness tests indicate considerable difference in technique in welding the two studs. By sheer chance the stud selected for impact testing was the one showing a very high hardness and a martensitic structure in the heat-affected zone. The other stud shows the same depth of penetration and the same width of heat-affected zone but a considerably lower hardness and a tempered martensitic structure with some precipitated ferrite. Since in both samples the width of the heat-affected zone is approximately the same, the conditions of current value and time of flow must have been approximately the same. The only explanation of the differences in hardness and structure which readily comes to mind is that the untested stud of the welding has been given a second 'shot' of current, which has had the effect of tempering the fusion and heat-affected zones by reducing the cooling rate through the critical range or, more probably, by reheating to above the lower critical.

STRUCTURE OF HEAT-AFFECTED ZONE OF THE TESTED STUD.

White constituent is white etching martensite
and remainder is nodular martensite.

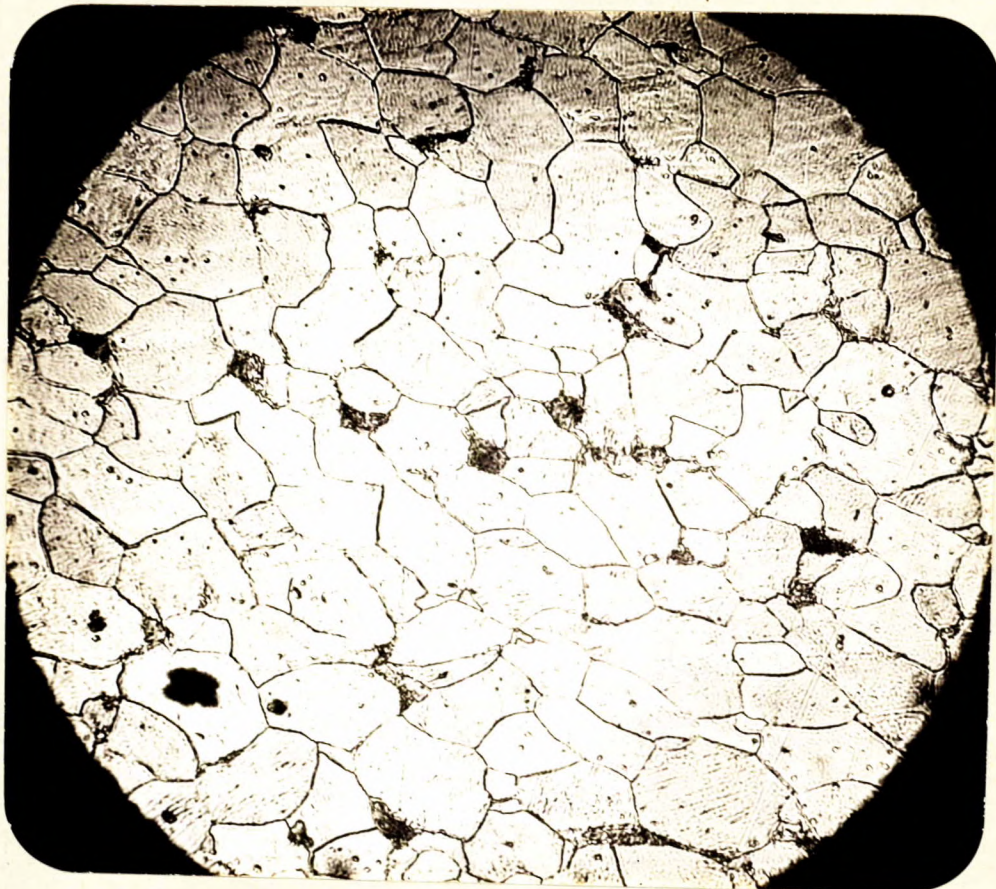
Figure 8.

LOW-CARBON STRUCTURE OF STUD MATERIAL.

Ferrite and islands of pearlite.
