Investigation No. 1545.

Investigation of the Corrosion of
a Steam Condensate Steel Pipe.

CANADA
DEPARTMENT
OF
MINES AND RESOURCES
Mines and Geology Branch

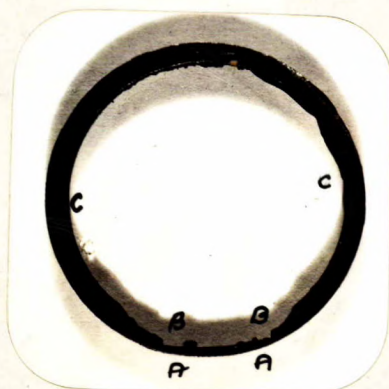
Figure 1.

CROSS-SECTION OF PIPE.
(Approximately $\frac{3}{4}$ size).

In the most heavily attacked portion of the pipe, A-A (Figure 1), the surface was covered with a black corrosion constituent. Small projections in this area had a partial coating of red constituent over the black. Through B-B and above to C, the outer constituent is red. The decrease in steel thickness and the reddish colour taper off from the thin area until both are apparently negligible through a plane C-C and above it.

Tests showed the black corrosion constituent to be magnetic.

Because of the adhering corrosion products the "eating" action is said to be corrosive rather than erosive. The localized nature and gradation of the corrosive attack indicate that the corroded area was at the bottom of the pipe. The returning steam condensate, at most times, is evidently not nearly enough to fill the pipe and thus the corrosive agent or agents were presented for a much longer time to the bottom of the line. This assumption could, of course, be checked by comparing the location and nature of the corroded areas encountered. In so far as the pipe is concerned the localized nature of the attack would support the above contention, especially as the possibility of this being due to a particular length of pipe being defective is ruled out by the fact that similar failures are reported to have occurred in other parts of the line.

Corrosion, in the present case, is thought to have been unusually rapid because of the cooperative combining of oxygen content, temperature, rate of condensate flow, and the character of the corrosion products. Consideration might be given to some method of feed water de-aeration or to neutralization of oxygen by chemical means. If chemicals are used, the pH of the water must not, of course, be allowed to rise too high because of the danger of pitting or caustic embrittlement in the steam boiler. The removal of oxygen would largely remove the problem as to the oxide formed. Indeed, any marked reduction in oxygen content would be expected to result in considerable improvement and may possibly serve, as well, to change the corrosion product to the more protective red constituent.

A practical expedient would appear to be to rotate the

pipe from time to time (if this does not involve considerable mechanical difficulties). This would assure more uniform corrosion and a consequent increase in pipe life.

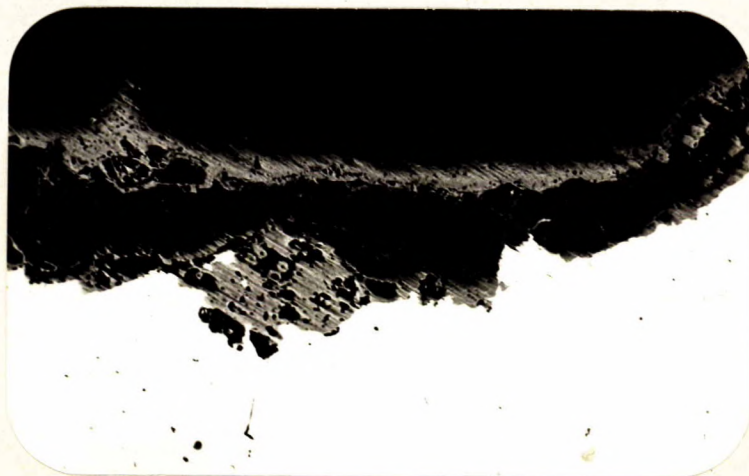
A cross-section of the pipe was mounted in bakelite and polished. Two types of corrosion constituents were seen in the pipe below the plane C-C (Figure 1). These are shown, at 250 diameters, in Figure 2. In some places, such as the one pictured, the red constituent (light colour) is both next to the steel (shown white) and on the outer surface. In other places (particularly between A-A) the black constituent is adjacent to the metal. Very little evidence of corrosion or of corrosion products was found on the side of the tube opposite to the heavily attacked portion.

X250, unetched.

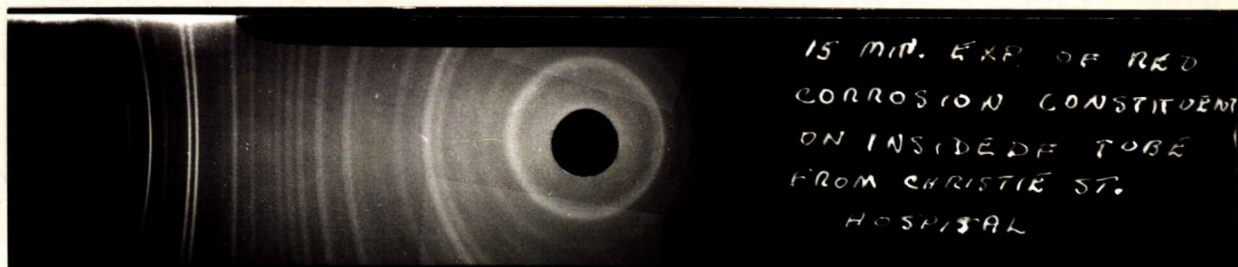
Figure 3.

RED CORROSION CONSTITUENT.

Comparison of diffraction patterns (Figures 3 and 6) positively identifies the red corrosion constituent as $\text{Fe}_2\text{O}_3 \cdot x \text{H}_2\text{O}$. The black corrosion product, as indicated both by comparison of diffraction pattern, Figure 4, with one obtained from magnetite ore and by magnetic tests, is predominantly or wholly Fe_3O_4 ($\text{Fe}_3\text{O}_4 \cdot x \text{H}_2\text{O}$).

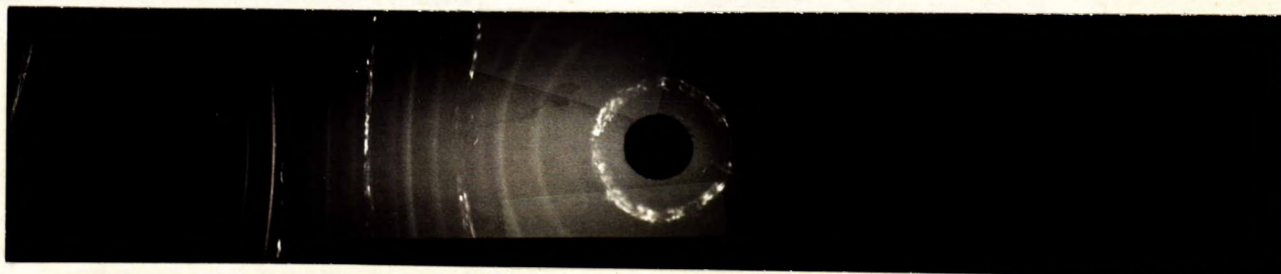
Figure 4.

BLACK CORROSION CONSTITUENT.

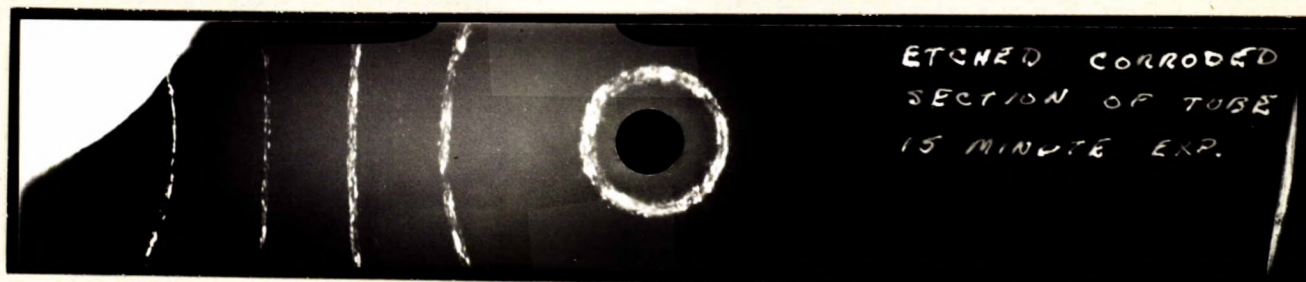
Figure 5.

MACRO-ETCHED, HEAVILY CORRODED STEEL.

The microstructure of the pipe shows that it has been normalized (probably from the forming temperature). X-ray diffraction patterns of macro-etched sections from heavily corroded and relatively uncorroded parts of the tube confirmed the fact that there was no great difference in

internal strain and that no severe strain existed in the tube.

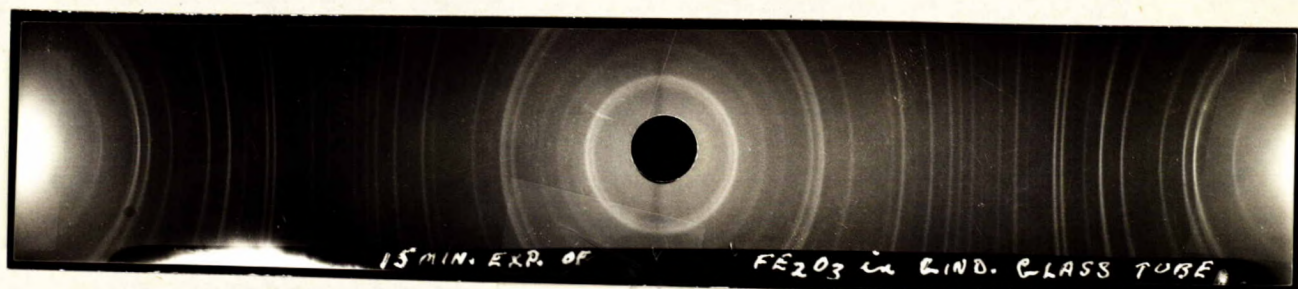
Figure 6.

PREPARED Fe_2O_3 ($\text{Fe}_2\text{O}_3 \cdot x \text{H}_2\text{O}$).
