December 6th, 1943.

ORE DRESSING AND METALLURGICAL LABORATORIES.

Investigation No. 1549.

Examination of Samples of Welded  
Joints of a T.16 Universal Carrier.

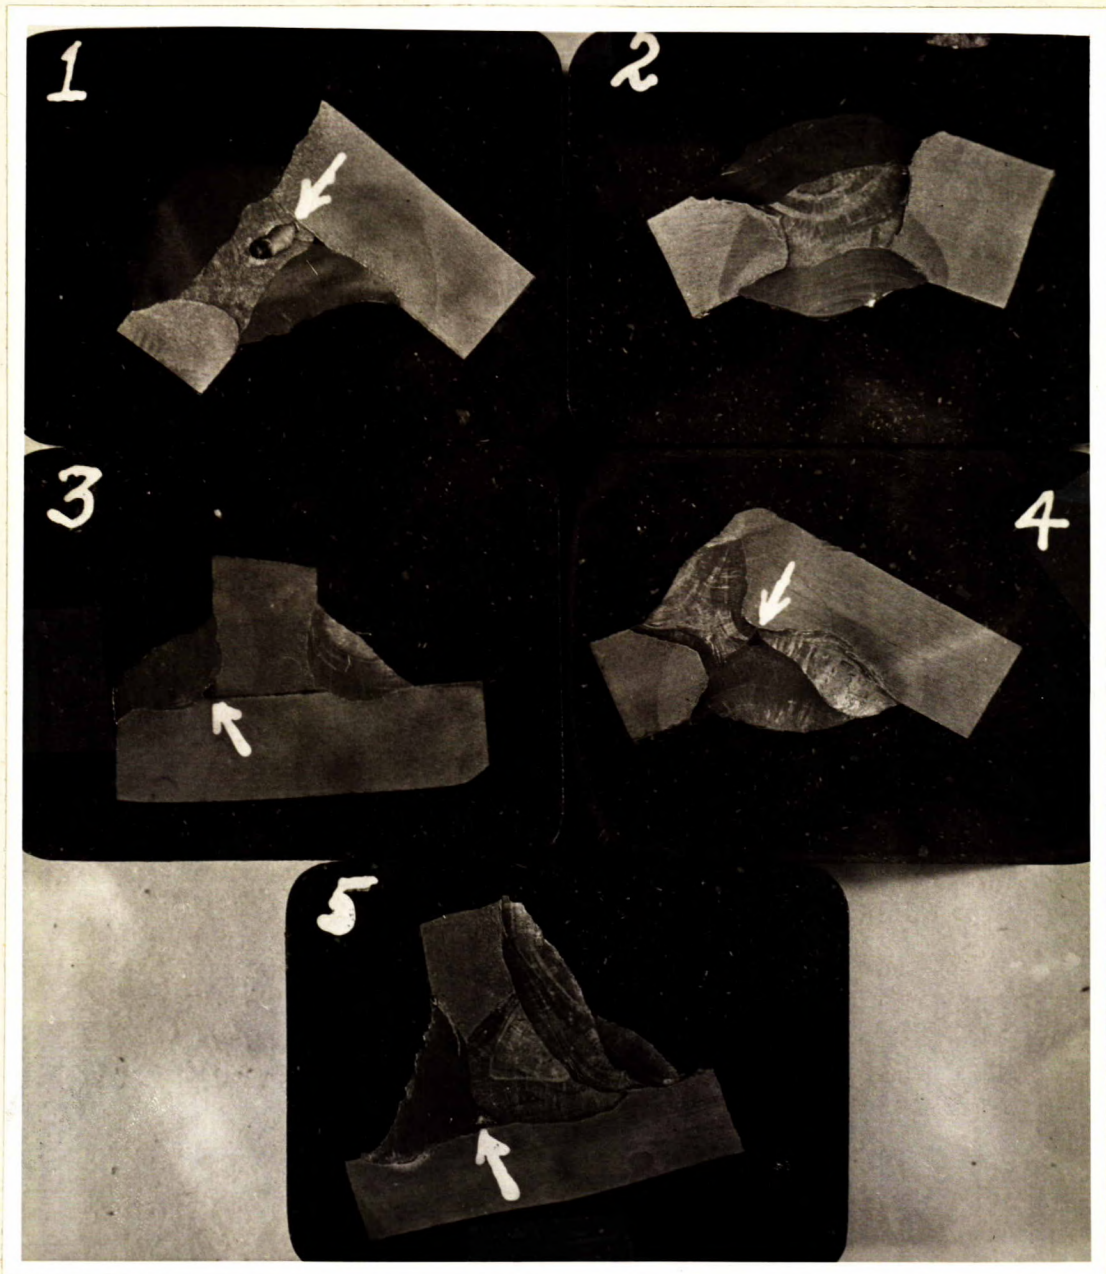
Figure 1.

The macro-examination reveals that all samples, with the exception of Nos. 3 and 5, are three-pass welds. Sample No. 3 is a double-pass fillet weld. Sample No. 5 is a four-pass weld which should have been made in two passes. In this particular case it is apparent that poor fit-up has necessitated buttering and an excessive use of weld metal to bridge the gap. Sample No. 10 shows the same type of defect. Nearly all samples show a wider root gap than is desirable. This has resulted in excessive dilution of the weld metal in the root pass, brought about by a weaving motion of the electrode necessary to close the gap. The resulting dilution has produced a ferrite condition in the weld metal of the root pass. The above data should be compared with operation sheets to determine whether the proper technique is being followed.

Samples Nos. 1, 3, 4, 5, 9 and 10 all show slag inclusions at the roots of the welds. These are probably due to the weaving technique in the root pass which enhances the probability of slag being trapped.

SPECIMENS FROM SAMPLES NOS. 1 TO 5, INCLUSIVE.

White arrows point to slag inclusions. Note darker etch in root pass of Specimens 1 and 2. Note improper placement of weld metal of first pass on underside of large plate of 4. Note also excessive use of weld metal to counteract poor fit-up in Specimen 5.

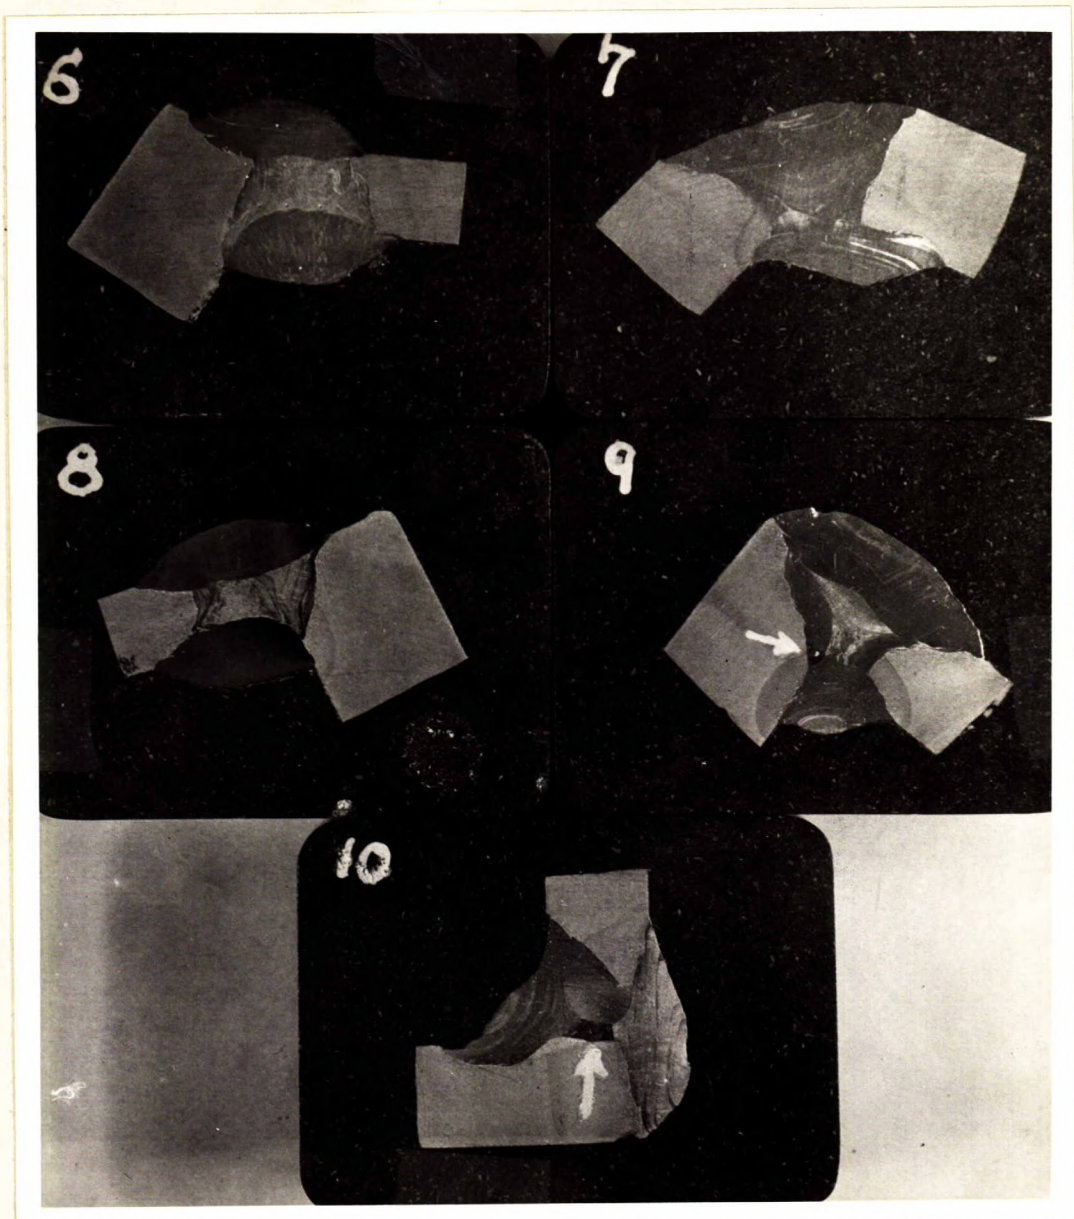
Figure 2.

SPECIMENS FROM SAMPLES NOS. 6 TO 10, INCLUSIVE.

White arrows point to slag inclusions. Note darker etch of root pass of Specimens 6, 7, 8, and 9. Note wide root gaps. Note that in Specimen 10 the edge of small plate has been buttered to counteract poor fit-up. Note also excessive weld reinforcement.

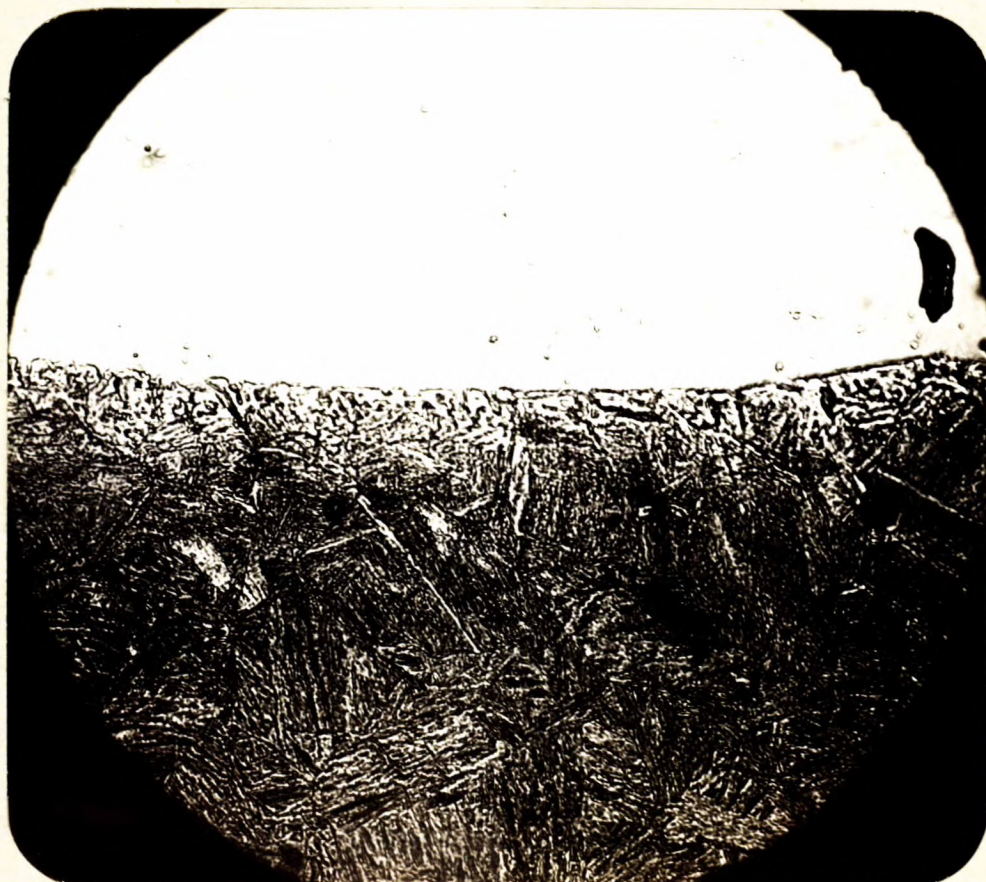
Figure 3.

STRUCTURE OF TYPICAL FUSION ZONE.

Pearlite adjacent to weld metal and  
martensite in the heat-affected zone.

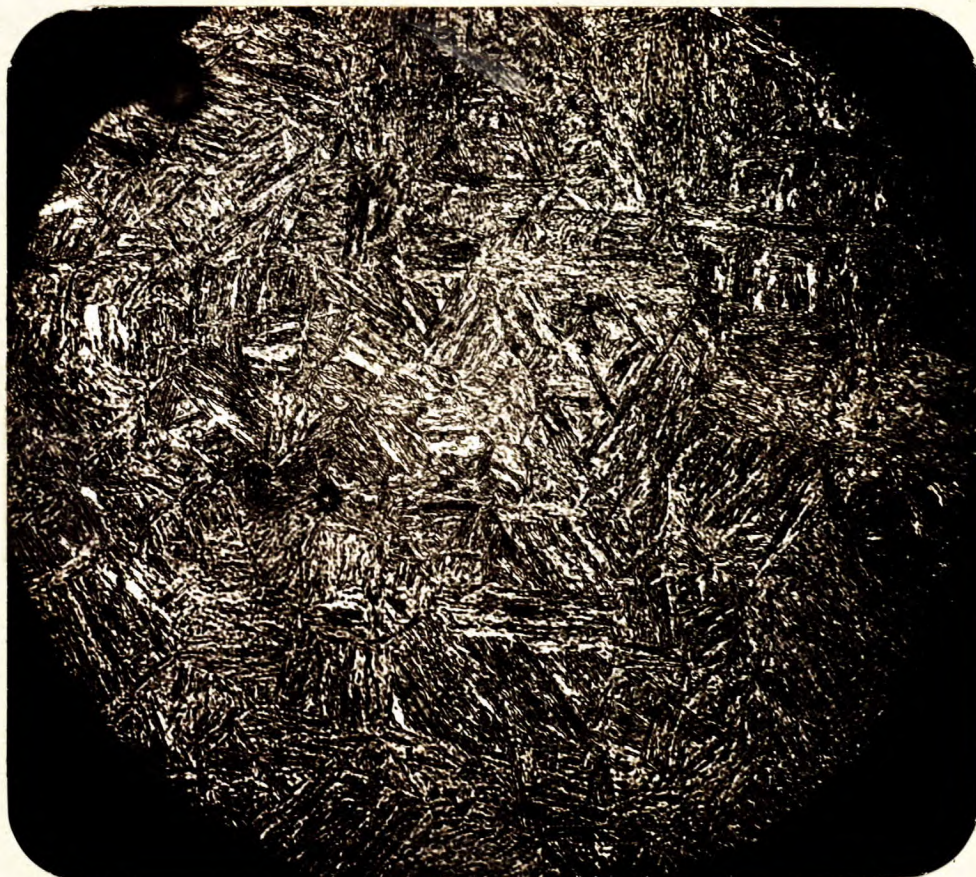
Figure 4.

Hardness tests show nothing abnormal, with the possible exception of fairly high hardnesses in the heat-affected zones of the top passes of welds. Hardnesses would indicate a brittle condition in the areas but there is little possibility of altering this without annealing beads, which are impracticable in welds of this size. The hardness ranges of the ferritic root passes may be attributed to the variations in the annealing effect, produced by subsequent beads. Every effort should be made to avoid dilution of such a magnitude as to produce ferritic conditions since shock properties are consequently lowered.

TYPICAL MARTENSITIC STRUCTURE OF ALL HEAT-AFFECTED ZONES.

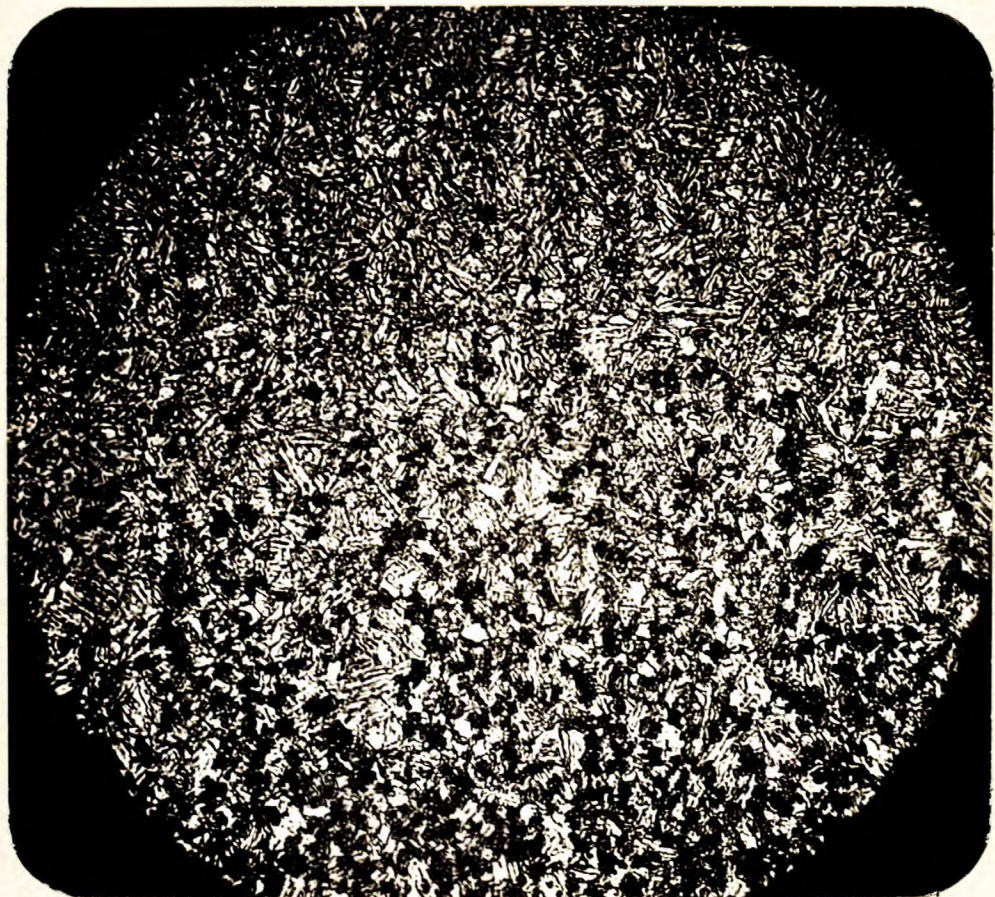
Figure 5.

TYPICAL STRUCTURE OF TRANSITION ZONES.  
NODULAR TROOSTITE IN HEAT-AFFECTED ZONE  
AND TEMPERED MARTENSITE OF UNAFFECTED  
ARMOUR PLATE.

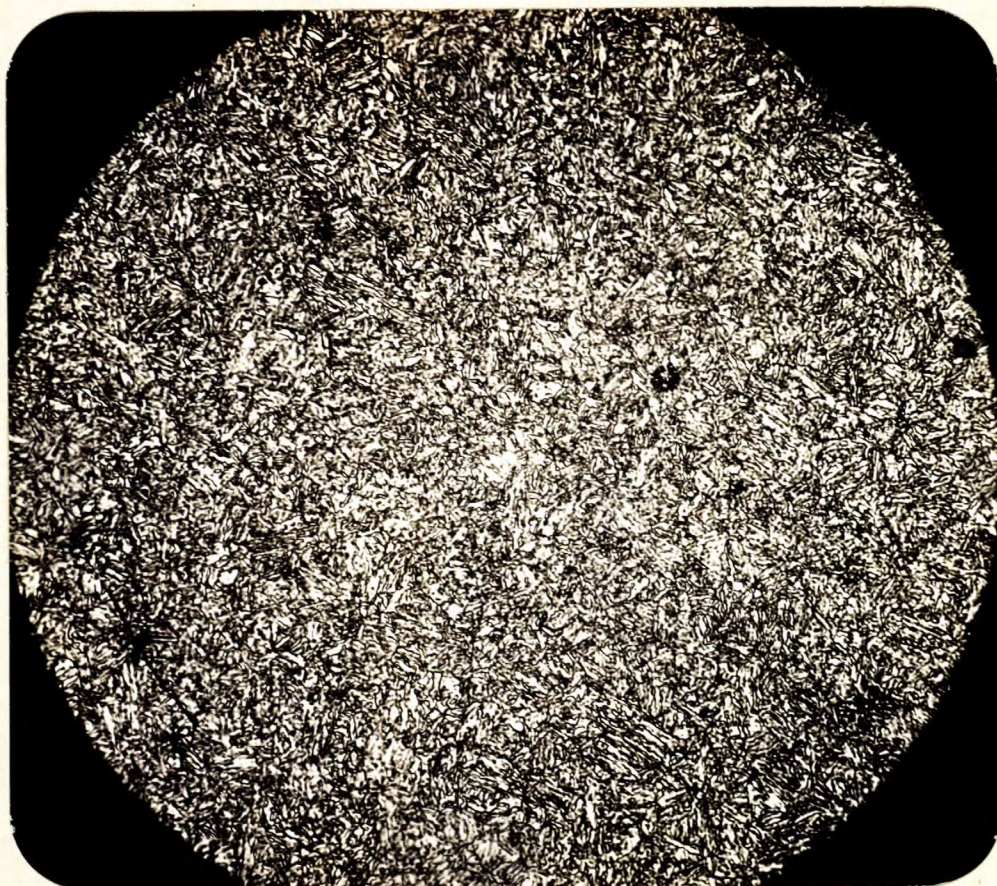
Figure 6.

The chemical analysis of the armour plate indicates that it is a carbon-manganese-chromium-molybdenum type, of good hardenability. The structure indicates that the armour plate is receiving a satisfactory heat treatment.

MARTENSITIC STRUCTURE OF ARMOUR PLATE.

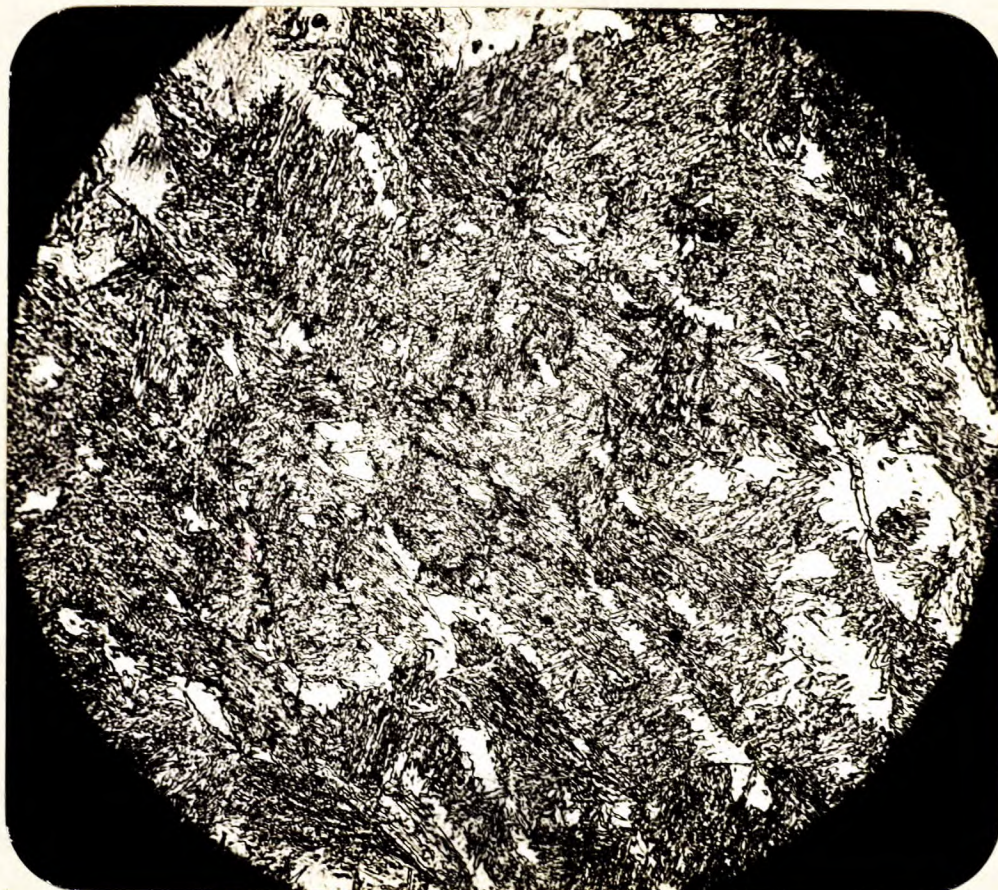
Figure 7.

TEMPERED MARTENSITIC STRUCTURE TYPICAL  
OF THE FERRITIC ROOT PASSES.

White constituent is retained austenite.

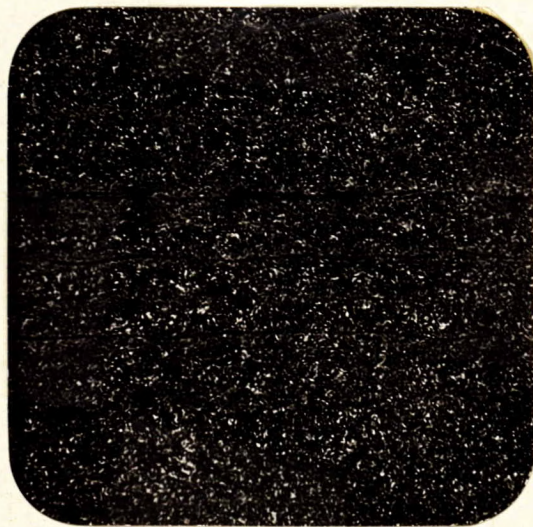
Figure 8.

Figure 8 shows a banded structure and numerous sulphide inclusions in the wide heat-affected zone of the larger plate of Sample No. 4.

in the heat-affected zones or the armour plate. Structures of the heat-affected zones, fusion zones, transition zones, and unaffected armour plate are normal. No evidence was found, in the samples submitted, of lack of fusion. One sample (No. 4) showed a banded structure in the heat-affected zone of the thinner plate, and sulphide inclusions considerably greater than normal. The banding indicates chemical inhomogeneity. The remaining samples show normal small sulphide and oxide inclusions.

BANDED STRUCTURE OF HEAT-AFFECTED  
ZONE OF ARMOUR PLATE.

Note sulphide inclusions.
