ORE DRESSING AND METALLURGICAL LABORATORIES.

Investigation No. 1550.

Investigation of Three Canadian Dry Pin
Track Pins Which Failed in Field Test.

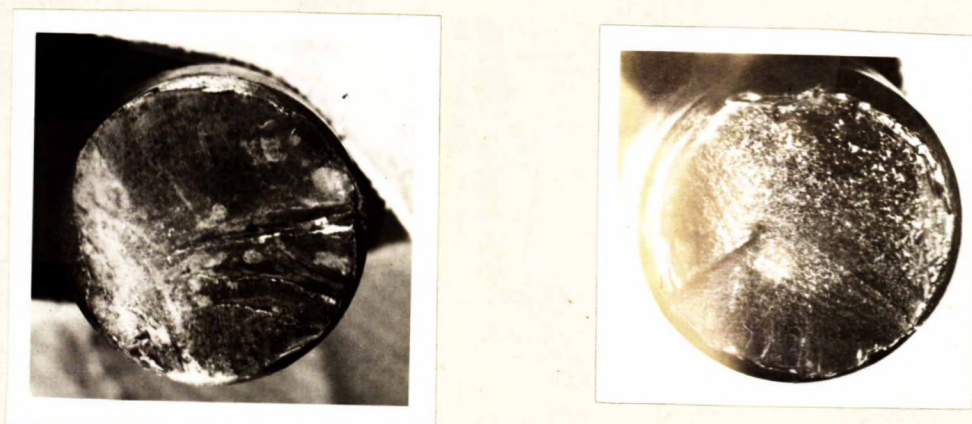
Figure 1.

Examination of the failed surfaces revealed duplex fractures, usually associated with fatigue failures. Figure 1 shows the surfaces of two pins.

FRACTURED SURFACES OF FAILED PINS.

Note duplex structure.

By running the track backward (grouser meeting the ground first after coming off the sprocket), more reversals of stress have been induced on the pins, causing fatigue failure. This is denoted by the duplex fracture observed on the broken

1. The pins failed due to fatigue.
2. Reversing the track from general assembly practice induces greater fatigue stresses on the pins.
3. Lowering the hardness range from Rockwell 'C' 45-51 to Rockwell 'C' 40-44 has produced a pin with more resistance to impact, as shown by the absence of failures on the standard assembled track, up to 1,500 miles.
4. Normal assembly practice appears to produce:
 - (a) High impact stress,
 - (b) low fatigue stress.Reversed assembly produces:
 - (a) High fatigue stress.The impact stress has not been determined in the field.
5. Core hardnesses are somewhat higher than surface hardnesses.
6. An 0.0091-inch wear has occurred per 1,000 miles.

1. It would be of interest to run a track with higher-hardness pins in the reversed manner. This would increase the fatigue life of the pins. It would also determine whether the

impact stresses are lessened by running the track in this manner.

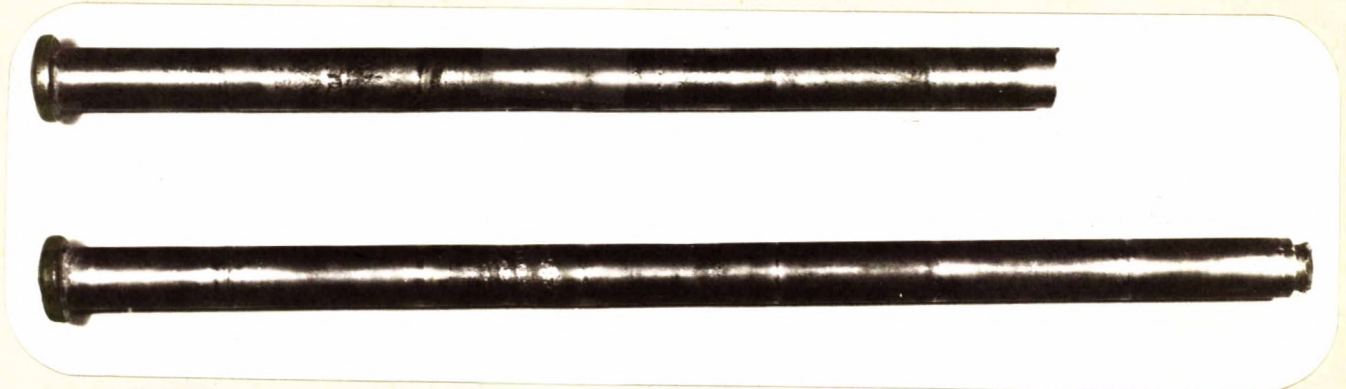
Figure 2.

Two of the pins broke at a point approximately three inches from the rivetting tip. Figure 2 shows a failed pin placed alongside the unbroken pin for comparison. The surface on the latter pin has been gouged circularly at one point by some imperfection in the link eye-hole. The third pin failed $5\frac{1}{2}$ inches from the tip.

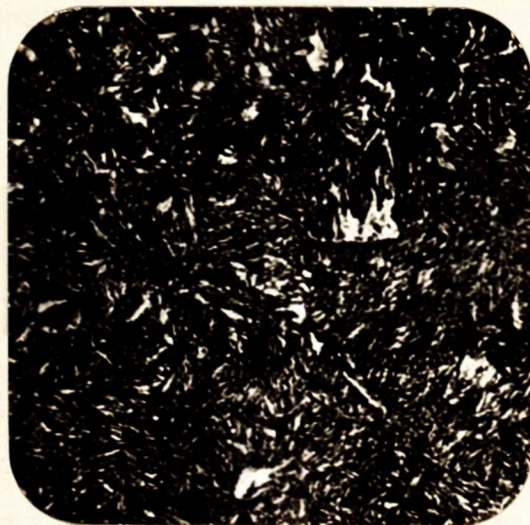
Figure 3.

A transverse section was cut from one of the broken pins. It was polished and etched in 2 per cent nital. Figure 3, taken at X1000 magnification, illustrates the structure obtained.

STRUCTURE OF CORE.

Tempered Martensite.

The microstructure obtained is tempered martensite.
