Investigation No. 1556.

Examination of a Broken Manganese Bronze Casting.

Bureau of Mines
Division of Metallic
Minerals.

Ore Dressing
and Metallurgical
Laboratories

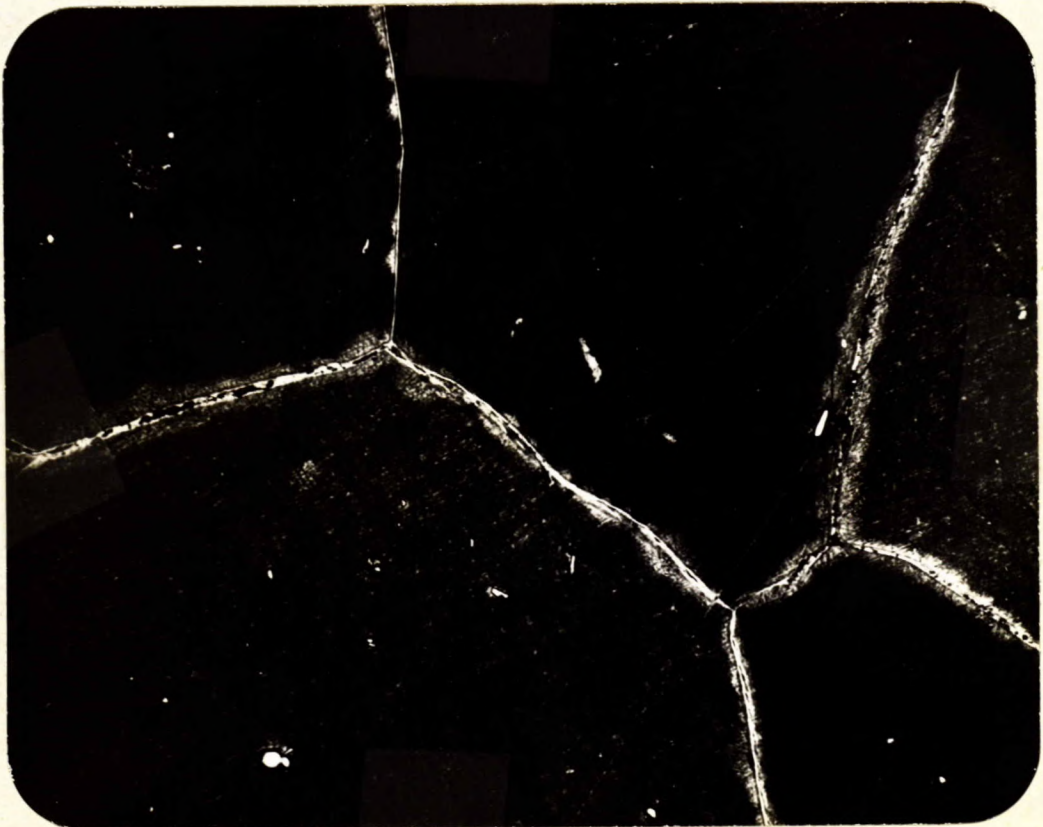
Figure 1.

Microscopic examination of the region adjoining the fracture revealed intergranular films penetrating from the surface and diminishing inwards.

Figure 1 shows such a film on the grain boundaries. Figure 2 shows segregations in the grains.

X250, FeCl₃ etch.

Microscopic evidence of intergranular films penetrating from the surface of the fracture and disappearing farther inside, would indicate that a fluid metal, e.g., a solder,

penetrated between the crystals of the manganese bronze casting.
