Investigation No. 1557.

Examination of a 6-mm. Armour Plate
Which Had Failed Ballistically.

CANADA
DEPARTMENT
OF
MINES AND RESOURCES
Mines and Geology Branch

O T T A W A December 16th, 1943.

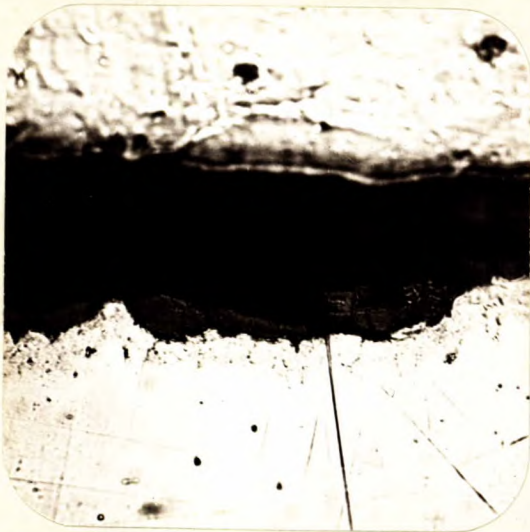
Figure 1.

The amount of scale present in the unetched structure is shown in Figure 1, taken at X500 magnification.

The scaling is not excessive, and no marked decarburization could be observed under the microscope, the amount of

X500, unetched.
SHOWING THE EXTENT OF SCALING.

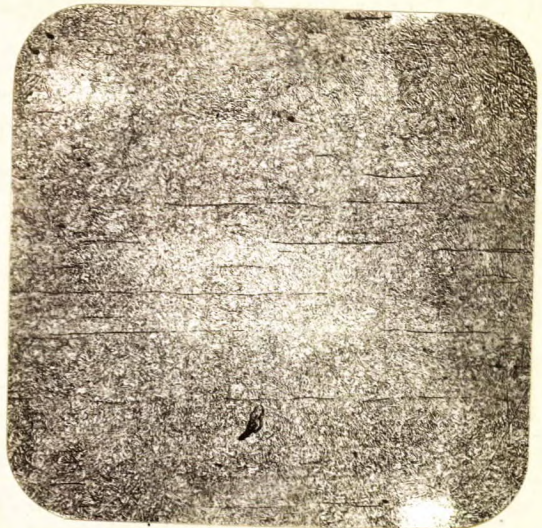
Figure 2.

The main characteristic of the steel is its dirtiness. An estimation of the amount of inclusions can be made from Figure 2, a photomicrograph at X100 magnification.

The most striking and important characteristic of this plate is undoubtedly the dirtiness of the steel, and this factor has a most detrimental effect on the ballistic properties, especially when the inclusions are present as elongated stringers. These inclusions are of the same type as those found in armour plate, A.E.D.B. Lots Nos. 817 and 818, covered by O.D.M.L. Investigation No. 1535 (November 19th, 1943). Previous U.S. Ordnance reports have shown definite correlation between the presence of elongated stringers and the tendency to spall.

The plate submitted for examination would not be expected to give good ballistic performance, because of its high content of elongated stringers. The low hardness possibly has been a contributing factor to the lowering of the ballistic properties.

X100, picral etch.
SHOWING AN INCLUSION PATTERN.

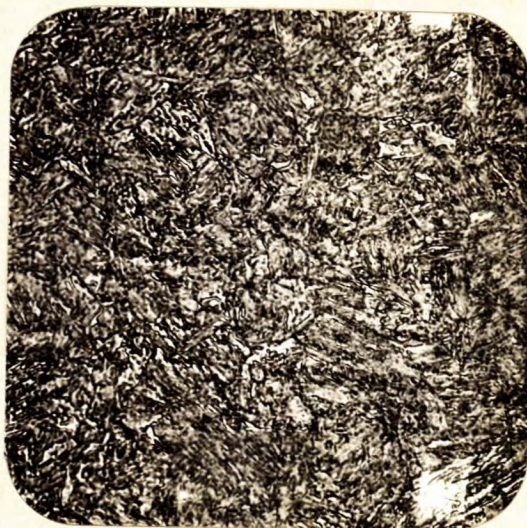
Figure 3.

The microstructure of the steel is shown in Figure 3, at X500 magnification. With the exception of a few very small areas of ferrite, the steel is wholly sorbitic.

X500, picral etch.
SHOWING THE MICROSTRUCTURE
OF THE STEEL.

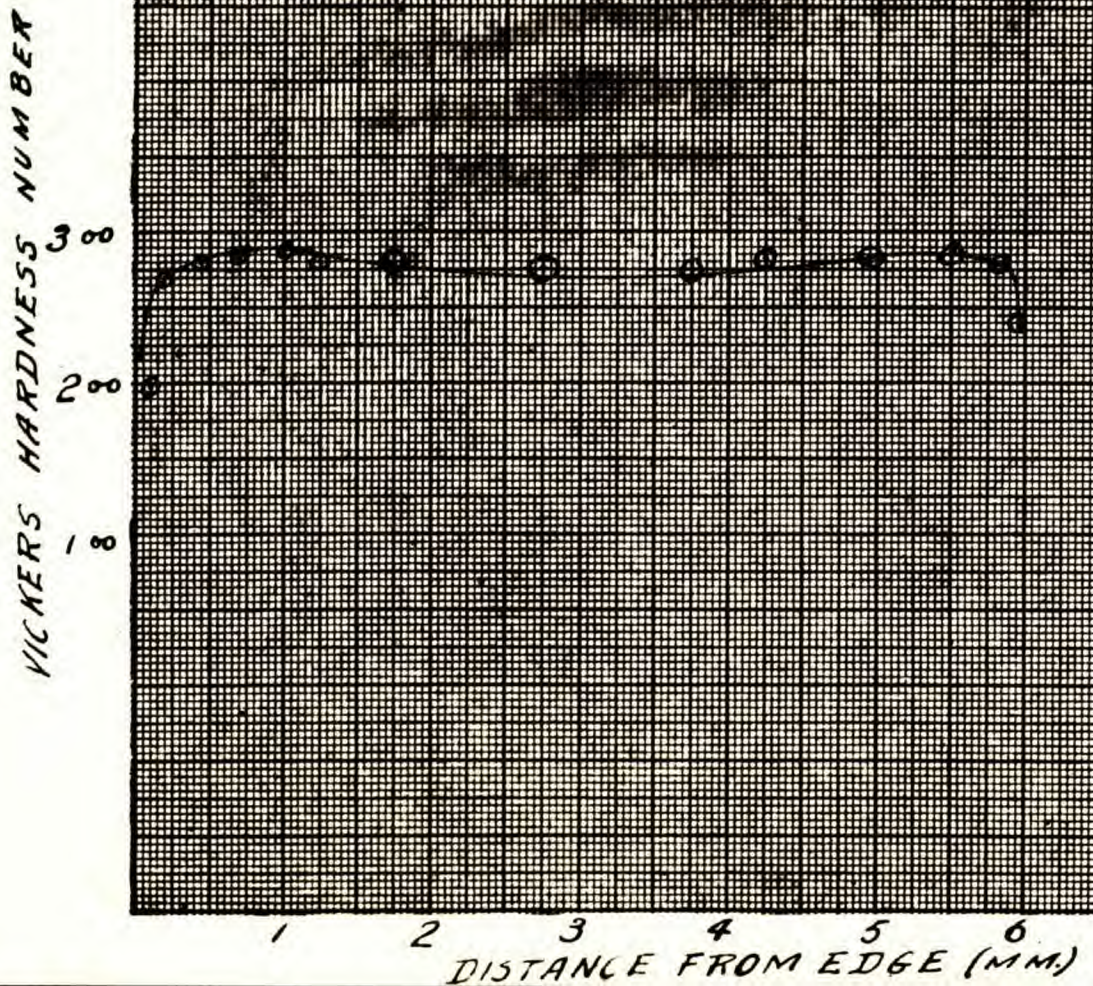
Cross-Directional Hardness

The results of a cross-sectional hardness survey are shown in an attached sheet at the end of the report. The estimation of the depth of decarburization can also be calculated from this chart.

free ferrite being approximately the same near the edge as in the centre of the plates. However, the depth of decarburization, as observed by the hardness survey, is shown to be 0.25 mm.
