January 7th, 1944.

ORE DRESSING AND METALLURGICAL LABORATORIES.

Investigation No. 1567.

Examination of Additional Welded Splash Strips.

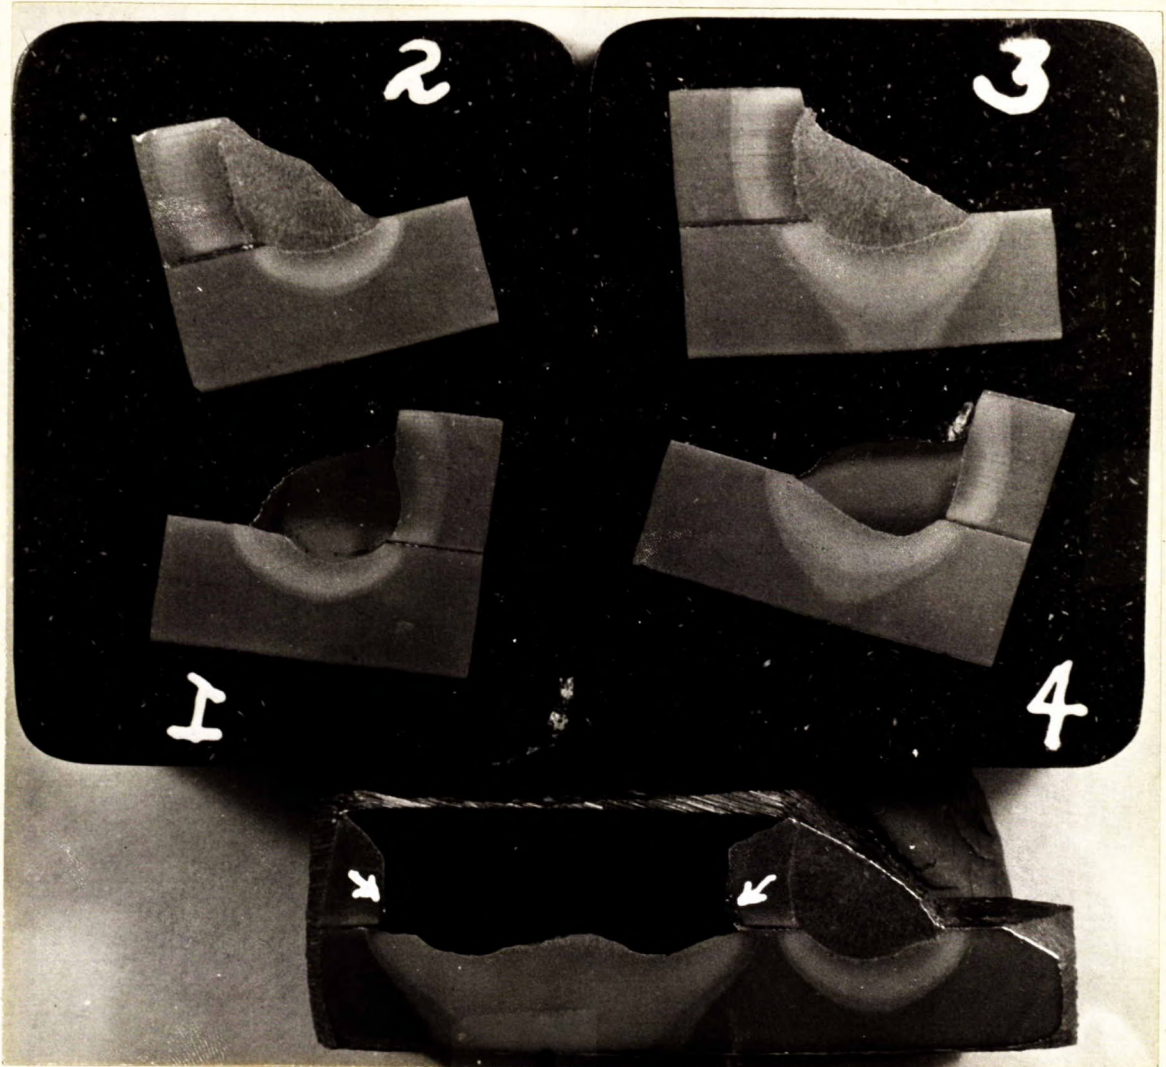
Figure 3.

A visual examination of the test plates indicates that the plates were welded from the outside towards the centre. This is good welding technique in that this reduces locked-up stresses. It is also noted that the location of the welds (see Figure 3 and 4) is irregular in that in some cases the weld metal is washed up to the top of the splash strip and in others only 2/3 of the distance. The areas of impact of the tested sample show only short cracks.

As in the previous examination (Report of Investigation No. 1513), there would seem to be considerable variation in welding technique from bead to bead on the same test plate. This is shown by the variation in depth and width of the heat-affected zones. However, it is noted that there is a considerable improvement in penetration and bead contour. It is probable that the variations in the heat-affected zones can be accounted for in variations of welding speed. All fillet welds are greatly improved over those previously examined and there was found only one slag inclusion in the roots of these welds. The extent of these improvements may be best appreciated by comparing Figures 3 and 4 of this report with comparable figures of the previous

MACRO SAMPLES OF WELDS OF UNTESTED PLATE.

Note absence of slag inclusions at roots of fillet welds. Arrows point to small slag inclusions at roots of plug weld. Weld contours good.

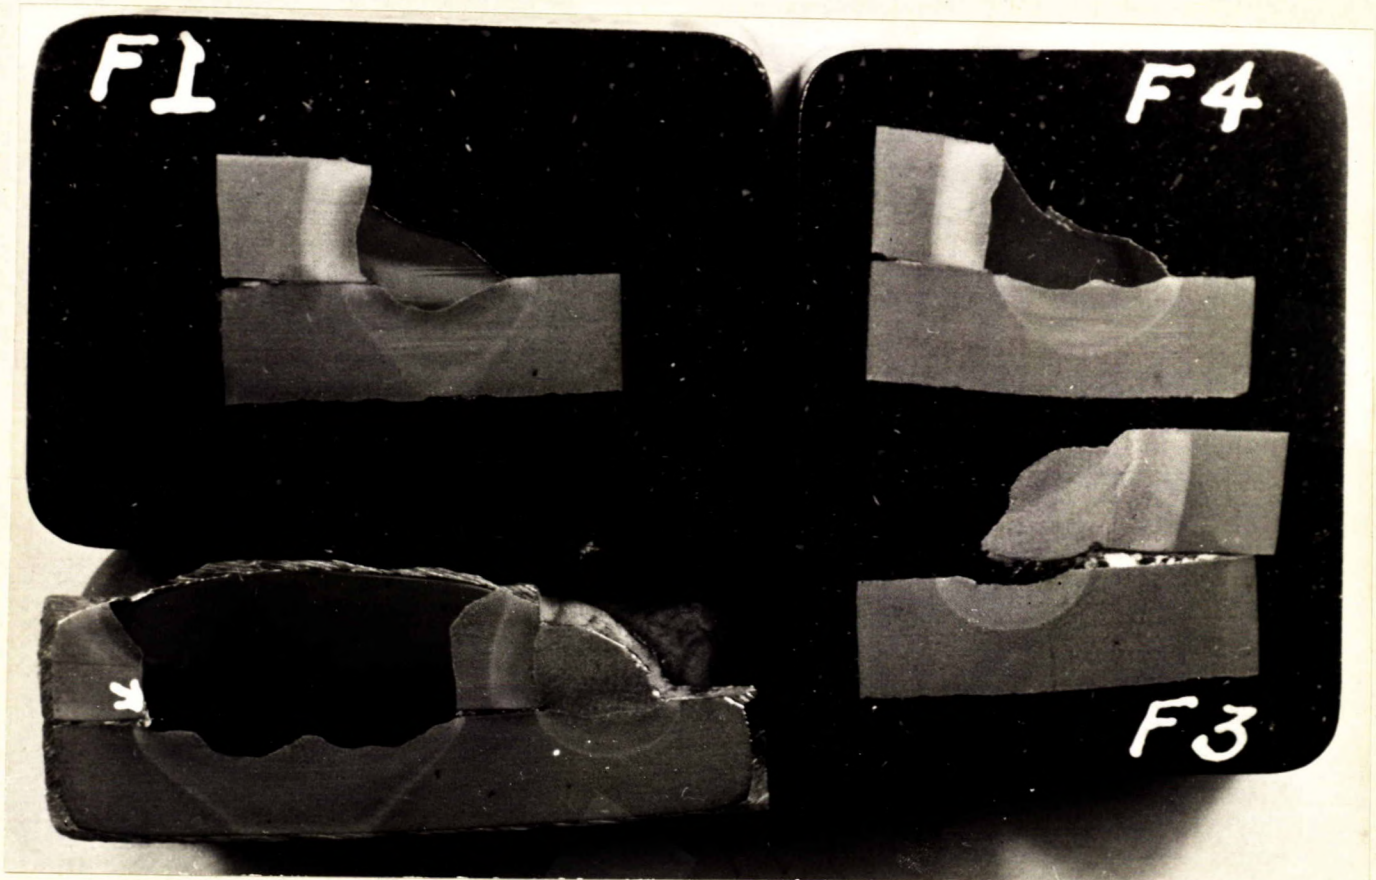
Figure 4.

MACRO SAMPLES OF WELDS OF TESTED PLATE.
WELD 2, SAME SECTION AS PLUG WELD.

Note absence of slag inclusions at roots of
fillet welds. Arrow points to slag inclusion
at root of plug weld. Weld location irregular.
Note failure of Weld 3 occurred through the
fusion line.

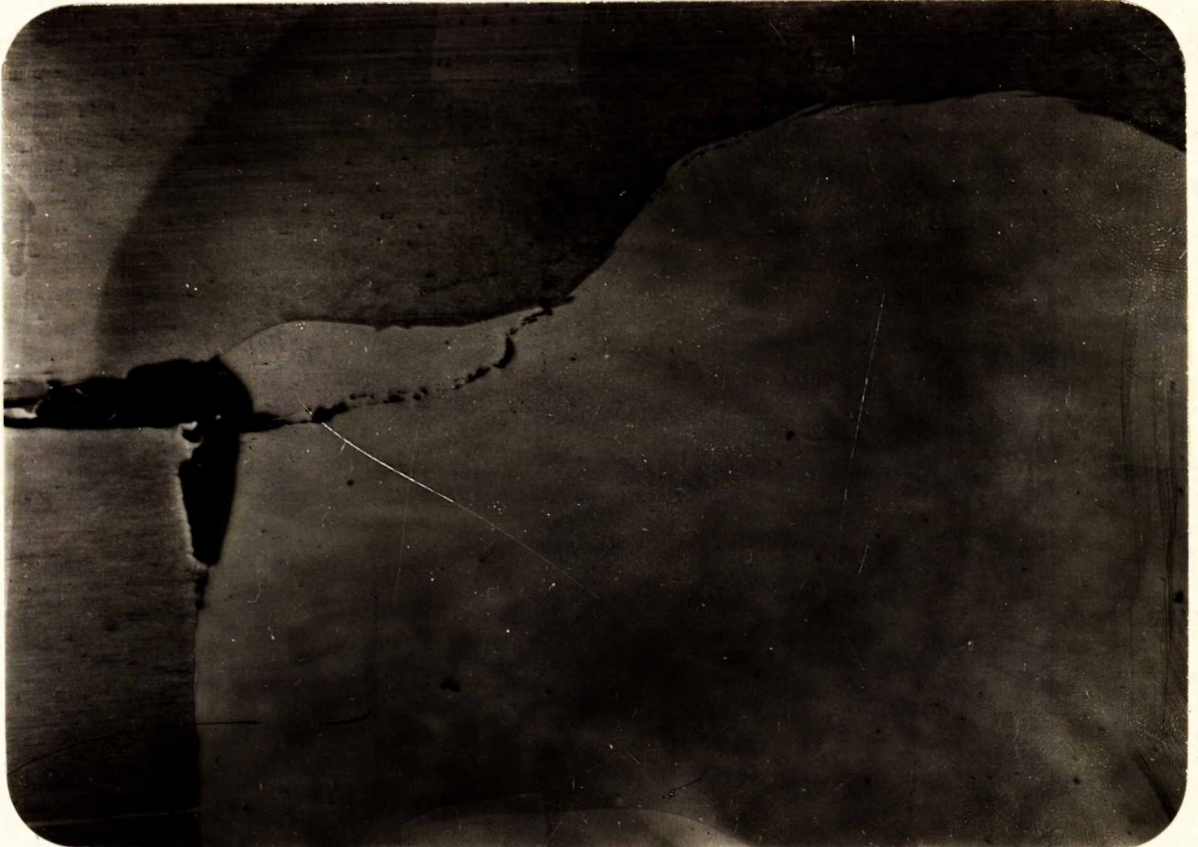
Figure 5.

4. Transverse sections of all welds were examined under the microscope. Figure 5 shows a small crack in a plug weld of the tested plate, originating at an area of lack of penetration at the root of the weld. Figure 6 shows a small crack originating at a slag inclusion at the root of Weld 4 of the tested plate.

A close visual examination of all heat-affected zones and all welds failed to reveal "hard" cracks. This is to be expected, in view of the considerably lower hardness values obtained. In all but one case the hardnesses obtained in the present investigation were considerably lower than in the previous examination. In one case (fired plate, Weld 4) the hardnesses of the heat-affected zones and weld metal (530 and 468 respectively) were comparable to those previously found. In this weld there was a crack originating in a small slag inclusion at the root of the weld. The slag inclusion has acted as a stress raiser, and impact stresses have been absorbed by cracking in the harder-than-normal weld metal. A similar cause and effect was found in the plug weld of the fired plate (Figure 5), which emphasizes the necessity of eliminating the defect.

PLUG WELD OF FIRED PLATE.

Note crack originating at a small slag
inclusion at the root of the weld.

The plug welds also indicate a considerable improvement in welding technique. The average penetration is greater, and slag inclusions at the root of the weld are much smaller. Due to the stress-raising effect of slag inclusions, every effort should be made to eliminate them entirely. On plug welds the procedure recommended in Report of Investigation No. 1513 should be followed and this will eliminate slag inclusions.

3. Plug welds show small slag inclusions at the roots of the weld which have resulted in a crack. The previously recommended technique for these welds will eliminate these defects.

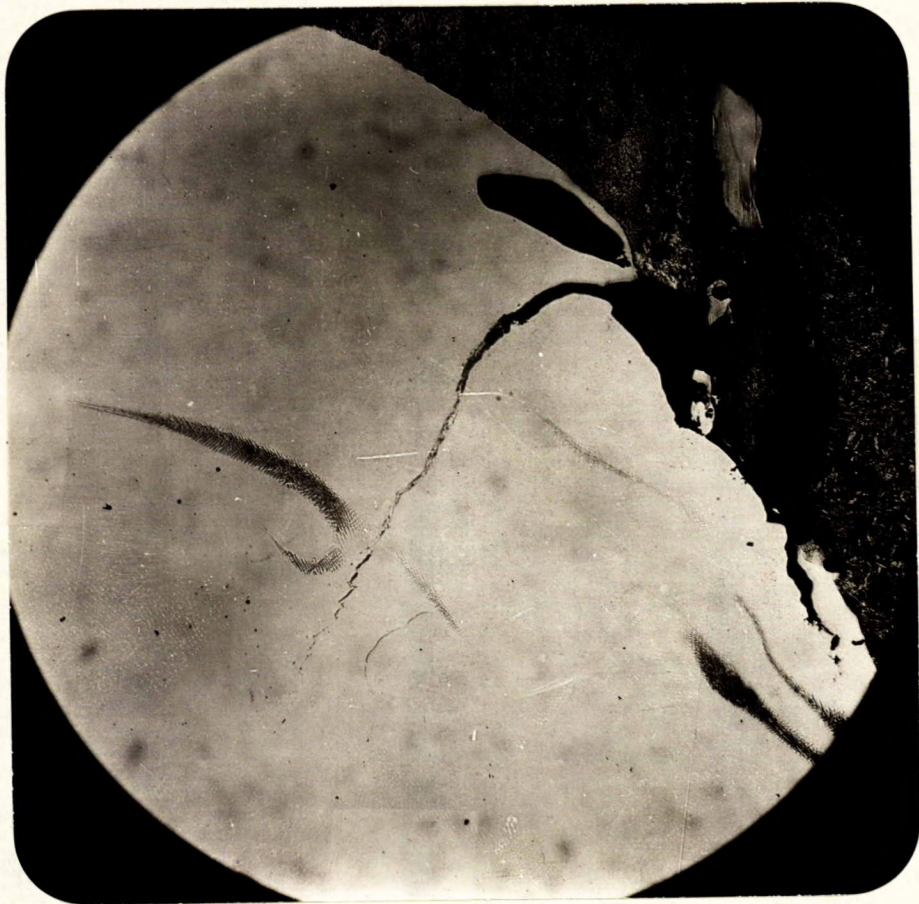
Figure 6.

WELD 4 OF FIRED PLATE.

Note small crack originating at a small
slag inclusion at the root of the weld.

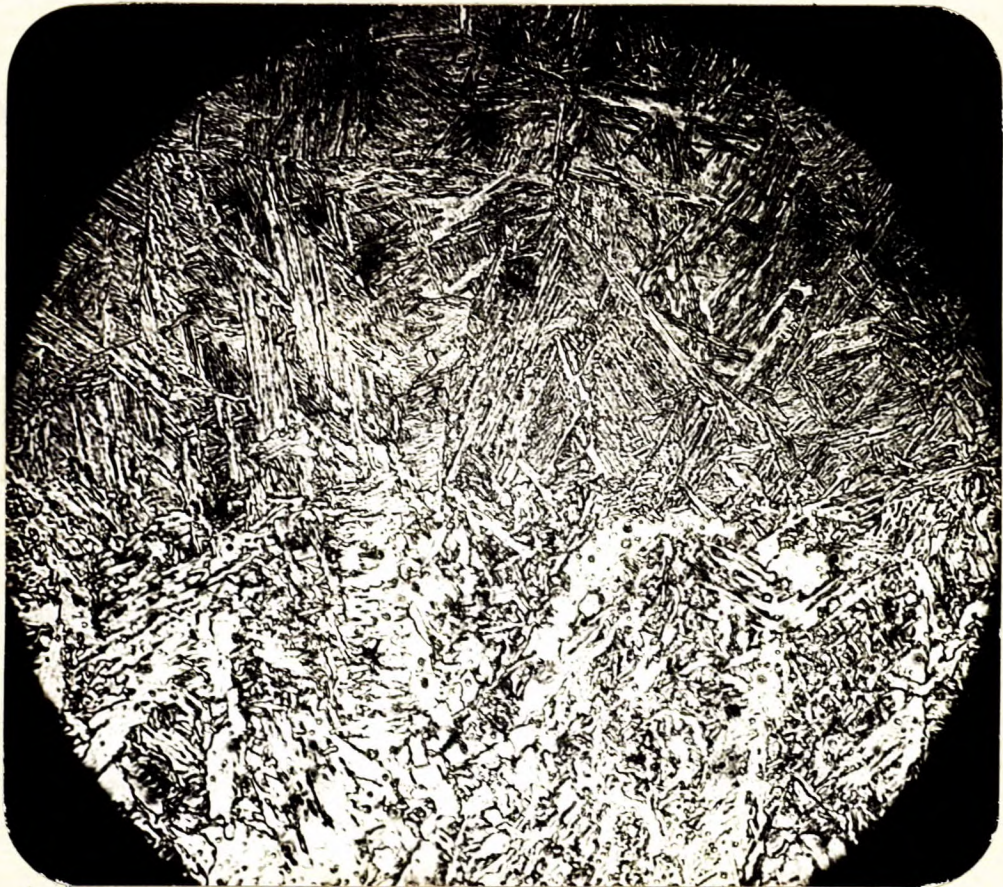
Figure 7.

The structures of the heat-affected zones, fusion zones and transition zones show nothing abnormal.

X500, etched in 2 per cent nital.
TYPICAL FUSION ZONE OF A FERRITIC WELD.

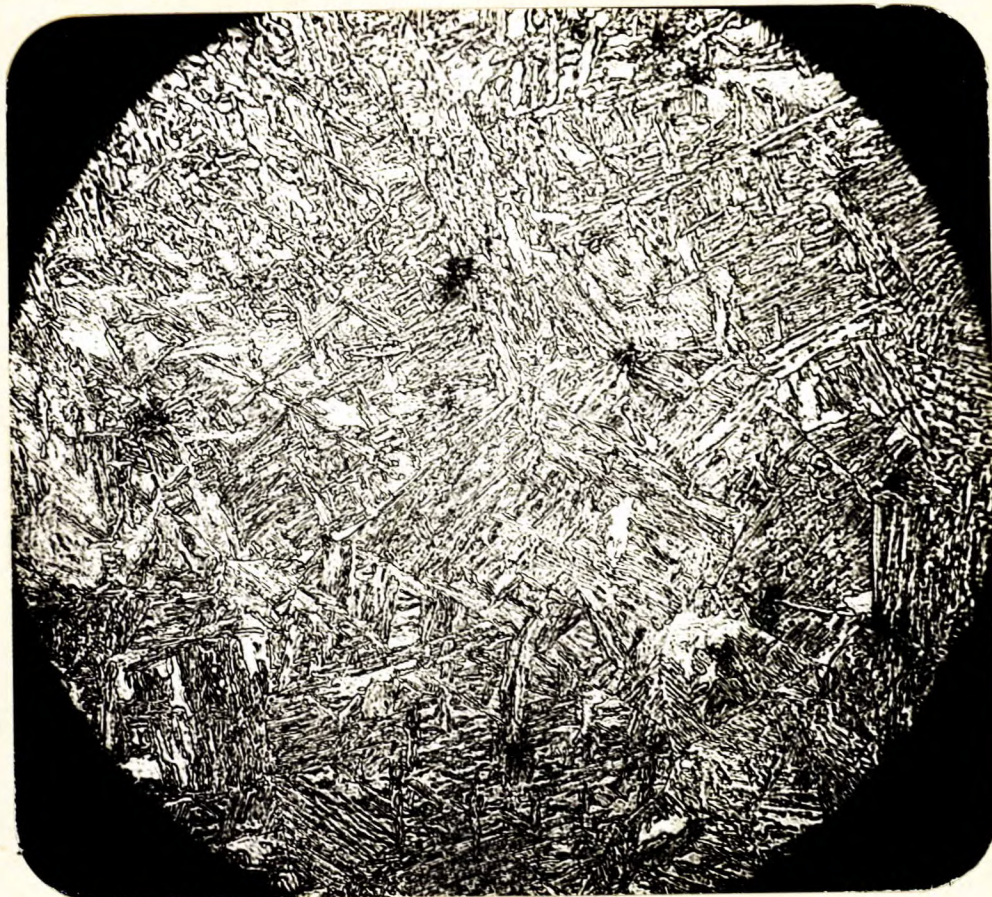
Figure 8.

TYPICAL STRUCTURE (COARSE MARTENSITE) OF ALL
HEAT-AFFECTED ZONES.

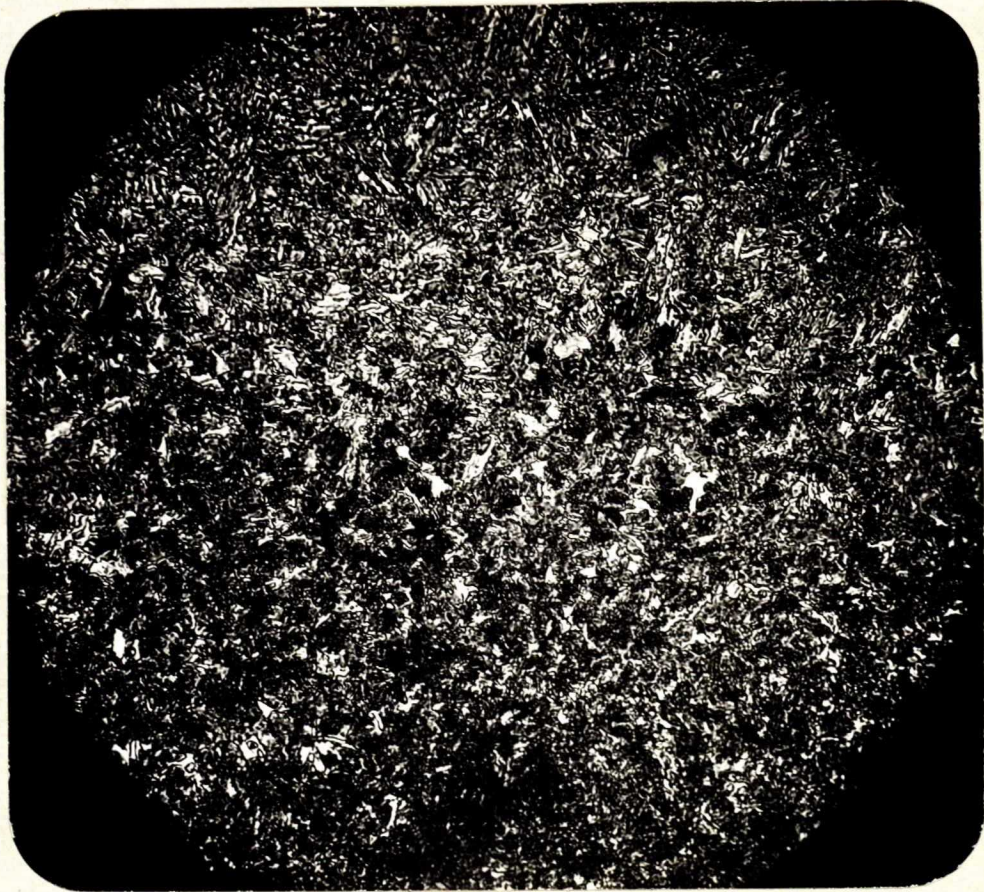
Figure 9.

TYPICAL STRUCTURE OF TRANSITION
ZONES OF ALL WELDS.

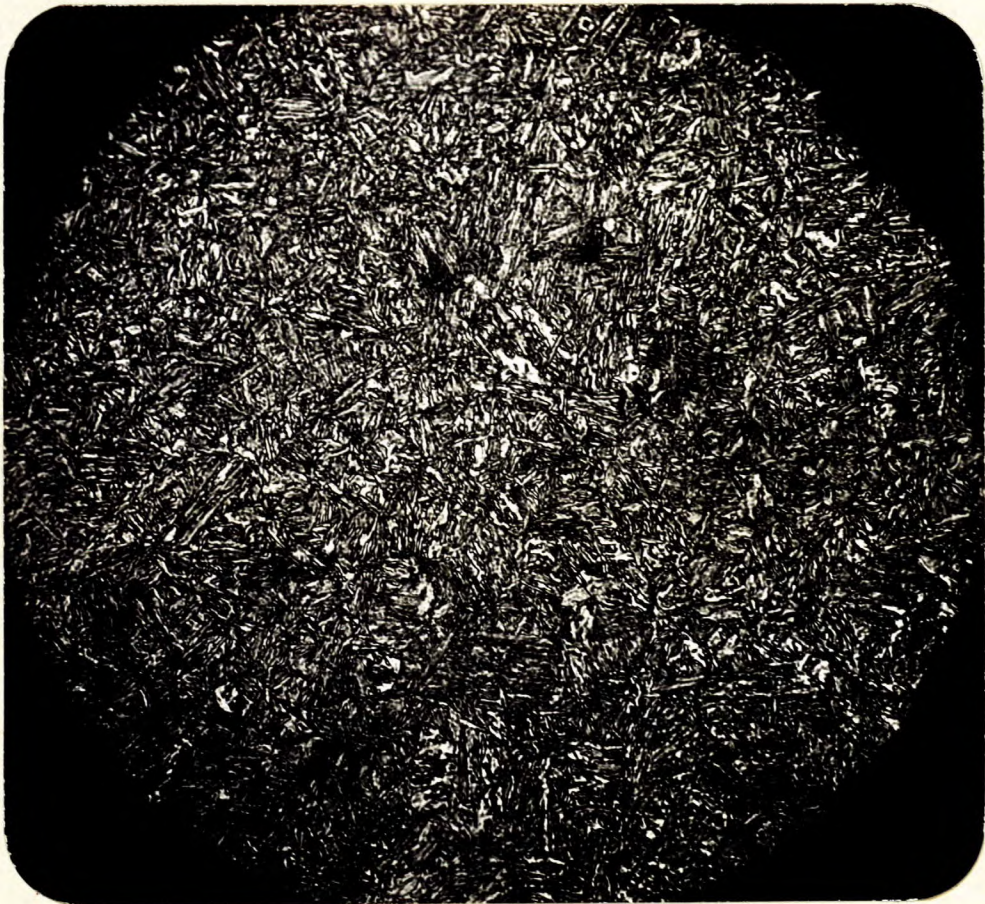
Figure 10.

X500, etched in 2 per cent nital.
STRUCTURE OF NORMAL ARMOUR PLATE.
TEMPERED MARTENSITE.
