ORE DRESSING AND METALLURGICAL LABORATORIES.

Investigation No. 1569.

Examination of a Bosch Fuel Injection Valve.

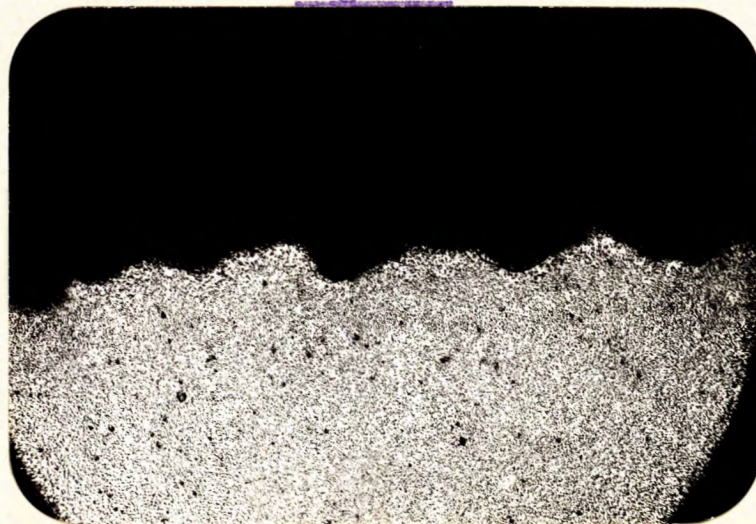
Figure 1.

The spindle showed evidence of pitting on the upper end. Fairly deep corroded lines running parallel to the longitudinal axis were also observed. These corroded grooves curved at the upper end of the spindle.

X100, etched in picric-HCl-alcohol solution.

CROSS-SECTION OF SPINDLE SHOWING  
GROOVED SURFACE.

The curving nature of the grooving on the spindle would seem to indicate that the attack has not been entirely of an abrasive nature. Indeed, the high hardness of this steel should confer good wear resistance, although a properly heat-treated high speed steel should be harder, a Rockwell 'C' of 65 being usual. Had the grooves been straight one could have concluded that faulty operation (such as use of dirty oil, etc.) was responsible for the attack on the metal. The curving of the lines, it is believed, indicates a lack of homogeneity of the steel which led to a selective corrosion. No evidence of this condition could be obtained, however. The metallurgical examination, apart from the fairly low hardness for this type of steel, indicated a satisfactory material. The low hardness may have contributed to the failure but is not considered to have been the primary cause, as the attack seems to have been by corrosion rather than wear.

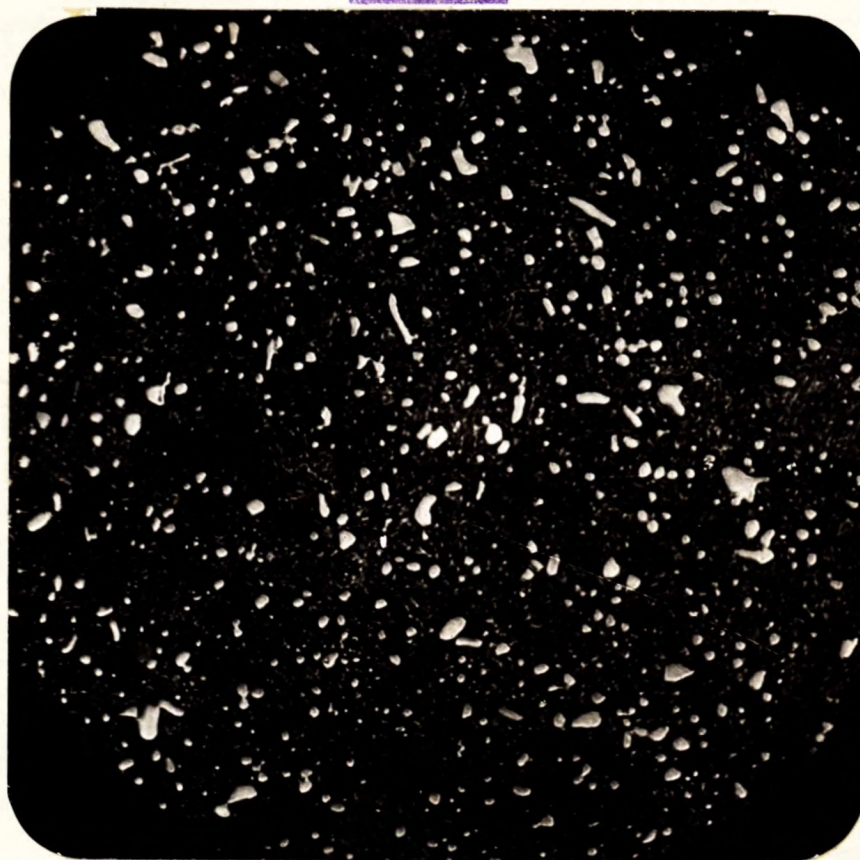
Figure 2.

The structure of the steel illustrated in Figure 2 consists of carbides (white etched globules) in a dark etching matrix of tempered martensite.

X500, etched in picric-HCl-alcohol solution.  
SHOWING UNIFORM CARBIDE DISTRIBUTION.

A spark test indicated that the spindle was made from some grade of high speed steel. This was confirmed by a microscopic examination. The structure was found to be similar to that of a tungsten-chromium-vanadium 18-4-1 type of high speed steel. The extent of the attack on the surface of the spindle was found to vary, in some areas, such as shown in Figure 1, the surface was deeply grooved, while in other areas no attack was observed. No carbide segregation was noted, the

distribution of the carbides throughout the matrix being quite uniform.
