O T T A W A      January 5th, 1944.

Investigation No. 1570.

Examination of Blistered Aluminium Alloy Sheet.

CANADA  
DEPARTMENT  
OF  
MINES AND RESOURCES  
Mines and Geology Branch

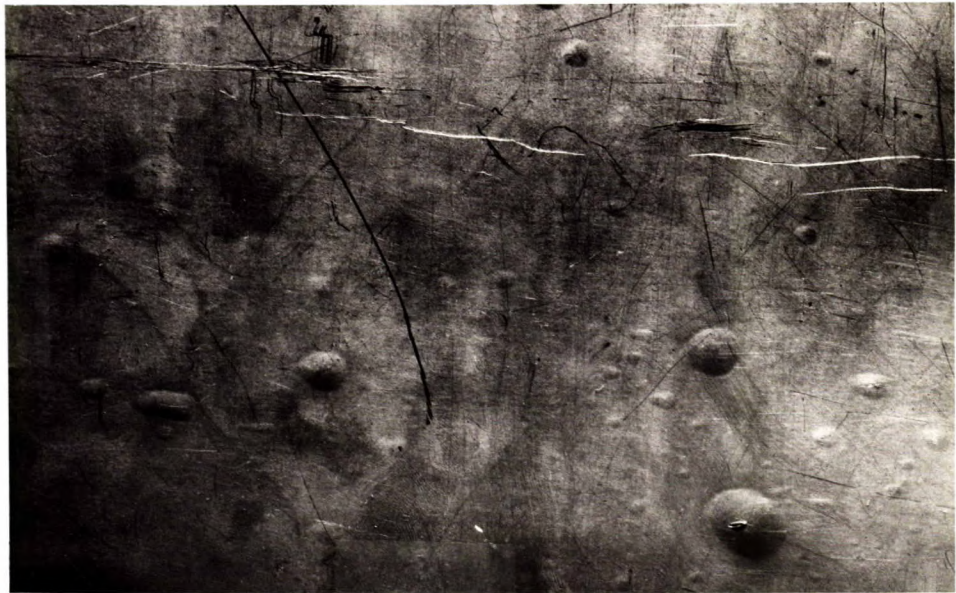
Figure 1.

Three samples of D.T.D. 213 aluminium alloy sheet were submitted. Two of these samples showed blistering (see Figure 1) and the third sample showed a sliver rolling defect) and some minor blisters (see Figure 2).

BLISTERED SHEET SAMPLE AS RECEIVED.  
(Approximately  $1\frac{1}{2}$  times actual size).

The blistering of the examined sheet samples which renders the material useless was not caused by the heat treating operation, but resulted from a previous production defect.

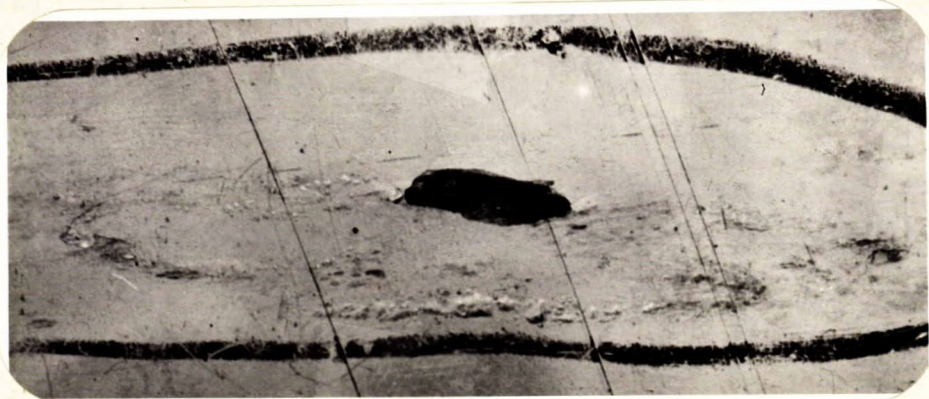
Figure 2.

SLIVER ON SHEET SAMPLE AS RECEIVED.  
(Approximately  $1\frac{1}{2}$  times actual size).

The sliver (Figure 2) is a rolling defect and cannot be connected with the occurrence of blisters.

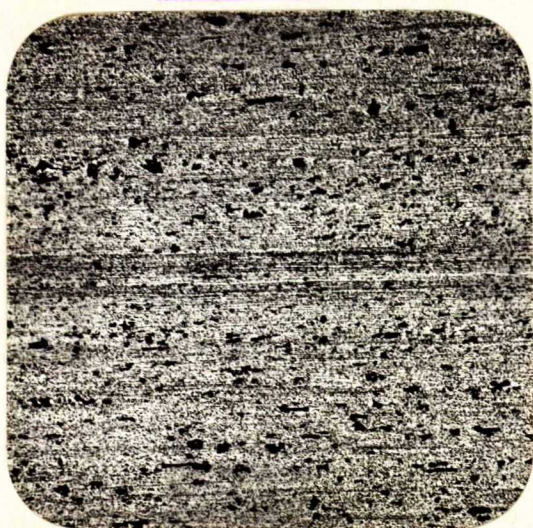
Figure 3.

Figures 3 to 6 show the microstructure of sections of the examined sheet samples. The photomicrographs shown are taken from locations near blisters (Figures 3 and 5), or from sections cut through blisters (Figures 4 and 6).

X100, Keller's etch.

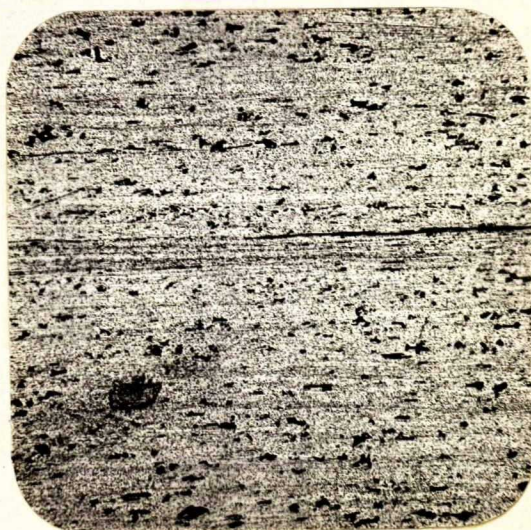
Figure 4.

X100, Keller's etch.

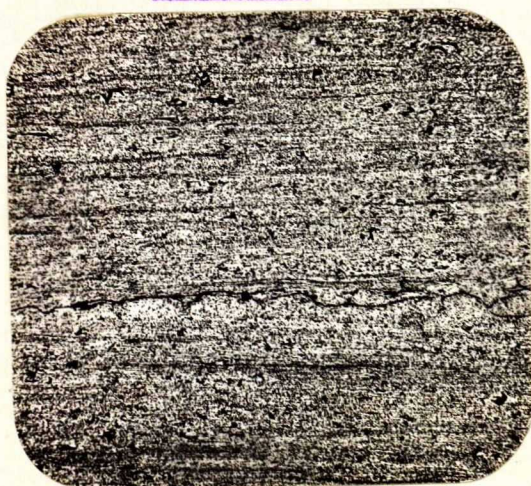
Figure 5.

X100, Keller's etch.

The directional discontinuities and streaks of the material (Figures 5 to 7) confirm that blistering on the examined sheets, revealed after annealing, was due to defects in the material, caused in the earlier production stages.

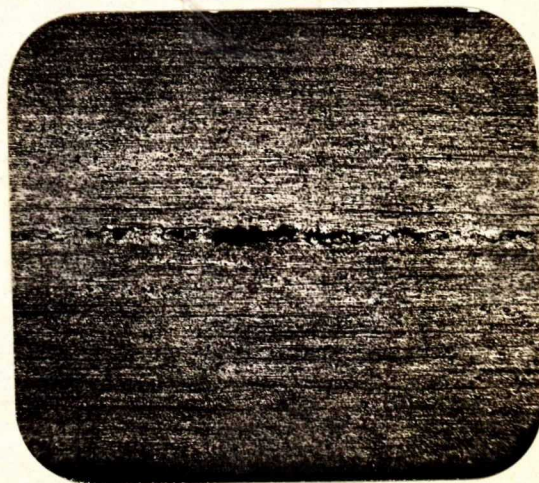
Figure 6.

X40, Keller's etch.

MICROSTRUCTURE OF SECTION.

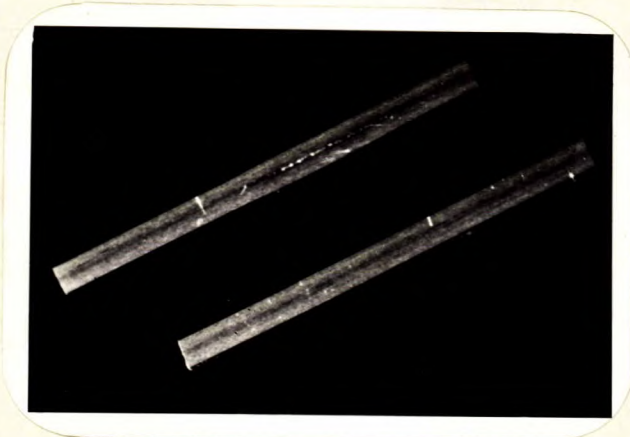
Figure 7.

Figure 7 shows the macroscopic appearance of an etched cross-section of the examined sheet, which reveals a distinctive streak and some discontinuities.
