R E P O R T  
of the  
ORE DRESSING AND METALLURGICAL LABORATORIES.

Investigation No. 1575.

Examination of Spacing Washers from  
Canadian Dry Pin Track.

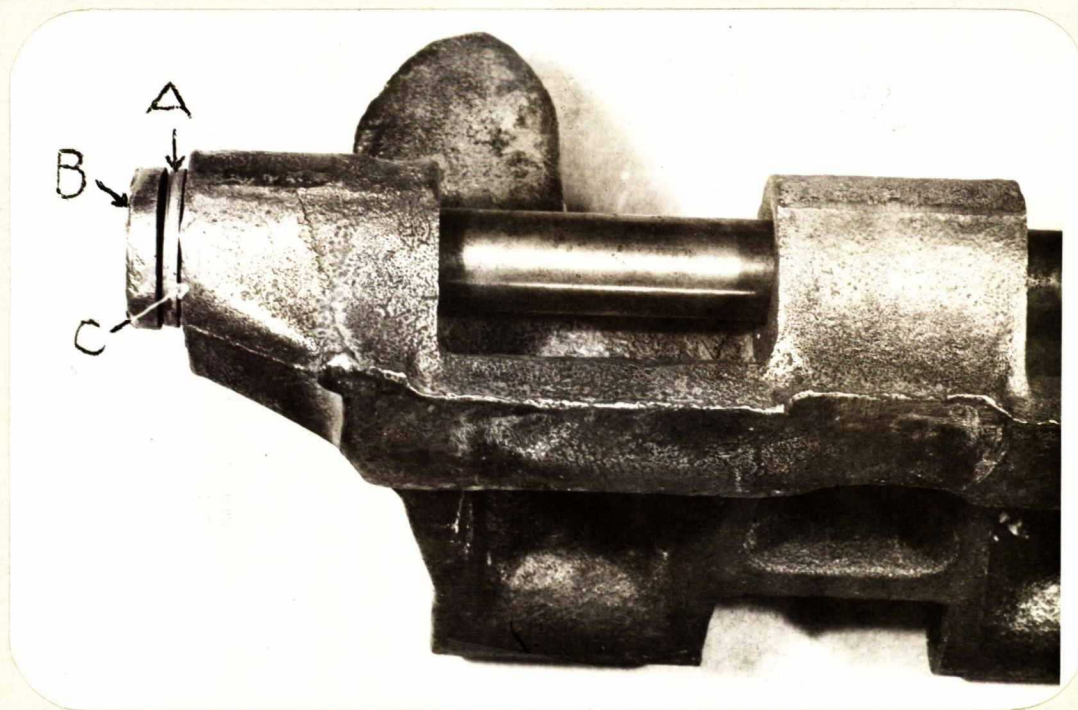
Figure 1.

METHOD OF INSTALLATION OF SPACING WASHER.

3. The track should be assembled so that the spacing washers are free to turn and not jammed between the link surface and the rivetting washer.

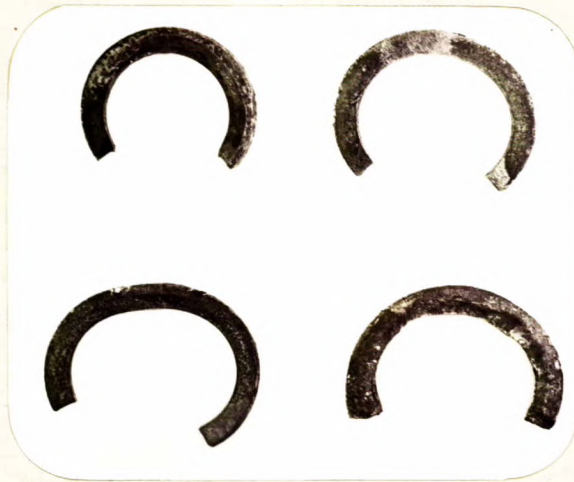
Figure 2.

The broken washers had failed in two places. Some were deformed very little, while others had been bent out of round (possibly to remove them from the track). There were no noticeable signs of wear on any of the samples submitted. The fractures were dirty and nothing could be determined from them. Figure 2 shows four broken washers.

BROKEN WASHERS.

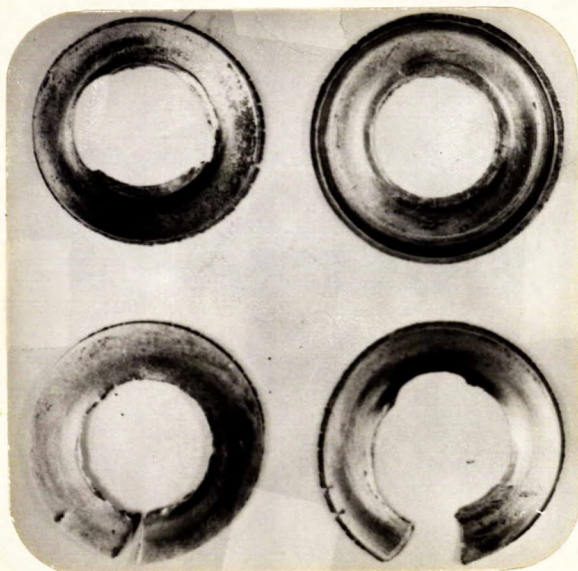
Figure 3.

1. A punch was made up so that the washers could be hammered flat. After pounding to the breaking point a comparison between these washers and those broken in service was made, in order to determine whether this action was taking place in the regular assembly as a result of hammering between the link and the rivetting washer. Figure 3 shows four washers after having been subjected to several hundred blows using the punch with a two-pound hammer.

FLATTENED WASHERS.

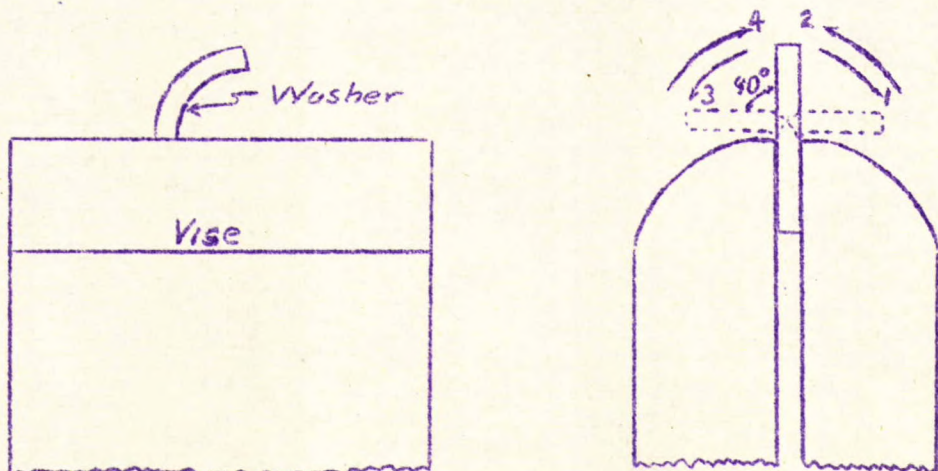
Figure 4.

METHOD OF TESTING WASHER BY REPEATED BENDS.

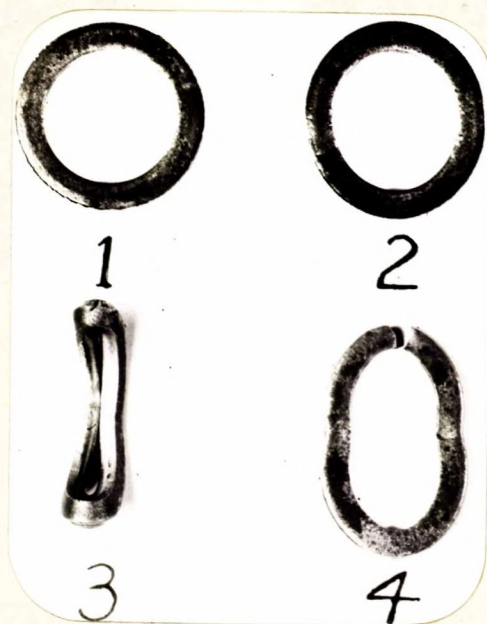
Figure 5.

small cracks occurred towards the end of bending. No. 3 of Figure 5 shows this washer.

1. New washer.
2. Washer after hammering on pin.
3. Washer after flattening in vise. Note small cracks.
4. Washer after pulling in tensile machine with U-bolt holder.

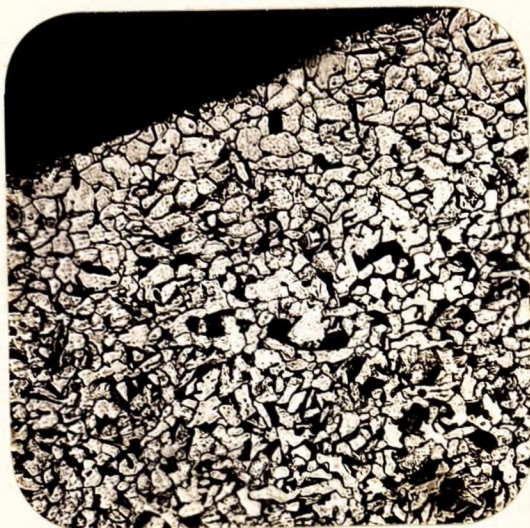
Figure 6.

X250, nital etch.  
SECTION AT SURFACE OF NEW  
WASHER (SAE 1025).

Note partial surface  
decarburization.

The large ferritic grain size at the surface observed in the low-carbon washers was not seen in the SAE 1025 washers. However, the partial surface decarburization observed on some of the washers examined (see Figure 6) would tend to lower the fatigue strength, and hence the service life. These washers showed more evidence of cold-working at the fracture than the SAE 1010 washers.

2. Any surface decarburization should be eliminated by the heat treatment.

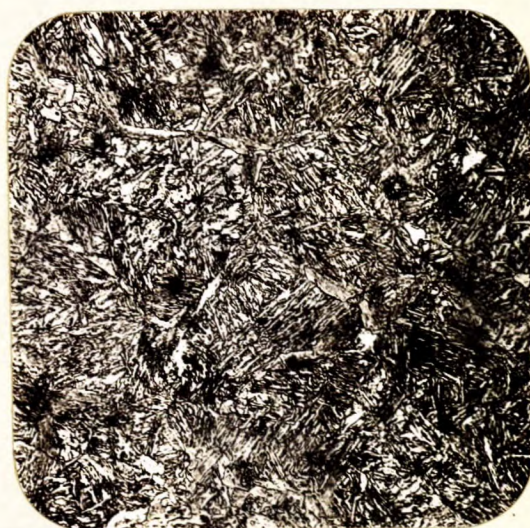
Figure 7.

X250, nital etch.  
STRUCTURE OF HEAT-TREATED  
WASHER (SAE 1025).

Tempered martensite.

1. In order to improve the performance of the washers and to increase their service life they should be made from SAE 1025 or SAE 1030 steel heat-treated to 26 to 31 Rockwell 'C'.

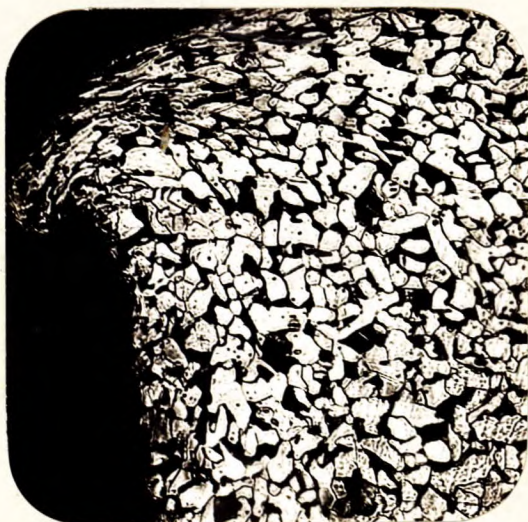
Figure 8.

STRUCTURE AT FRACTURE  
OF SAE 1025 WASHER.

Note evidence of cold work  
and "burring".

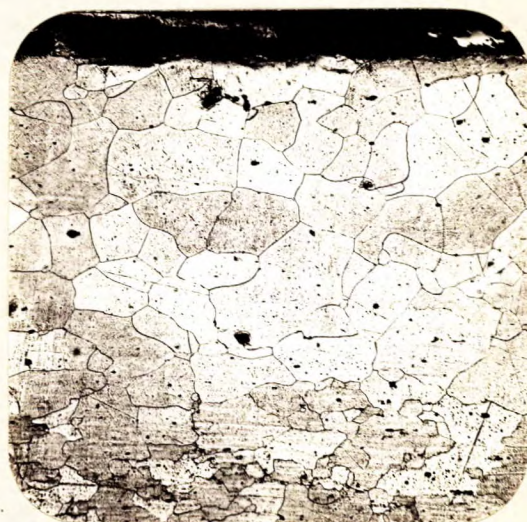
Figure 9.

STRUCTURE AT SURFACE OF  
LOW-CARBON WASHER.

Note larger grain size  
at surface, and  
decarburation.

The large ferritic grain size and the decarburization at the surface of the SAE 1010 washers would be expected to have an adverse effect on the fatigue strength, and hence the service life, of the washers. Ferritic grain growth would be aided by decarburization. Large ferritic grain size in low carbon steels will cause brittleness. Therefore, due to this brittleness, surface cracks might well have been caused by impact, lowering the fatigue strength of the washers. There was no great amount of distortion at the fractures of the low-carbon washers.
