January 21st, 1944.

ORE DRESSING AND METALLURGICAL LABORATORIES.

Investigation No. 1579.

Investigation on the Canadian Dry
Pin Rivetting Tip.

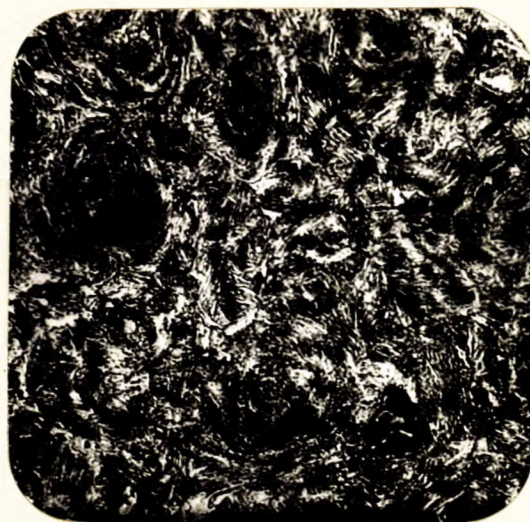
Figure 1.

X500, etched in 2
per cent nital.

Note distorted structure.

The distorted structure observed with pins of Lot No. 1 indicates that the effect of rivetting penetrates through the entire length of the tip. The depth of this effect, of course, is influenced by the hardness of the tip.

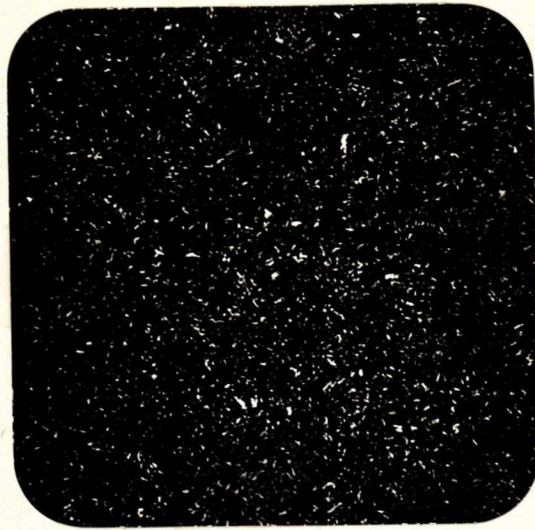
Figure 2.

X500, etched in 2
per cent nital.

TEMPERED MARTENSITE.

The pins of Lot No. 2 varied in hardness from Rockwell 'C' 30-38. This high hardness makes rivetting extremely difficult. The tip-softening process for these pins evidently was merely a draw treatment, probably around 1100° F. Vickers hardness tests on an unriveted pin of this lot definitely showed that the surface was harder than the core. This would suggest a higher carbon or nitrogen content, due to the presence of a cyanide skin. This lot of pins had been treated in cyanide baths in order to prevent decarburization on the hardening treatment. This harder skin could be expected to crack up on rivetting.

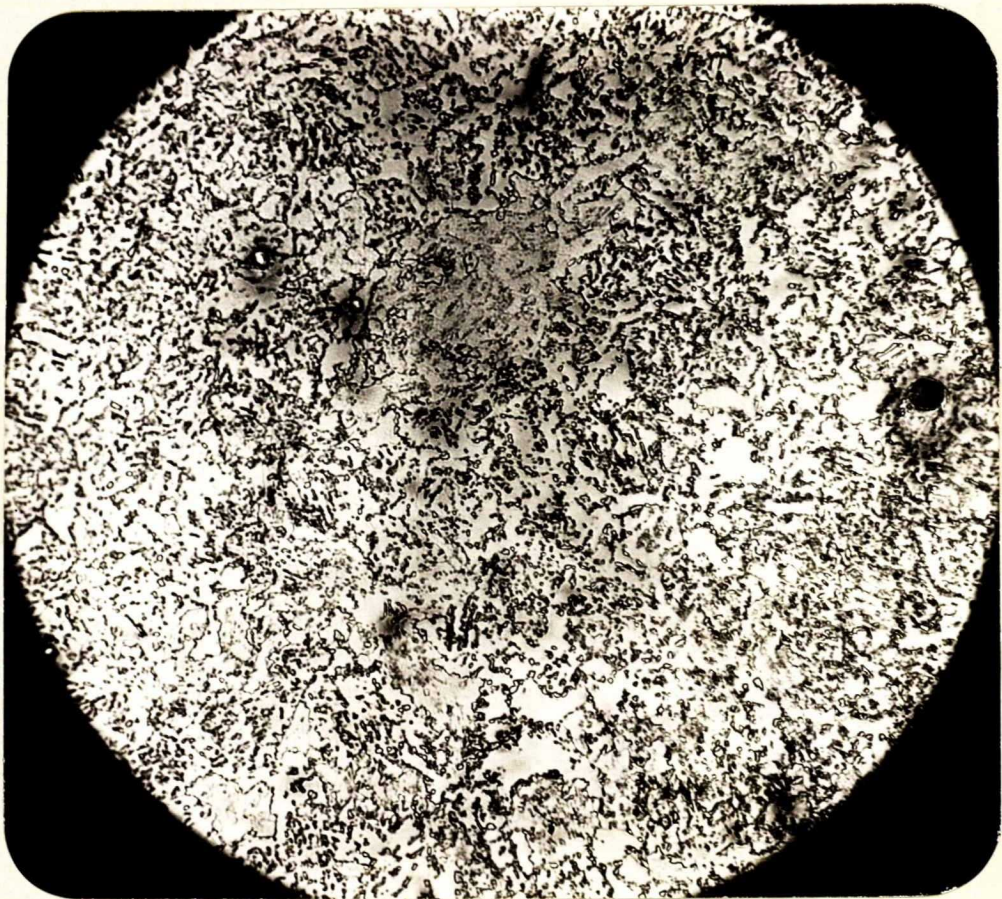
Figure 3.

X1000, etched in 2
per cent nital.

SPHEROIDAL STRUCTURE.

The spheroidal structure obtained for pins from Lots Nos. 3 and 4 indicates a change in the tip-softening process. These tips are probably being alternately heated above and below the lower critical (1400° F. approximately), a standard spheroidizing procedure which, by alternate solution and precipitation of carbides, allows for a coarsening of carbide particle size.

For SAE 9255 steel the above process need not be very long. This structure appears to be excellent for rivetting and whereas it formerly was difficult to rivet pins of hardnesses higher than 27 R. 'C' in the core, it now appears that the 30 R. 'C' maximum allowed by the specification still gives a reasonably good rivetting tip. However, it would be advisable to check on the rivetting process from time to time by microscopic examination, to ensure the presence of this structure,

7. An occasional check should be made on the tip-softening process to ensure that spheroidization is taking place.

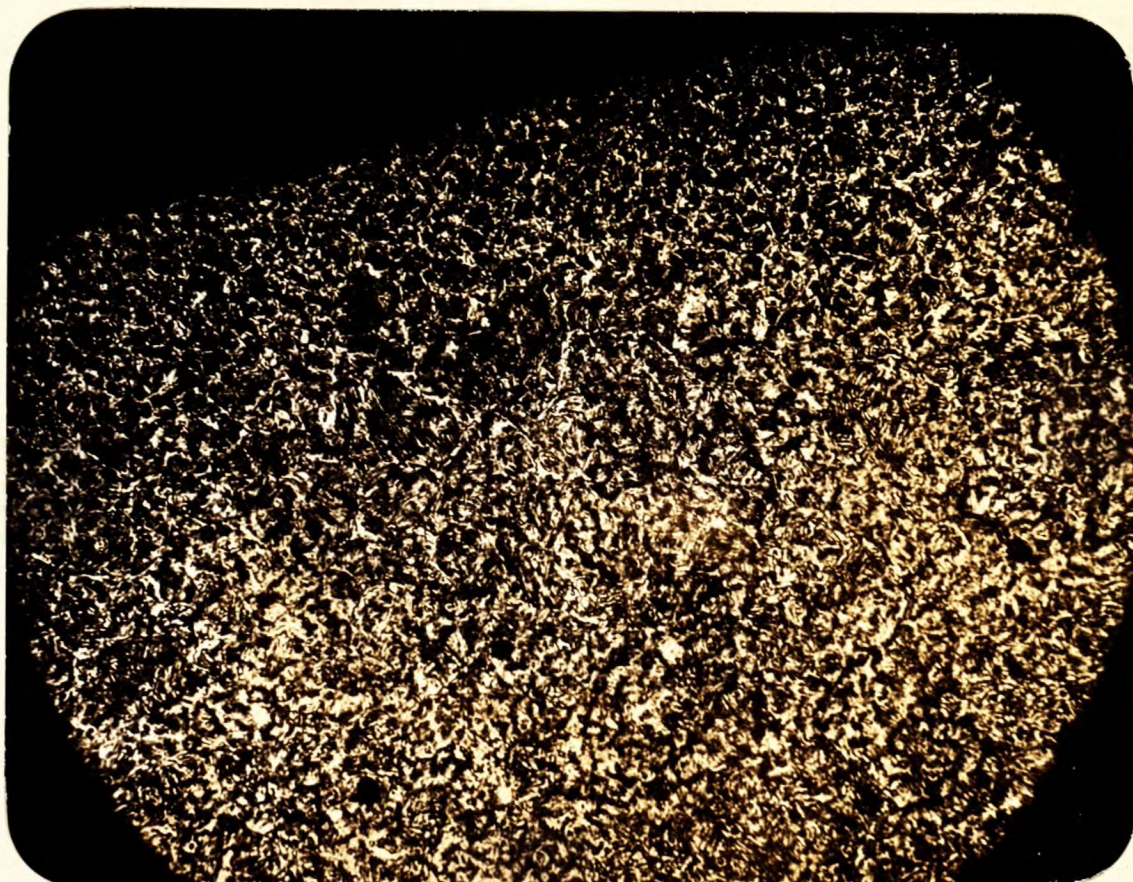
Figure 4.

X250, nital etch.
SURFACE OF A TIP FROM LOT NO. 1.

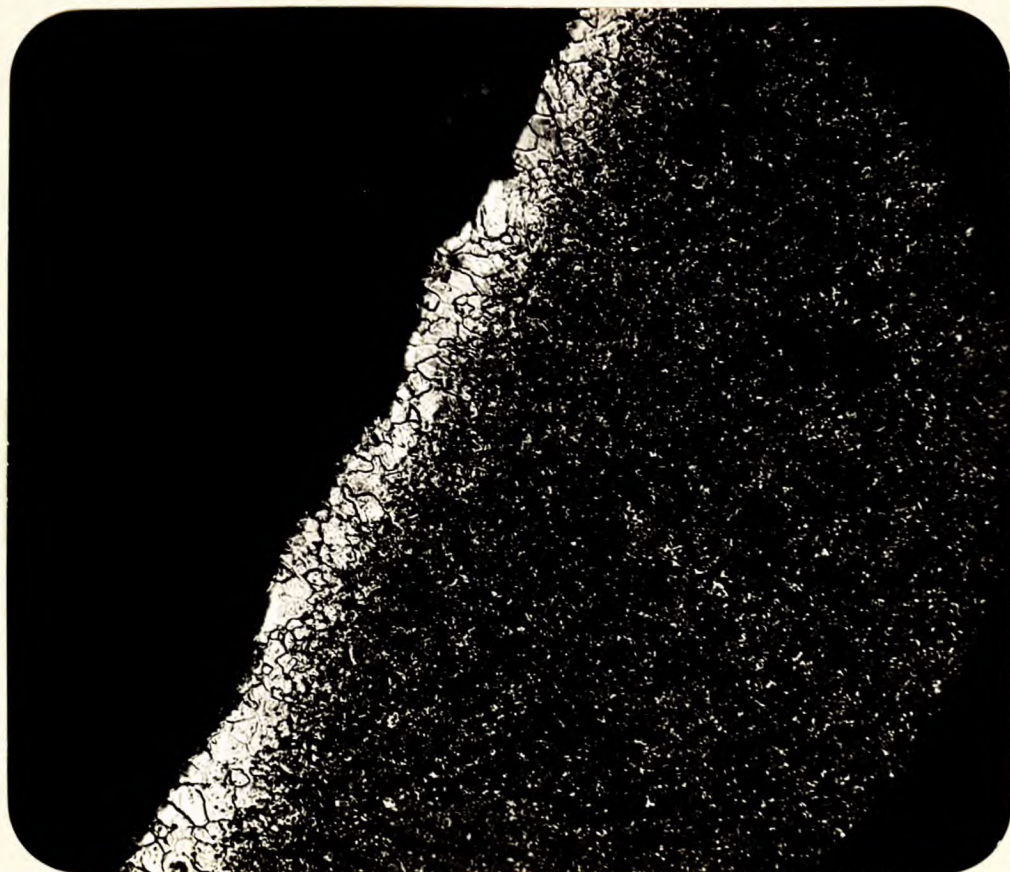
Figure 5.

X250, nital etch.
SURFACE OF A TIP FROM LOT NO. 3.
Note decarburized layer.

It is interesting to note that there is a slight amount of decarburization in the pin of the spheroidal type. It is felt that this is a good thing, in so far as the rivetting operation is concerned, nor is it regarded as being serious from the fatigue strength angle for C.P.R. pins of the Valentine type had low carbon tips of 150-180 Brinell and were very satisfactory, consequently high strength material in the tip does not appear to be necessary for this service. Indeed, the more ductile lower strength material would better withstand heavy blows without cracking. No decarburization is noted in pins from Lot No. 1. Pins from Lot No. 2 appeared to have a high carbon area to a depth of about 0.010 inch which etched somewhat deeper, but this could not be reproduced satisfactorily by a photomicrograph.
