R E P O R T
of the
ORE DRESSING AND METALLURGICAL LABORATORIES.

Investigation No. 1580.

Examination of a Cracked Piston Head
from a Canso Aircraft Oleo Leg.

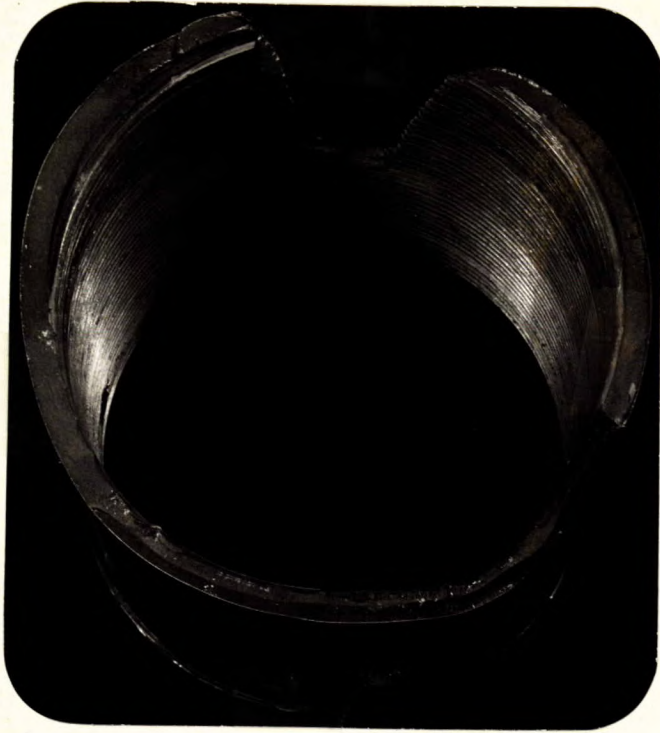
Figure 1.

The broken piston head was examined visually and representative photographs taken (see Figure 1). An interesting detail of the break may be seen. The dark zone extending about half way through the wall from the outside is evidence that a crack existed in the part before failure occurred.

It is evident, from the appearance of the fractured surface, that there was a crack in the piston head before complete failure took place, probably before it was installed in the aircraft. This crack could have been caused either by quenching or by welding (it is understood from the drawing that there is welding done on this part in the vicinity of the failure).

Of these three causes, the most likely is the third. If the crack had been present before or during heating for quenching, the surfaces of the crack might have been scaled, unless a controlled-atmosphere furnace was used. It is, therefore, more likely that the crack was formed during quenching.

PHOTOGRAPH, ABOUT $\frac{1}{2}$ ACTUAL SIZE,
SHOWING FRACTURED PORTION OF PISTON HEAD.

Note the presence of two distinct zones in the fracture, indicating that failure took place in two stages.

It is recommended that adequate magnaflux inspection be used to detect cracked parts before chromium plating.

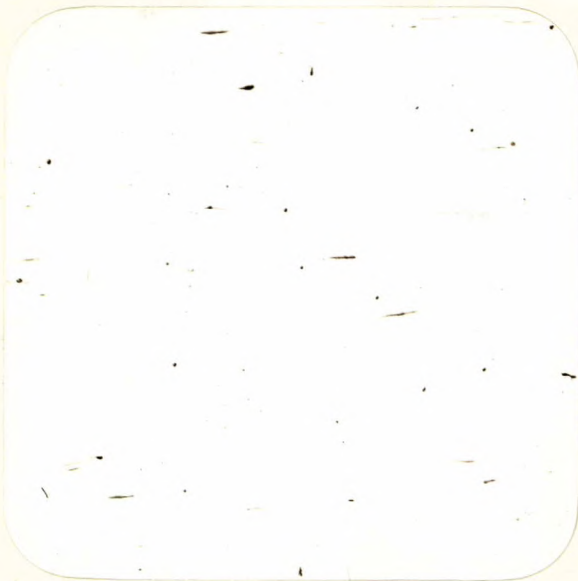
Figure 2.

The steel is not as clean as some steels examined by these Laboratories. However, it is not thought that it is sufficiently dirty to cause failure. The microstructure shows that the heat treatment was satisfactory.

X100, unetched.

PHOTOMICROGRAPH,
SHOWING INCLUSIONS.

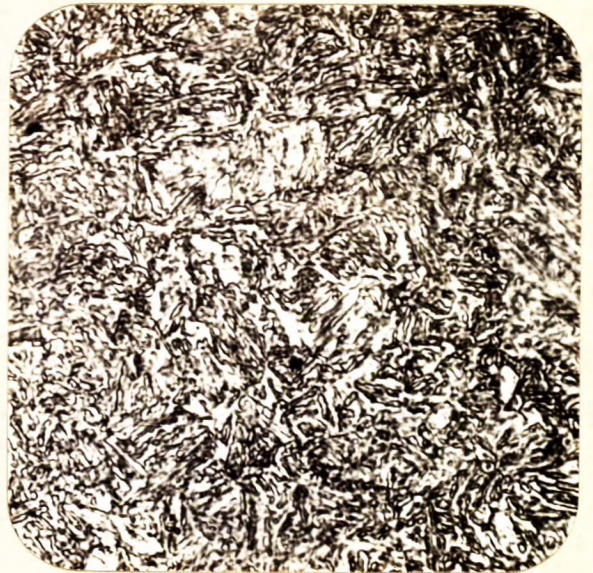
Figure 3.

by etching in 2 per cent nital. This is a normal structure for tempered martensite.

X1000, etched in 2
per cent nital.

PHOTOMICROGRAPH,
SHOWING STRUCTURE.
