January 24th, 1944.

ORE DRESSING AND METALLURGICAL LABORATORIES.

Investigation No. 1583.

Examination of Welds Cut from Compressed Air Reservoirs
C. Mk. 1A (E. Leonard & Sons, London, Ontario).

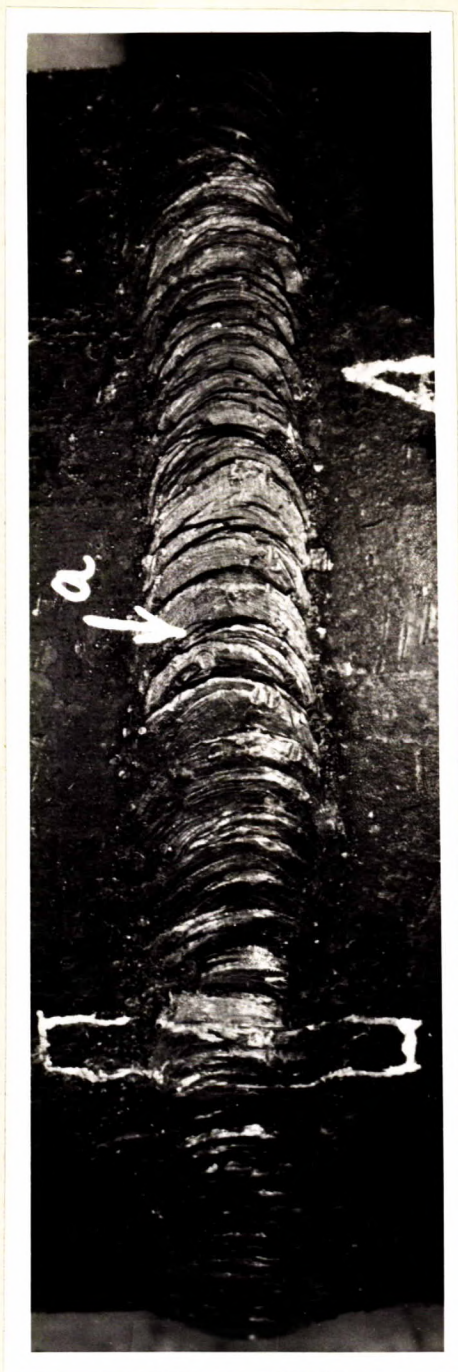
OUTSIDE OF WELD OF SAMPLE A.

Arrow 'a' points to a high spot in the weld. The white rectangle indicates an area from which a macro sample was machined. Note the irregular weave pattern.

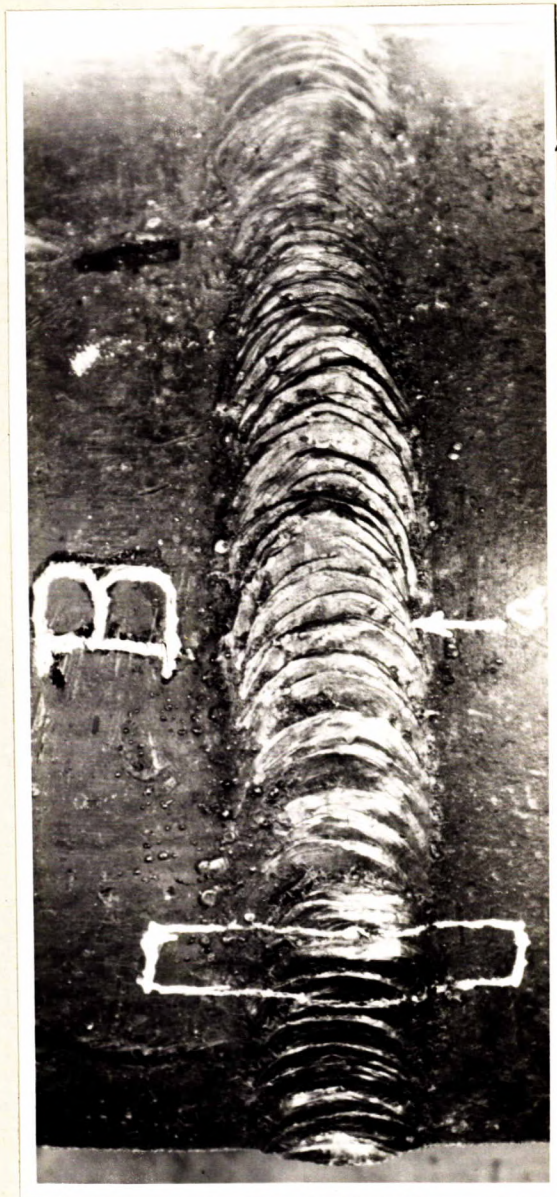
Figure 2.

OUTSIDE OF WELD OF SAMPLE B.

Arrow 'a' points to a high spot in the weld.
The white rectangle indicates an area from
which a macro sample was machined. Note
the irregular weave pattern.

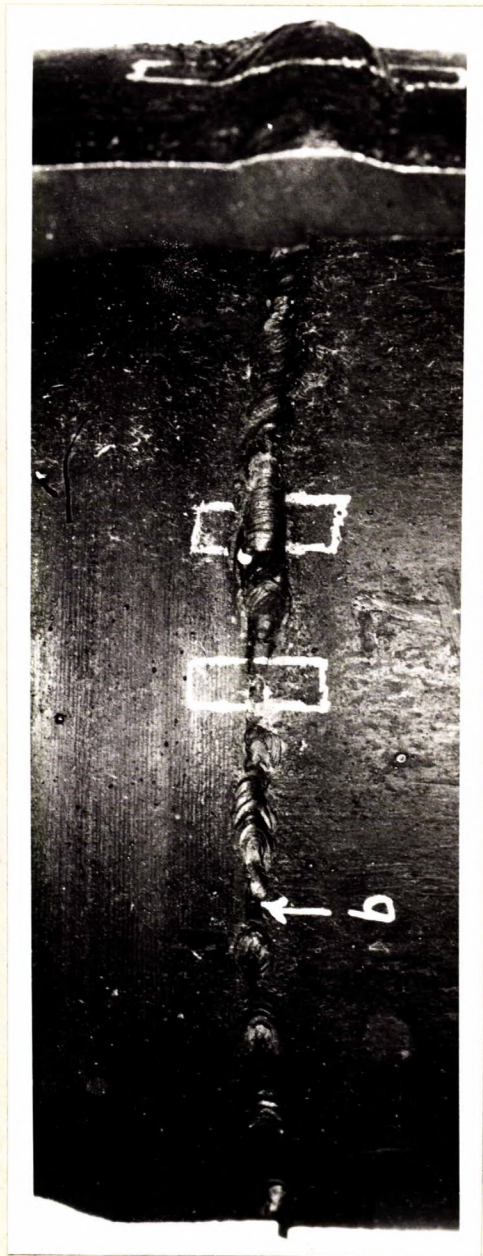
Figure 3.

INSIDE OF WELD OF SAMPLE A.

Arrow 'b' points to an area of incomplete penetration. Just to the left of this arrow is a shrinkage cavity. White rectangles indicate areas from which macro samples were machined. Note the irregularity of the penetration secured.

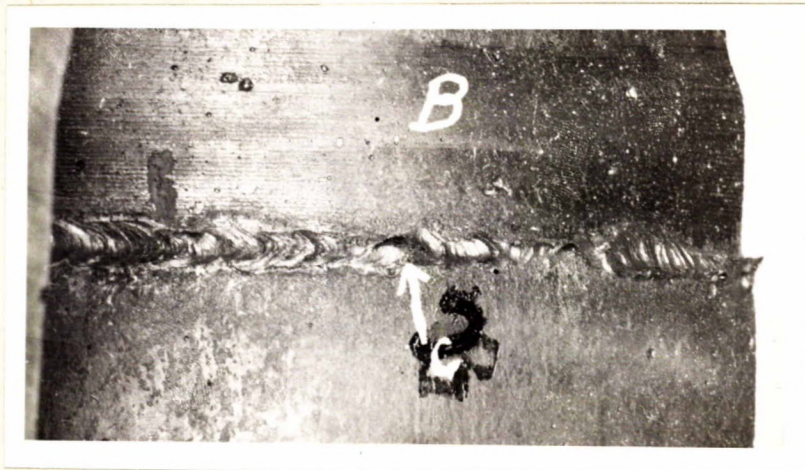
Figure 4.

INSIDE OF WELD OF SAMPLE B.

Arrow 'c' points to a shrinkage cavity.
Note the irregularity of the penetration
secured.

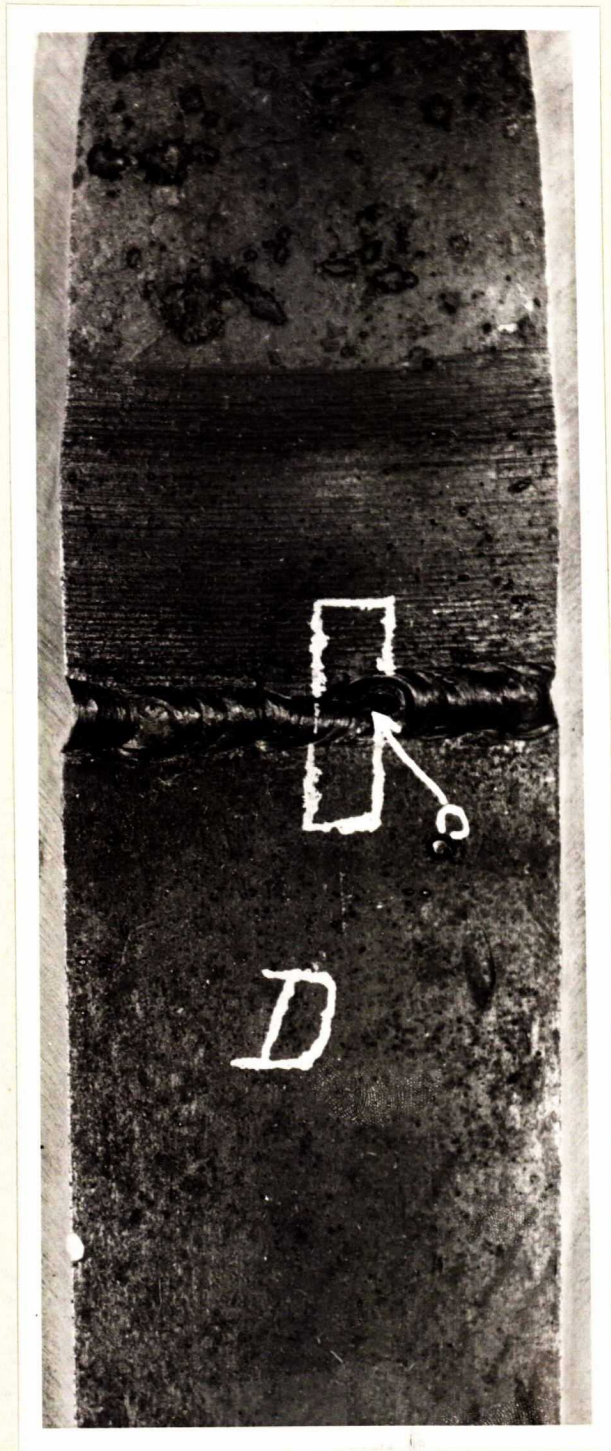
Figure 5.

INSIDE OF WELD OF SAMPLE D.

Arrow 'c' points to a shrinkage cavity.
White rectangle indicates area from
which a macro sample was machined.

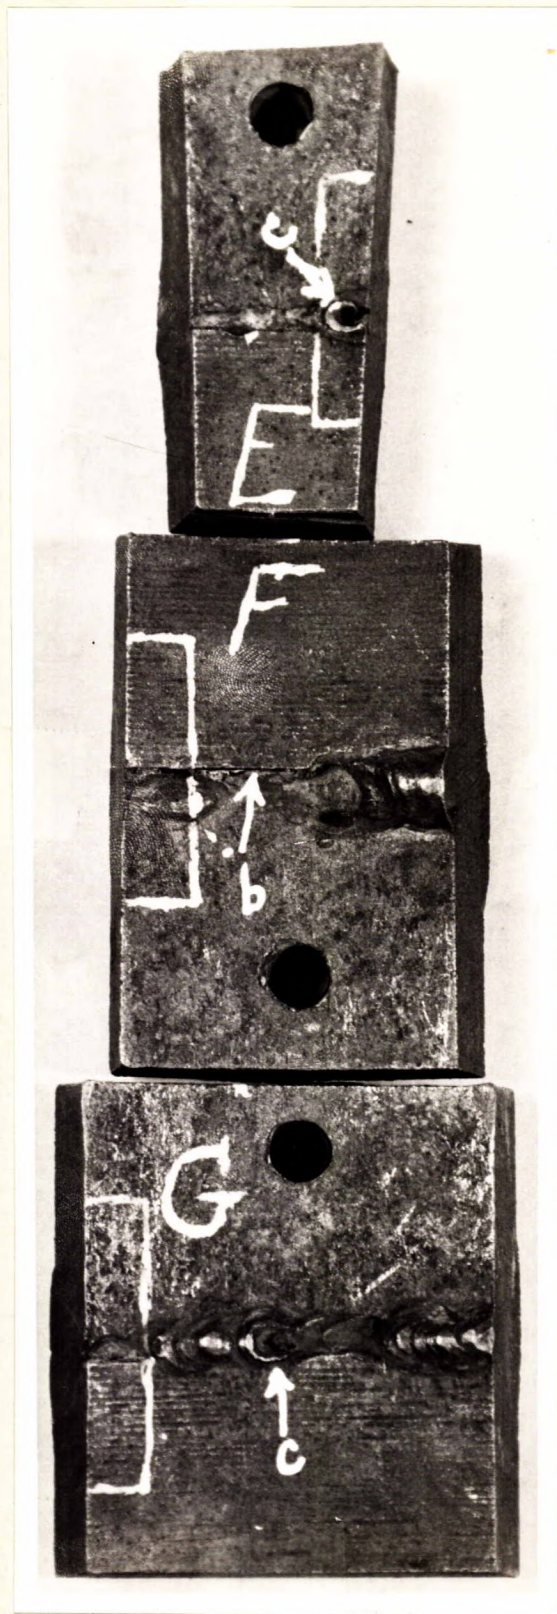
Figure 6.

INSIDES OF WELDS OF SAMPLES E, F, AND G.

Arrows 'c' point to shrinkage cavities.
Arrow 'b' points to area of incomplete penetration. White rectangles point to areas from which macro samples were machined.

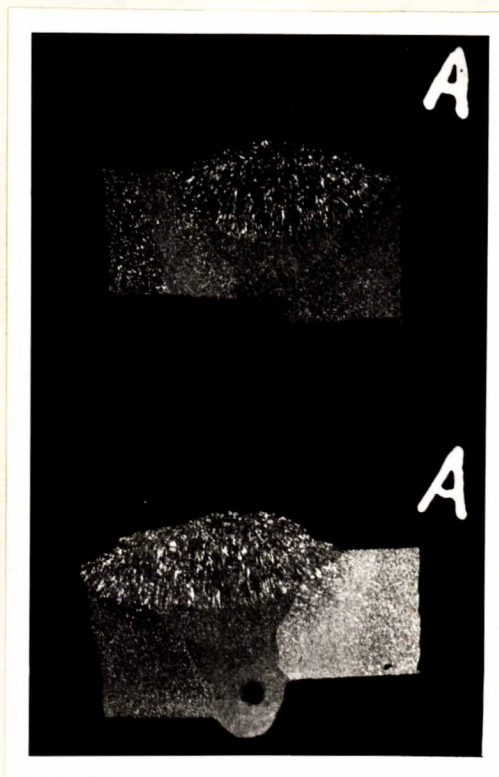
Figure 12.

TWO MACRO SECTIONS OF WELD OF SAMPLE A.

Note gas inclusions and improper alignment of plate edges to be welded. Bottom section shows improper edge preparation.

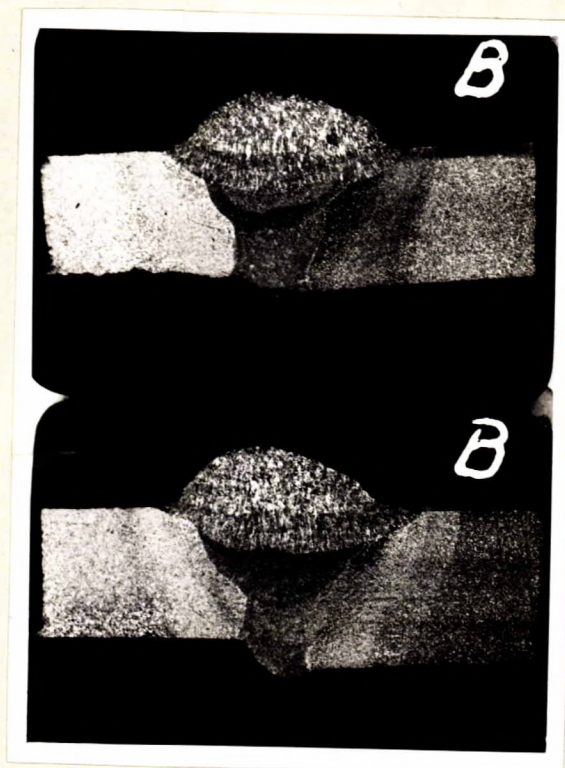
Figure 13.

TWO MACRO SECTIONS OF WELD OF SAMPLE B.

Note high piled-up welds, improper edge alignment, and improper edge preparation.

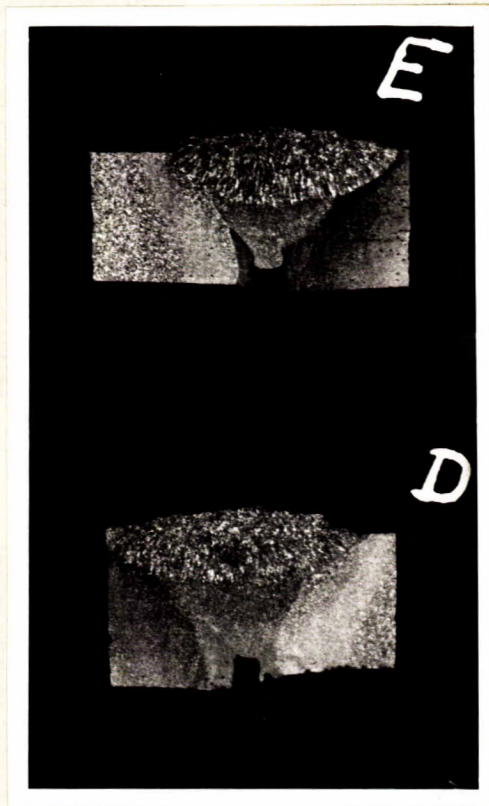
Figure 14.

MACRO SECTIONS OF WELDS OF SAMPLES D AND E.

Note incomplete penetration.

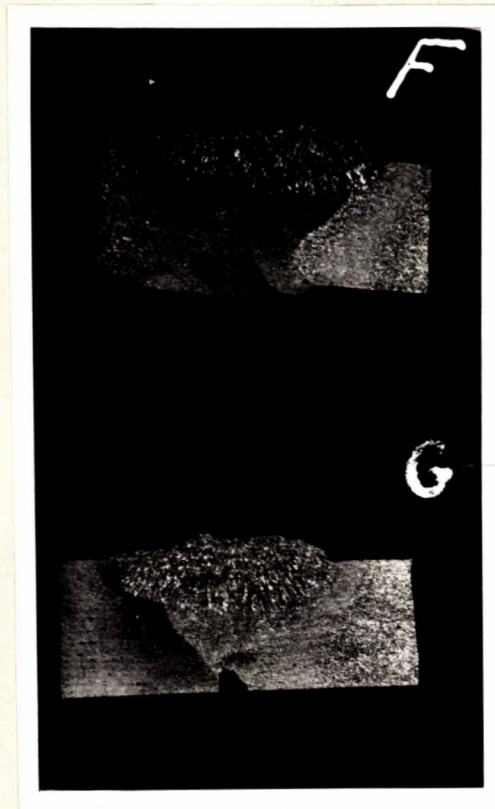
Figure 15.

MACRO SECTIONS OF WELDS OF SAMPLES F AND G.

Note incomplete penetration. Top sample shows lack of fusion along lower scarf face and improper edge alignment. Edge preparation of both incorrect.
