January 28th, 1944.

Investigation No. 1584.

Corrosion of an Aluminium Alloy  
Propeller Dome.

Bureau of Mines  
Division of Metallic  
Minerals

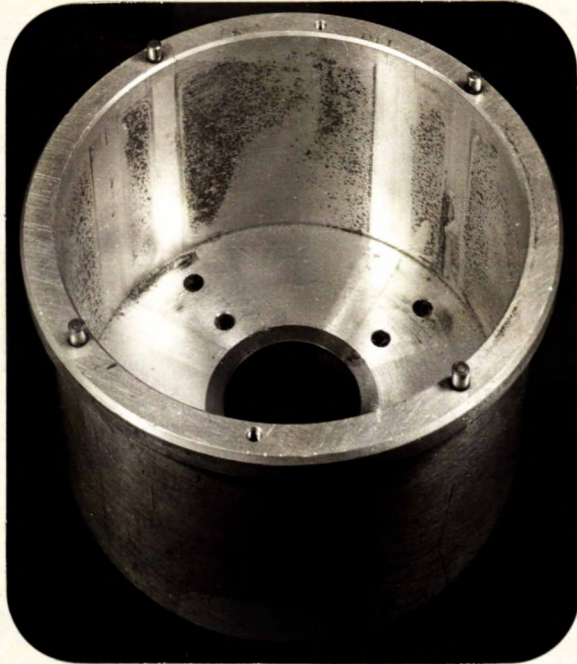
A view of the forging as received, showing roughness on the interior surface, is given in Figure 1.

DOME AS RECEIVED.

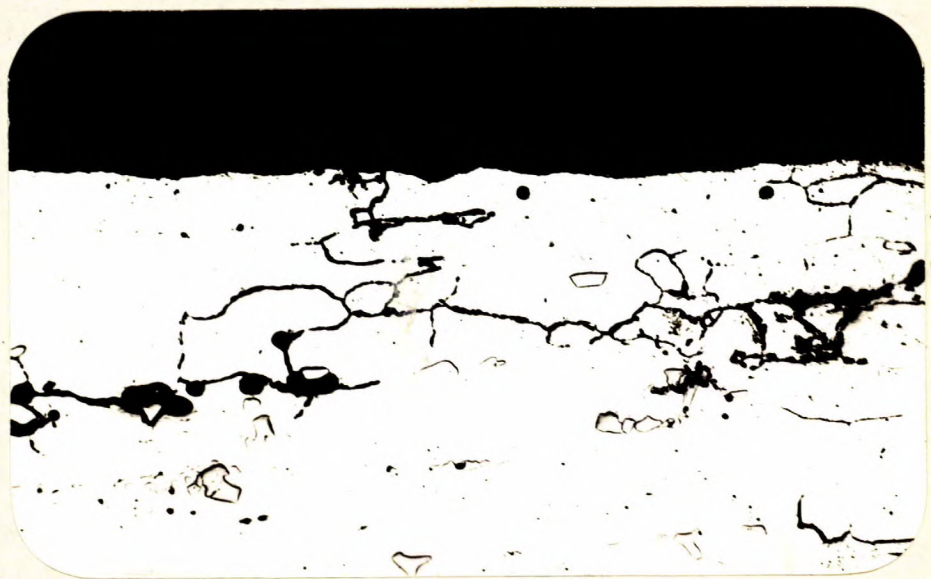
Figure 2.

A specimen was removed from the rough portion of the forging, and was mounted in bakelite, polished, and examined. Corrosion of the intercrystalline type was found to be present. This corrosion is shown, before and after etching, in Figures 2 and 3.

Note intercrystalline corrosion.

Corrosive attack was definitely found to be of the intercrystalline type, which indicates either overheating in service or some defect in heat treatment. Operational and heat treatment procedures should be reviewed with this in mind. The possibility of the lubricant being unusually corrosive should not be overlooked and this should also be checked.

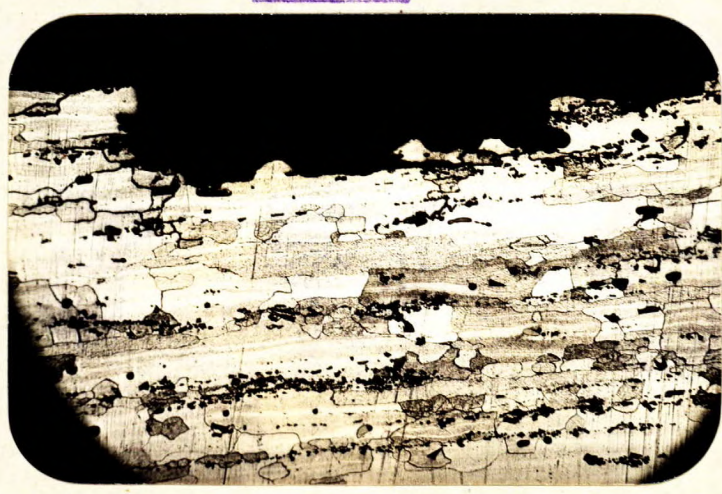
Figure 3.

Note intercrystalline nature of corrosion (particularly noticeable near A).
