January 28th, 1944.

ORE DRESSING AND METALLURGICAL LABORATORIES.

Investigation No. 1586.

Examination of Two Track Shoe Frames.

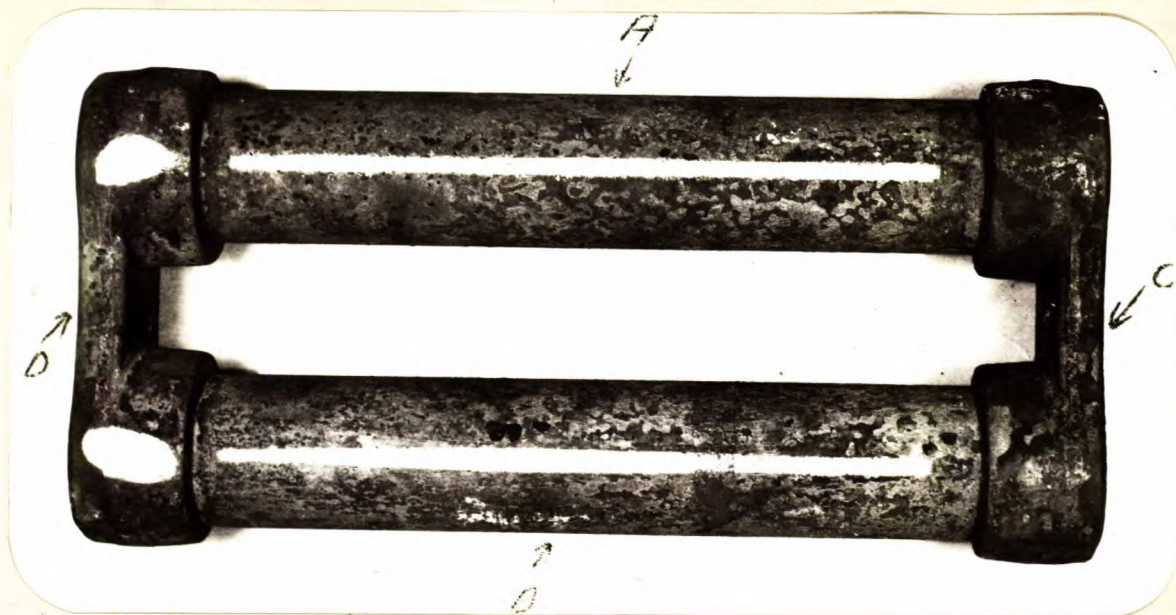
Transverse sections were cut from the tubes and end connectors of each link at the points marked A, B, C and D in Figure 1.

RAM TANK TRACK LINK FRAME.

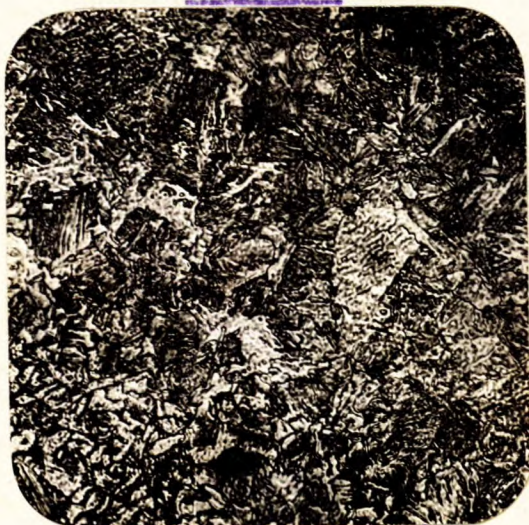
Figure 2.

Typical microstructures at the surface and centre of a section are shown in Figures 2 and 3 respectively. Both photomicrographs are at 500 magnifications. The white areas in Figure 2 are ferrite, the dark areas drawn martensite. The white constituent, ferrite, is produced as a result of decarburization. All areas in Figure 3 are drawn martensite. The microstructure of the specimen which was annealed in lead is shown in Figure 4; the white areas are ferrite and the dark areas carbon-poor pearlite.

X500, etched in 2 per cent nital.
 PARTIALLY DECARBURIZED ZONE.
 Ferrite and low-carbon martensite.

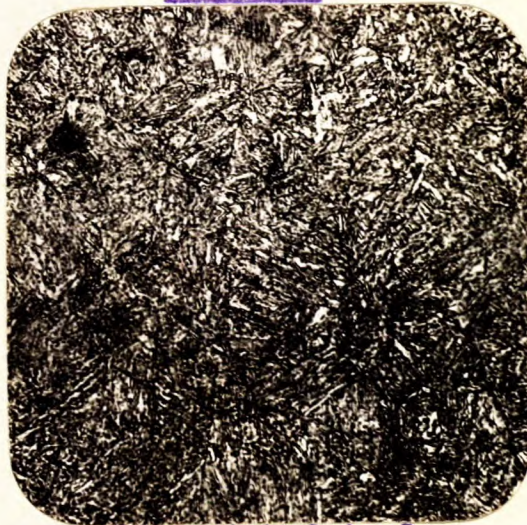
Figure 3.

X500, etched in 2 per cent nital.
 TEMPERED MARTENSITE.

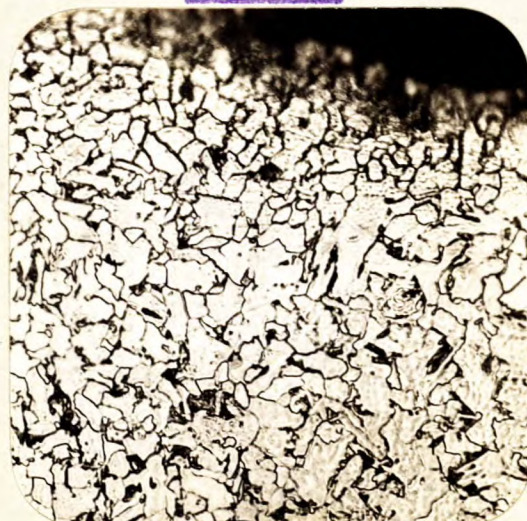
Figure 4.

X500, etched in 2 per cent nital.
 FERRITE AND CARBON-POOR PEARLITE.
