ORE DRESSING AND METALLURGICAL LABORATORIES.

Investigation No. 1588.

Examination of Two Pieces of 7-mm.  
Bullet-Proof Plate.

O T T A W A      February 5th, 1944.

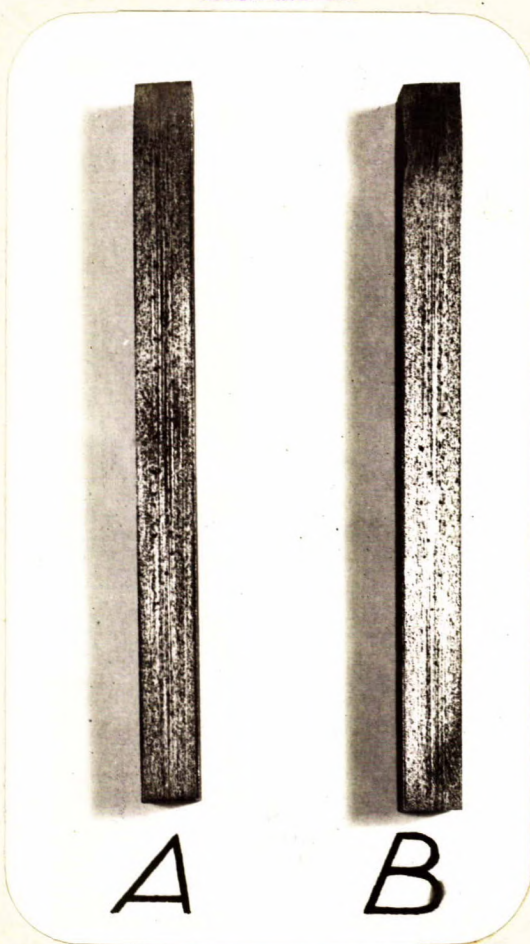
Figure 1.

MACRO-ETCHED LONGITUDINAL SECTIONS FROM  
7-mm. BULLET-PROOF PLATE.

rolling direction of the plate. The laminations revealed (see Figure 1) are normal for rolled plate and do not appear to be excessive.

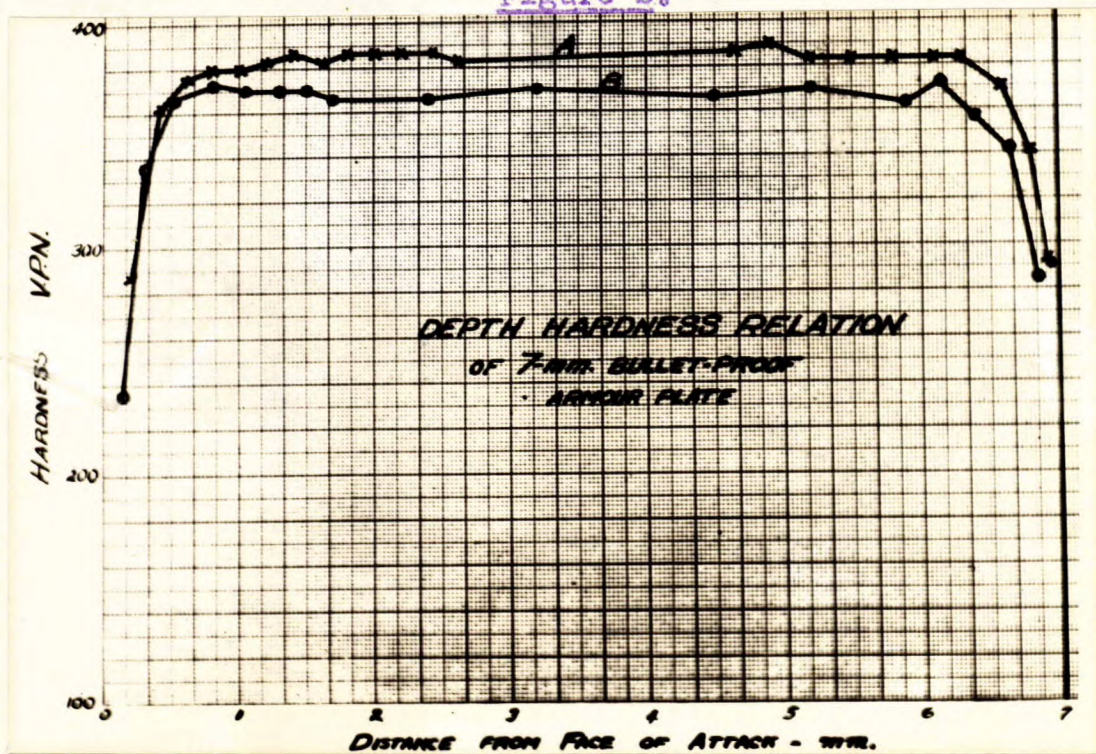
Figure 2.

DEPTH-HARDNESS RELATIONSHIP OF 7-mm. BULLET-PROOF PLATE.

Note lowering of hardness at surface, indicating partial surface decarburization.

Both the depth hardness surveys (see Figure 2) and microscopic examination (see Figures 5 and 6) show that the two pieces of plate are partially decarburized at the surface to a depth of about 0.020 inch (0.5 mm.), on both surfaces. One surface of each piece, the face which the bullet struck in each case, shows lower hardness readings than the other surface, indicating that one surface of the large plate from which the pieces were cut was decarburized more than the other surface. This decarburization probably occurred during the heating of the plate at the hardening temperature, and the greater decarburization probably occurred on the surface which was uppermost in the furnace (i.e., not in contact with the hearth).

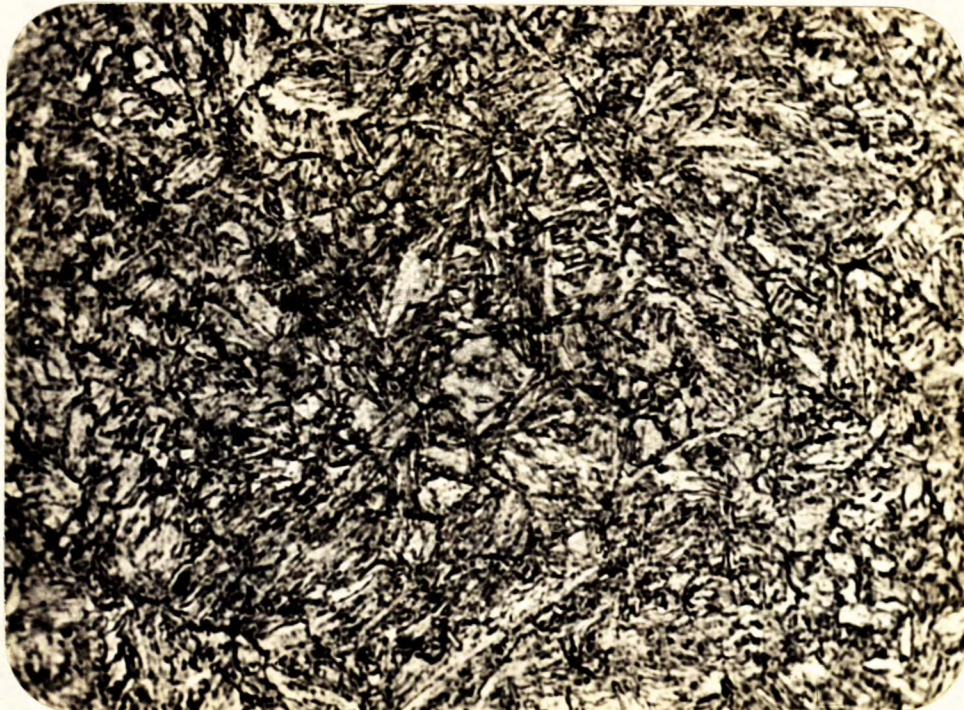
Figure 3.

X1500, picral etch.  
STRUCTURE OF PLATE A (LONGITUDINAL).  
Tempered martensite.

The microstructure of the plate material appears to be normal for the heat treatment the plate received. This consisted of a quench from above the critical, either in water-cooled platens or in water (probably the former), followed by a draw at 1000-1100° F. To the casual observer, no difference in microstructure existed between the two pieces, A and B. There is some indication, on comparing Figures 3 and 4, that piece B may tend to have a feathery structure commonly associated with high-temperature transformation products, while piece A has a tempered martensitic structure. However, there is insufficient evidence to say definitely that a difference in structure exists between the two pieces.

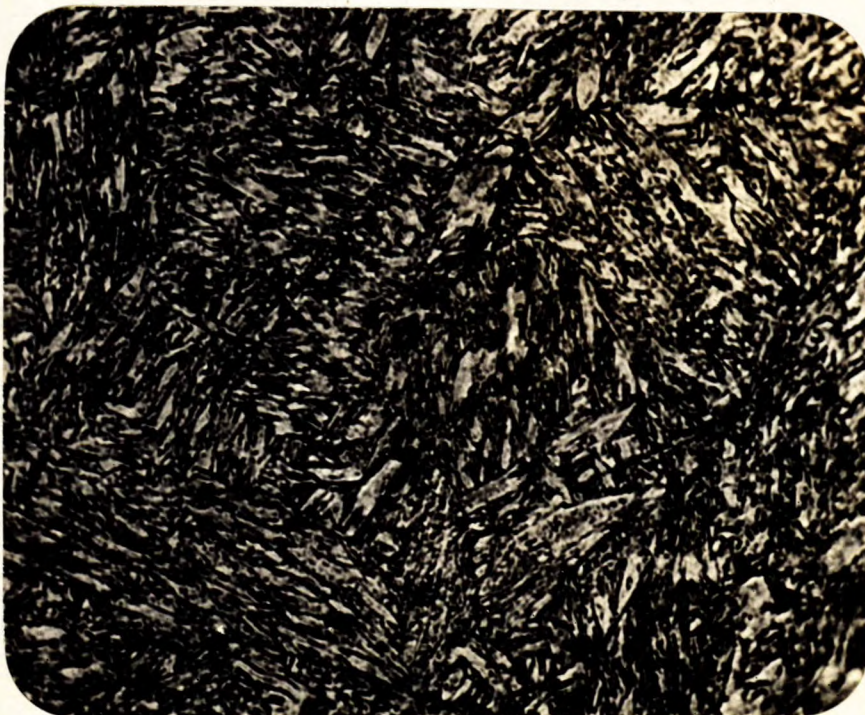
Figure 4.

X1500, picral etch.  
STRUCTURE OF PLATE B (LONGITUDINAL).  
Tempered martensite.

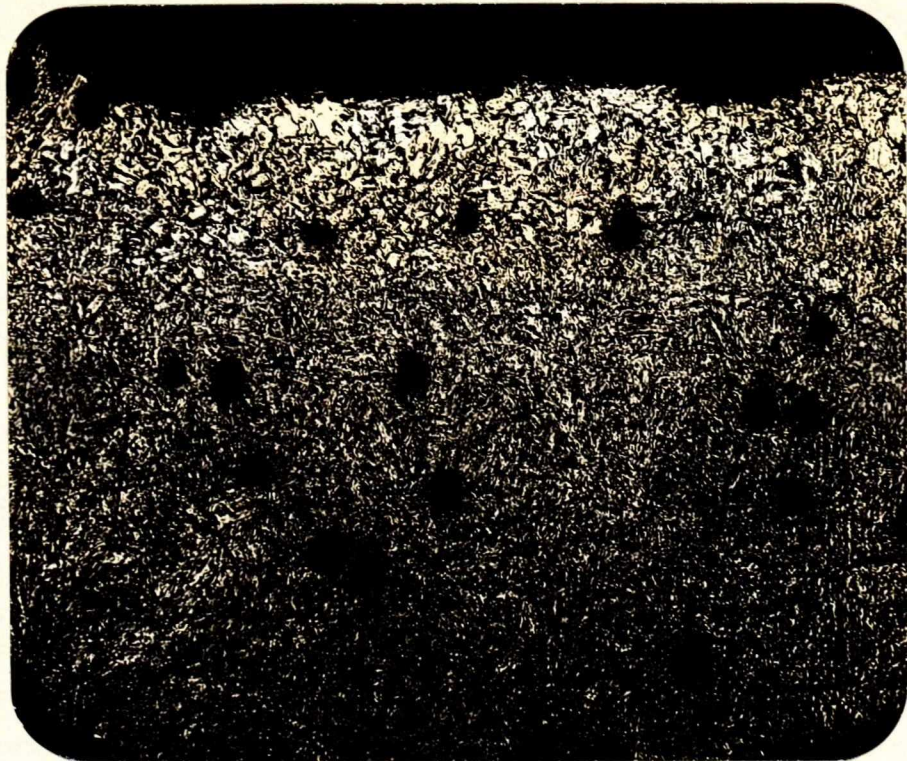
Figure 5.

SURFACE OF PLATE A.

Note decarburization at surface.

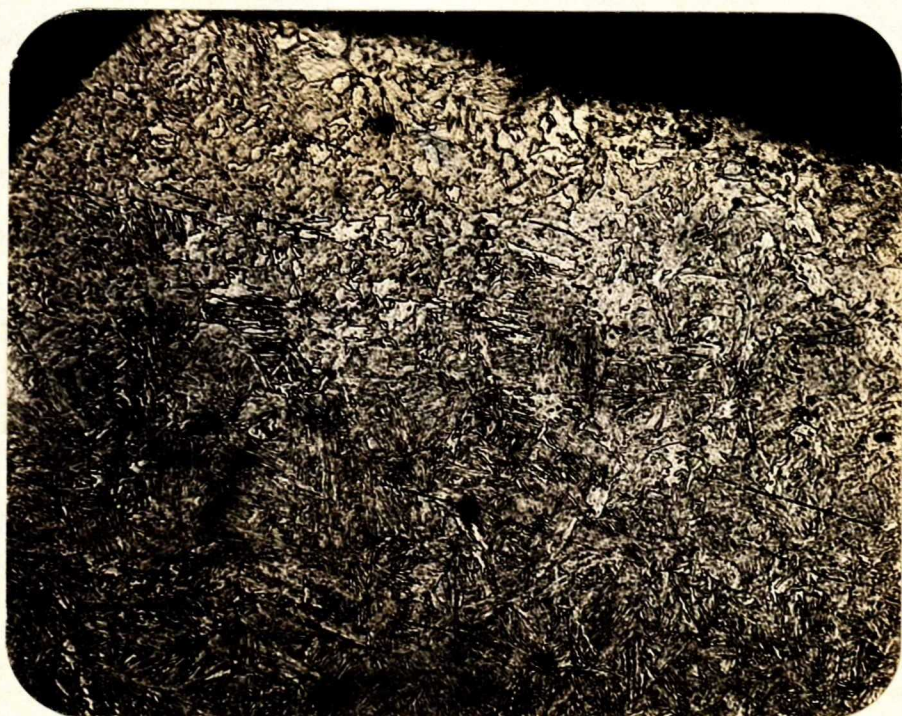
SURFACE OF PLATE B.

Note decarburization at surface.

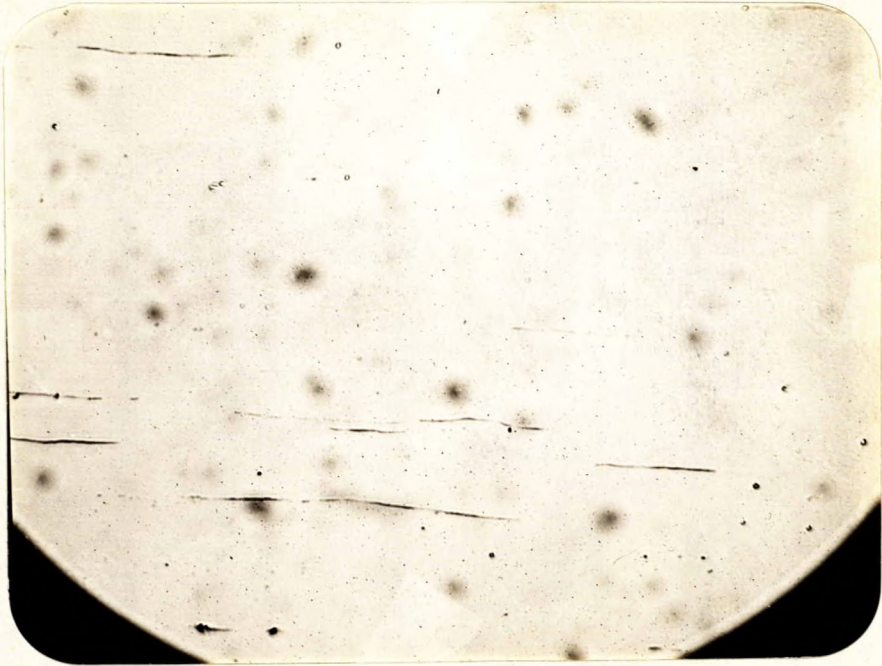
Figure 7.

On examining the unetched polished specimens under the microscope, the inclusions were found to be long stringers. Figure 7, at X250, shows some typical inclusions. The inclusion rating of both pieces of plate was found to be 2.5 by comparison with A.S.T.M. standard inclusion rating charts.

TYPICAL GROUP OF INCLUSIONS.

Microscopic examination showed the inclusions to be long grey stringers, probably of manganese sulphide. They were squeezed out into this form by the hot rolling of the plate. This type of inclusion is known to lower the ballistic properties of armour plate. It may be that the bullet striking B, by chance struck a group of inclusions with the result that the plate failed at that point.
