R E P O R T
of the
ORE DRESSING AND METALLURGICAL LABORATORIES.

Investigation No. 1591.

Investigation of Corrosion of Aircraft De-Icer Tanks.

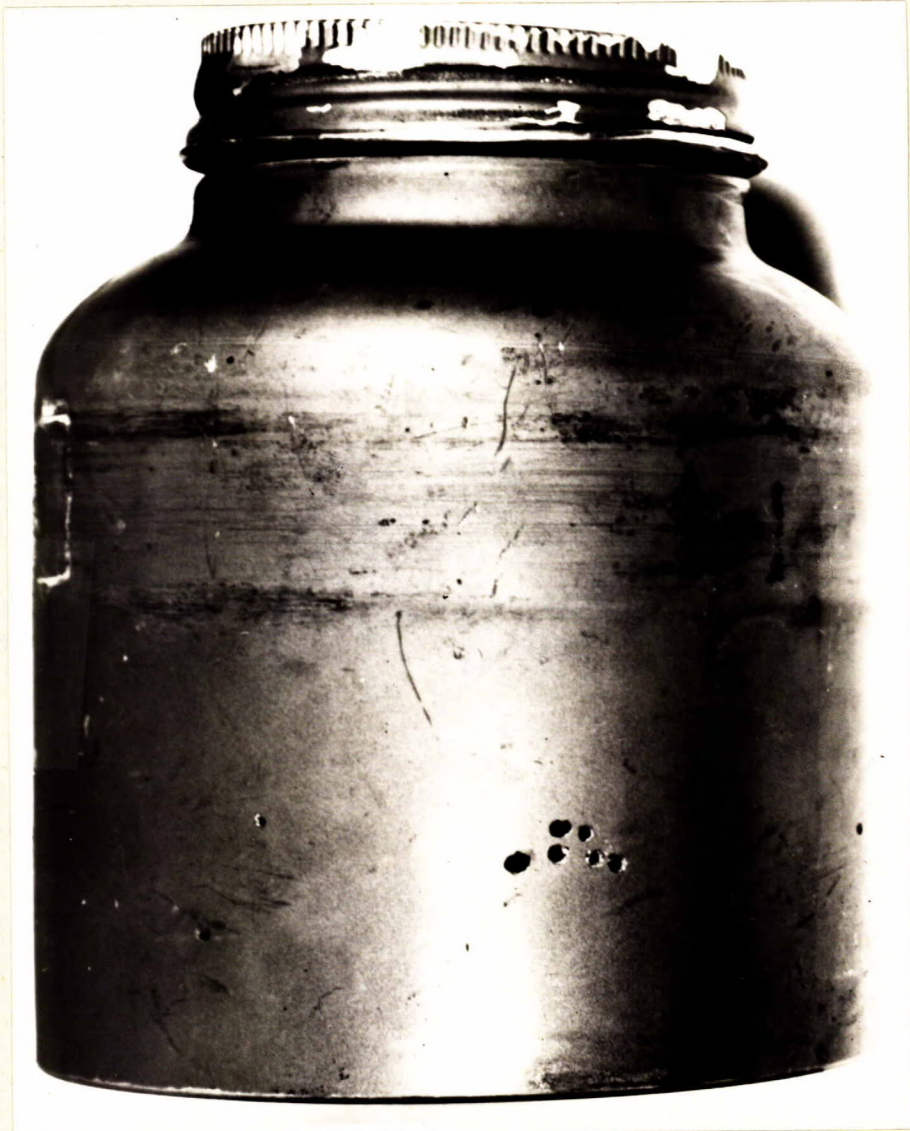
Figure 1.

GENERAL SHAPE OF WINDSHIELD DE-ICER TANK
FROM LIBERATOR BOMBER A.L. 593.

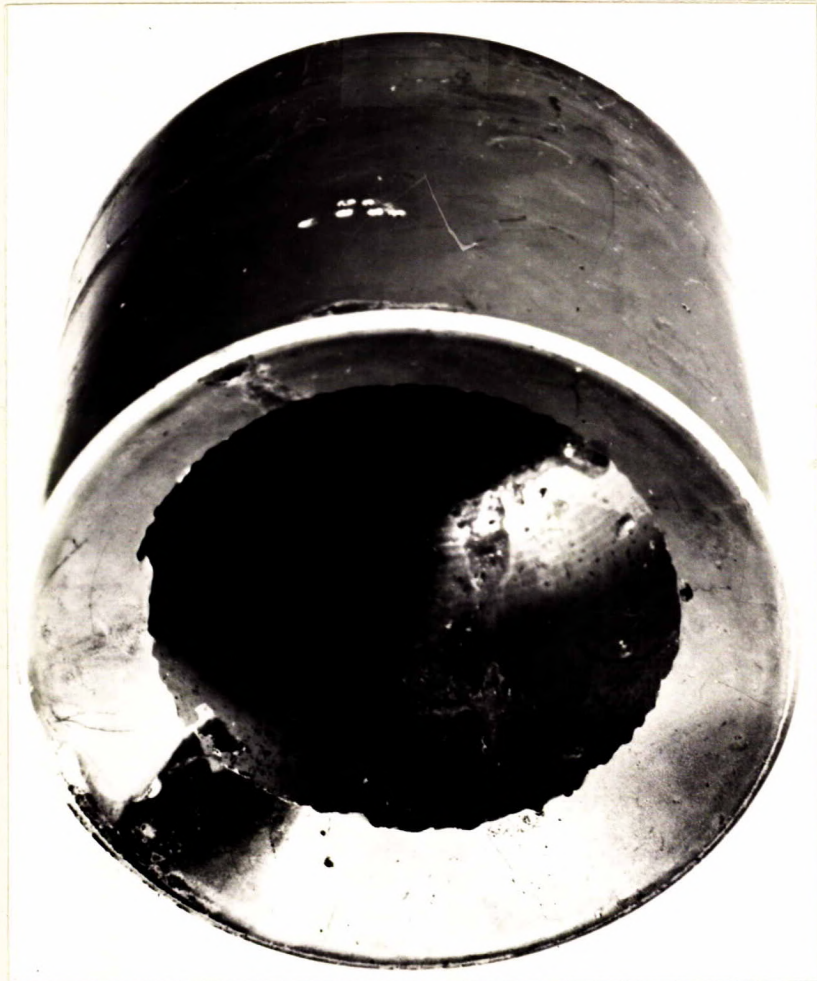
Figure 2.

BOTTOM OF LIBERATOR WINDSHIELD DE-ICER TANK.

Note circular bottom welded to tank
completely eaten away.

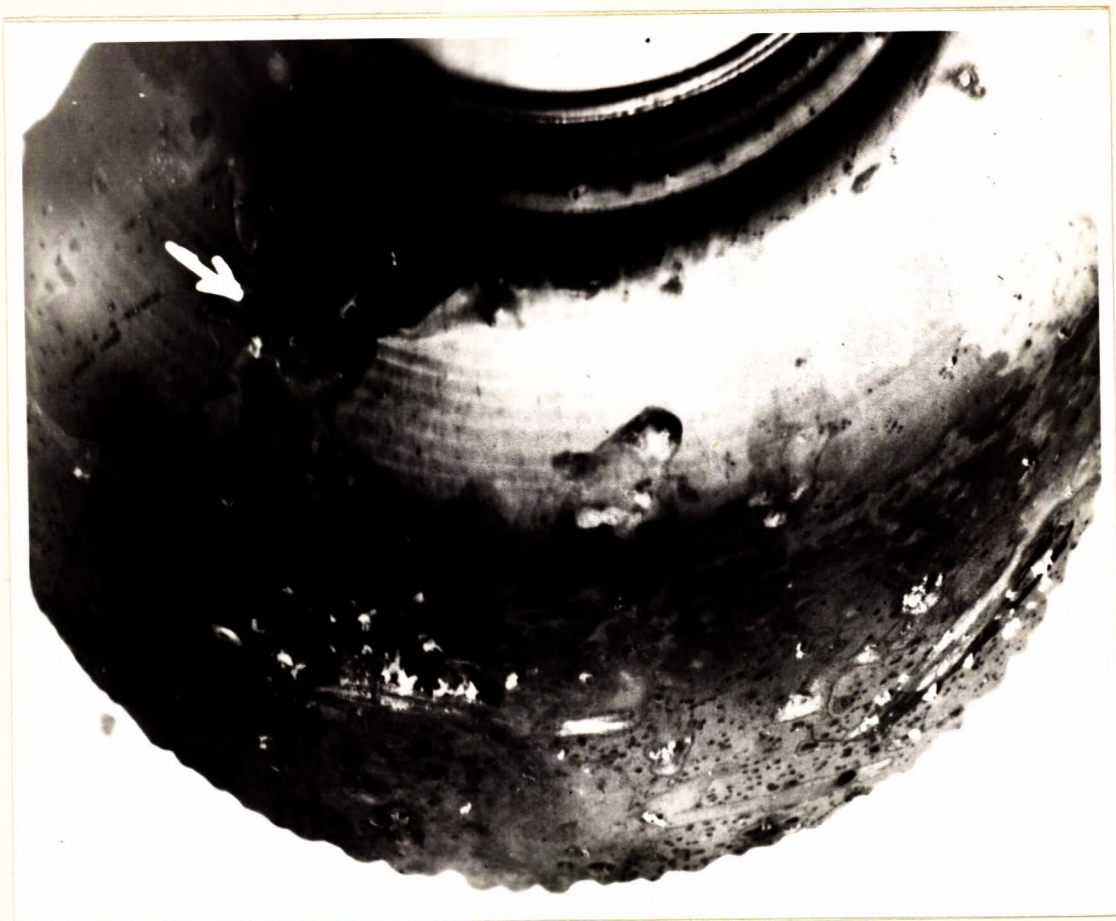
Figure 3.

In the Liberator windshield de-icer tank was found a yellow corrosion product. Chemical and spectrographic analyses revealed that this material contained 44.07 per cent water, 0.027 per cent fluorine and very high chlorine content, together with magnesium, aluminium and manganese.

LIBERATOR WINDSHIELD DE-ICER TANK.

Arrow points to yellow corrosion product. This corrosion product contains 0.027 per cent fluorine.

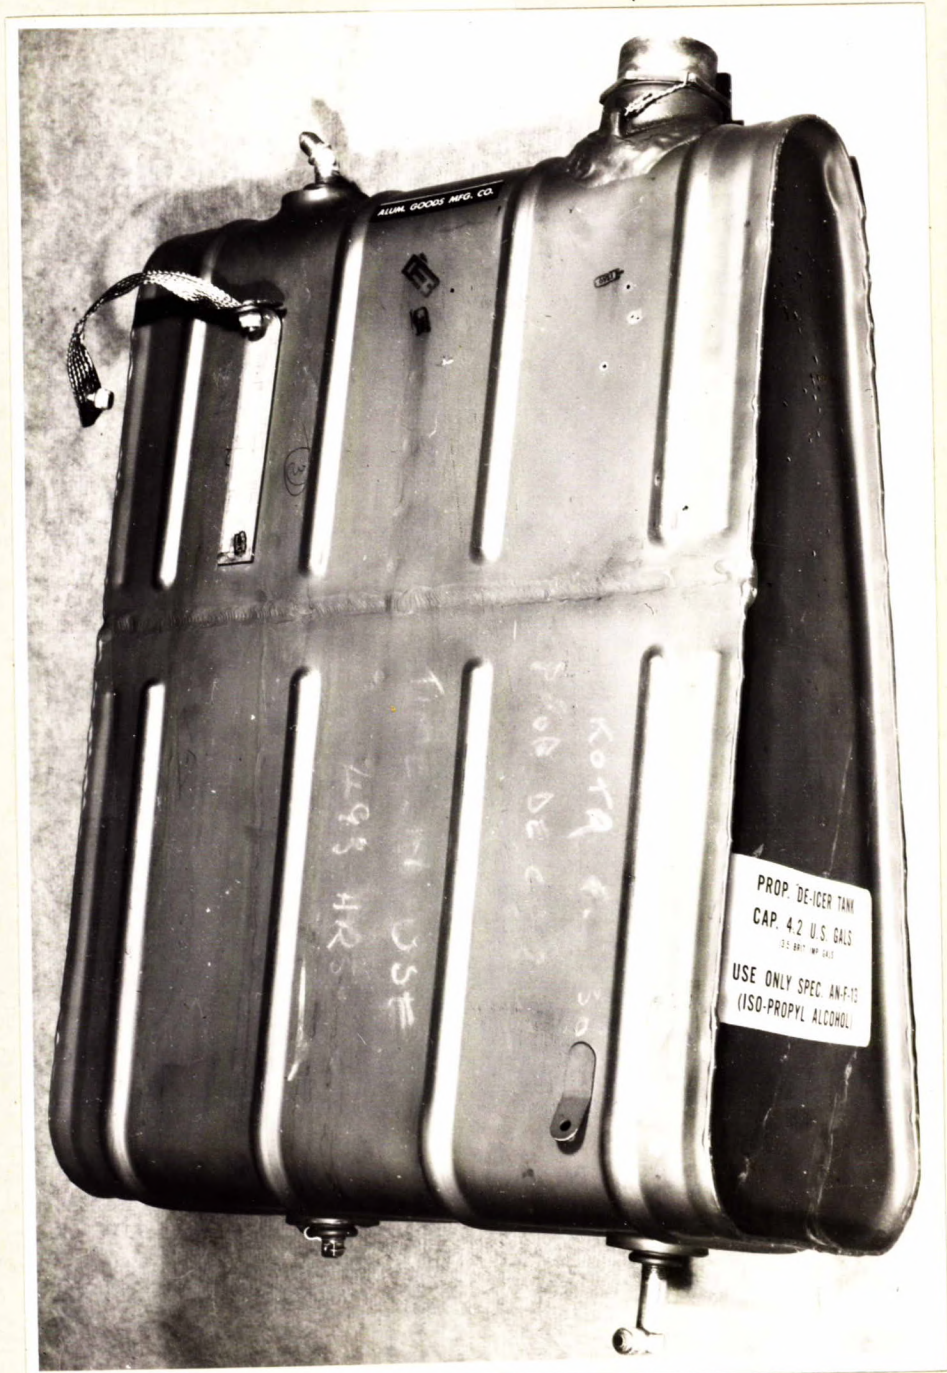
Figure 4.

GENERAL SHAPE OF DAKOTA III, F.L. 530,
PROPELLER DE-ICER TANK.

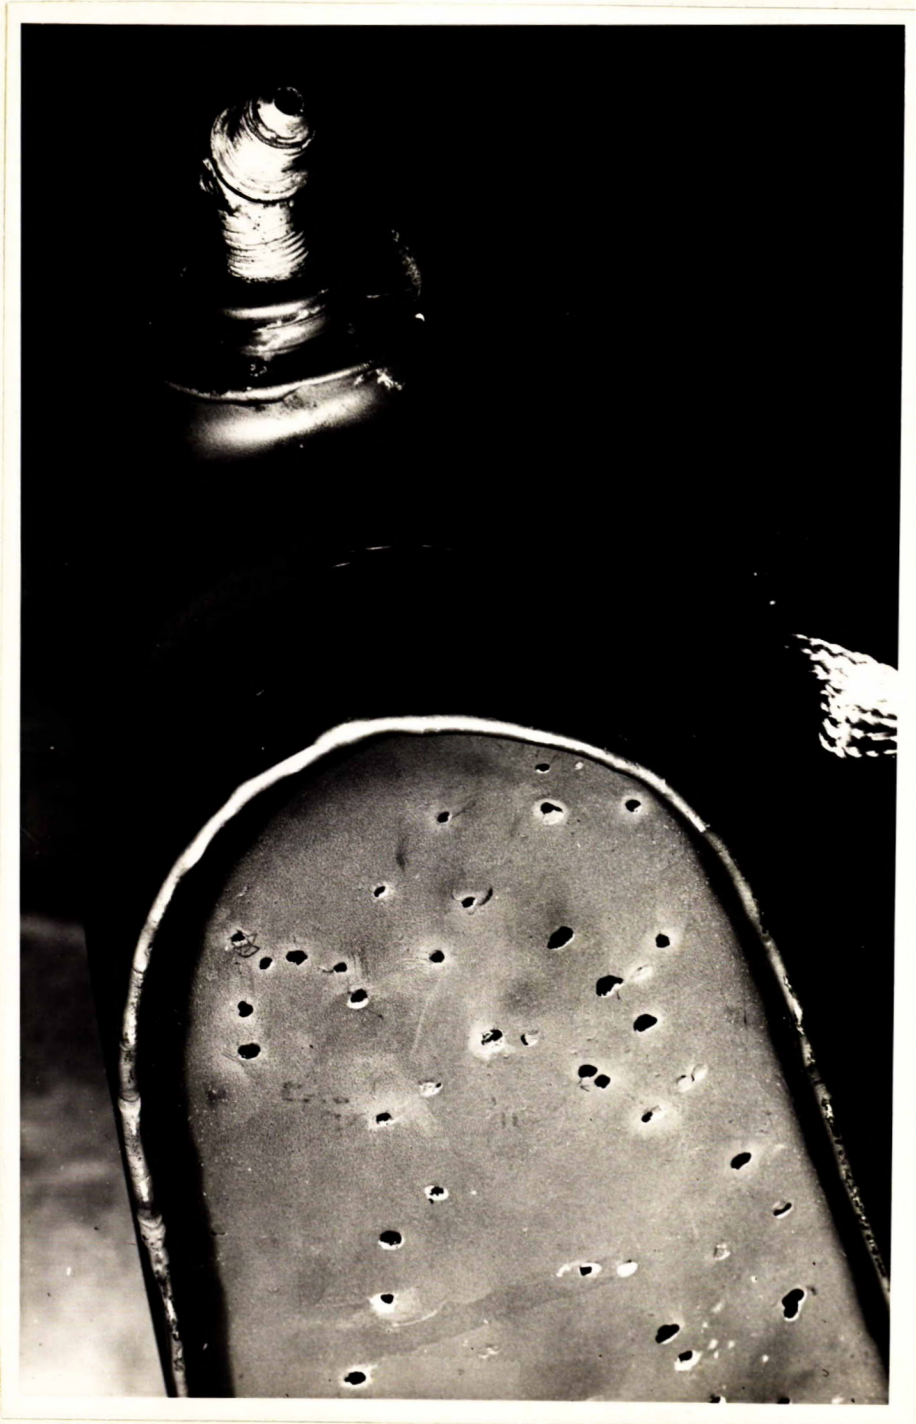
Figure 5.

WELD AND AREA OF CORROSION OF DAKOTA PROPELLER DE-ICER TANK.

Note the localization of corrosion in the vicinity of the weld.

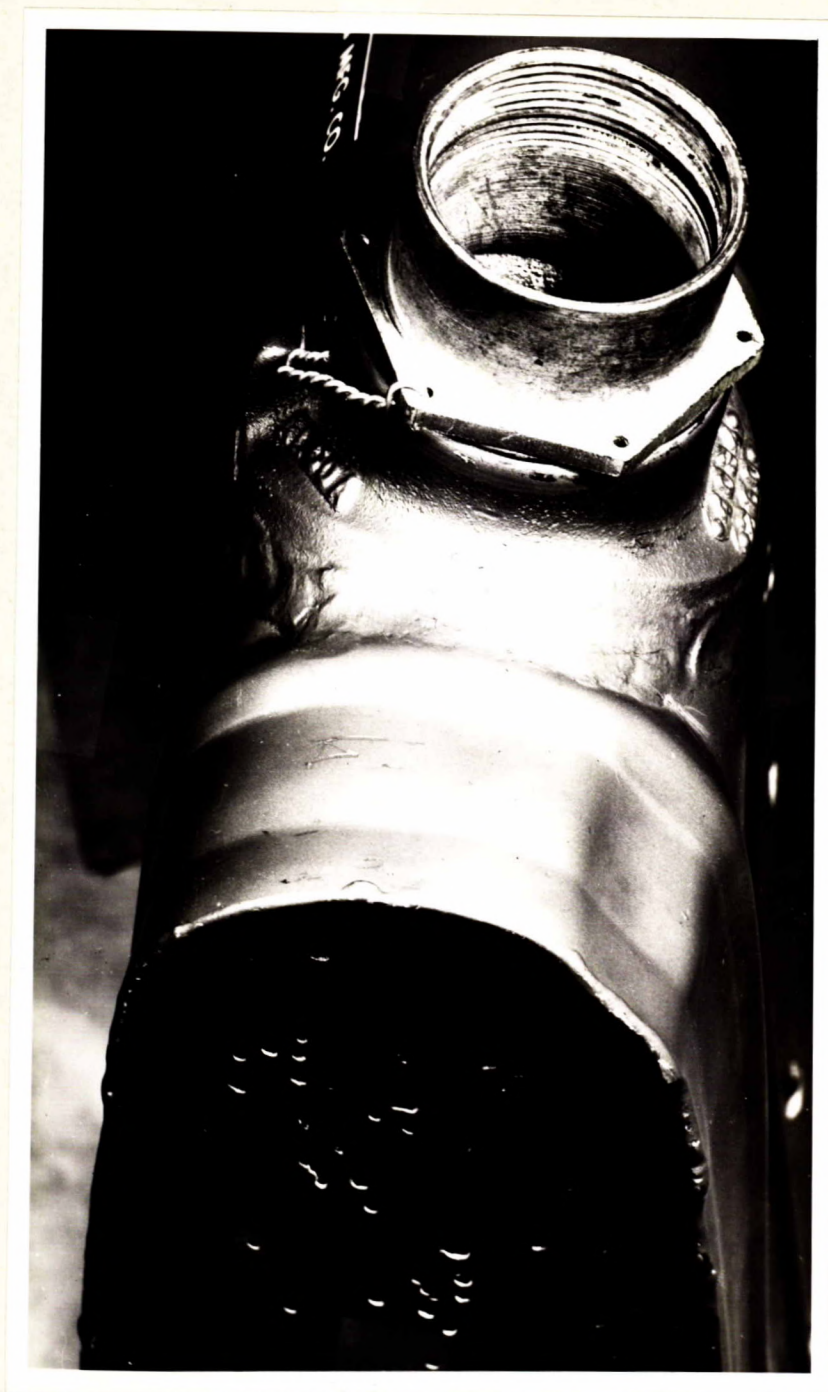
Figure 6.

WELD AND AREA OF CORROSION OF DAKOTA PROPELLER DE-ICER TANK.

Note the localization of corrosion in the vicinity of the weld.

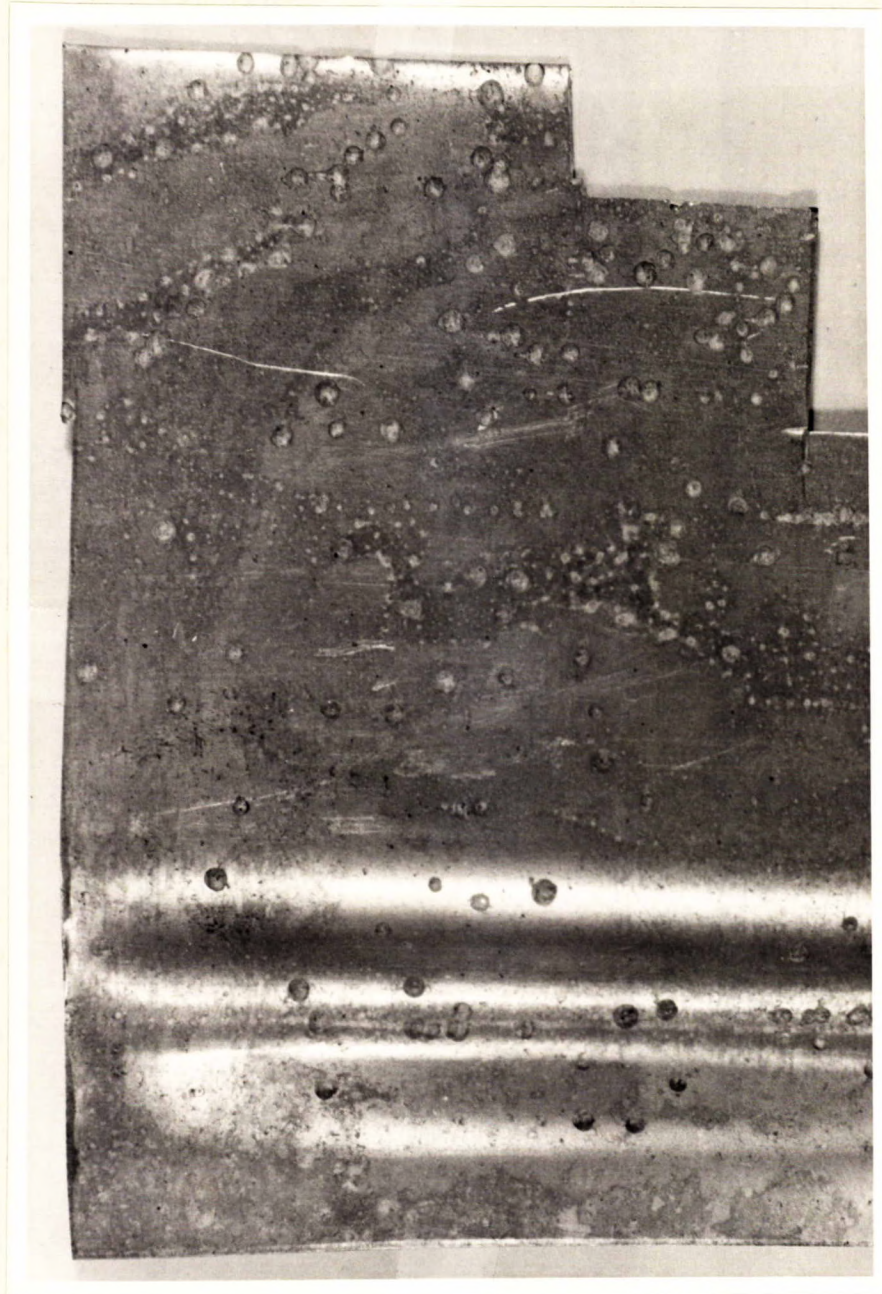
Figure 7.

CORRODED SECTION OF MITCHELL BOMBER
WING DE-ICER TANK.

Note local attack, characteristic
of all tanks examined. Arrows point
to corroded grooves in metal.
