O T T A W A February 10th, 1944.

ORE DRESSING AND METALLURGICAL LABORATORIES.

Investigation No. 1594.

Investigation of Failure of Connecting Rod
Bolts from a Merlin XXIX Aircraft Engine.

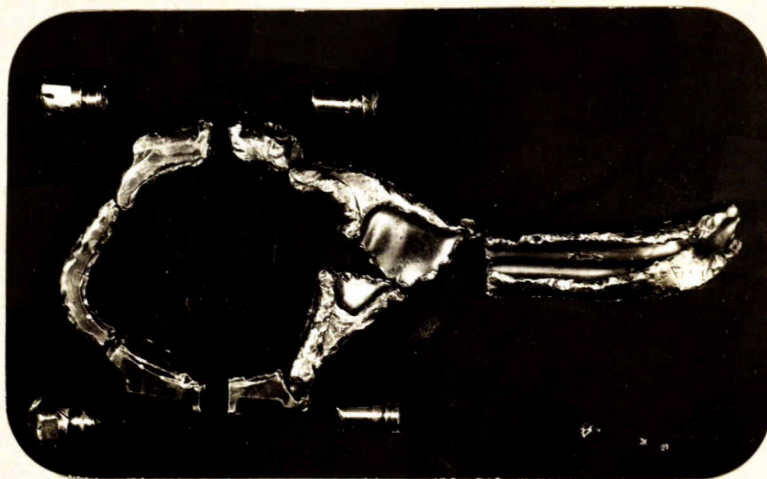
Figure 1.

It was obvious that the cause of the breakage of the connecting rod was the failure of the connecting rod bolts. The connecting rod broke up due to mechanical action. Figure 1 is a photograph of the broken pieces of the connecting rod and bolts. Figure 2 is a photograph of another bolt, indicating the points at which failure occurred. Figure 3 is a photograph showing the fracture at one point on the bolt.

PHOTOGRAPH OF BROKEN MERLIN ENGINE
CONNECTING ROD AND BOLT.

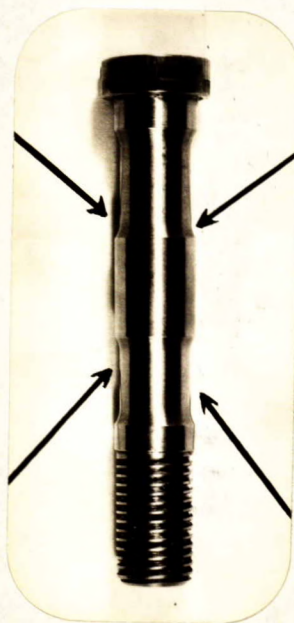
Figure 2.

PHOTOGRAPH OF A BOLT, INDICATING THE POINTS
AT WHICH FAILURE OCCURRED.

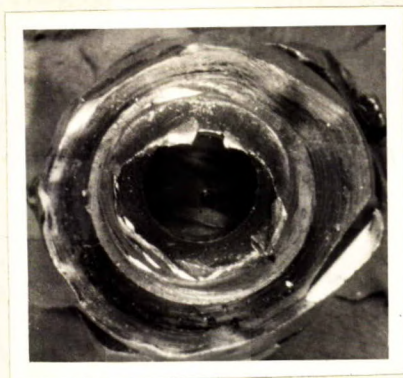
Figure 3.

1. The steel is metallurgically satisfactory.
2. The strength of the bolts is satisfactory.
3. The design of the bolts is satisfactory.
4. The bolts have, so far as it was possible to ascertain, a satisfactory finish.
5. It is concluded that the bolts failed in fatigue, due likely to the fact that they were insufficiently tightened while being assembled.
6. It is quite possible that the bolt was tightened

SHOWING THE TYPICAL FATIGUE
TYPE OF FAILURE.

sufficiently in the first instance but had to be slackened somewhat to admit the cotter pin. It is better practice to advance the nut to admit the cotter pin rather than to slacken it, even if this means stressing the bolt somewhat above the yield point.

7. If connecting rod bolts are tightened to such a degree that measurement of the extension shows that they have been stressed to the yield point or slightly beyond, they will not fail by fatigue, provided, of course, the operating tension load is equal to or less than the tension load placed on the bolt.

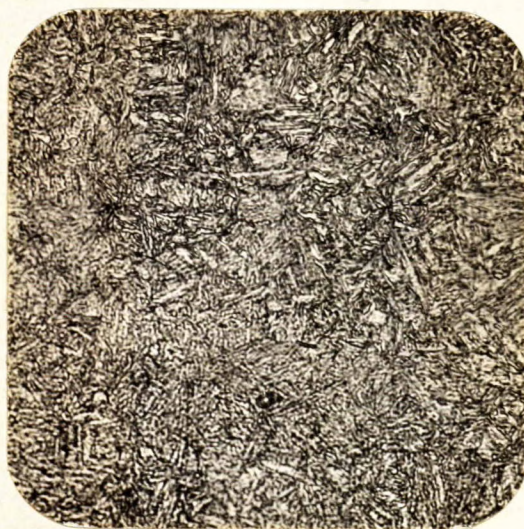
microstructure is shown in Figure 4. A specimen was cut from another bolt which had not failed and this also was examined under the microscope at X500, after etching in 2 per cent nital. The microstructure of both bolts is the same, showing that both bolts were given the same heat treatment.

X500, nital etch.

PHOTOMICROGRAPH OF BOLT, SHOWING TEMPERED
MARTENSITIC OR SORBITIC STRUCTURE.
