February 25th, 1944.

Investigation No. 1604.

Examination of Two Welded Propeller Shaft  
Flange Assemblies for Snowmobiles.

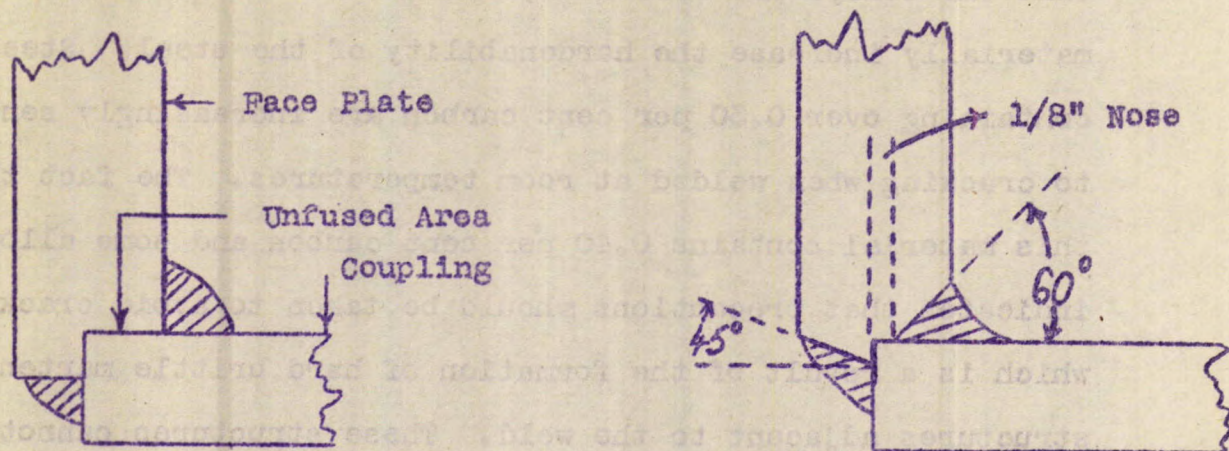
Present Design.

Recommended Design.

The recommended design with 1/8-inch nose will permit complete penetration of the joint, the nose being completely fused during welding. The nose will also permit assembling so that the face plate and coupling are concentric.

1. The assembly should be preheated to 500° F. before welding.
2. The assembly should be stress-relieved at 900° F. for 1 hour after welding.
3. The design of the joint should be changed so that the necessary machining will not weaken the joint. The design recommended above should prove satisfactory.
4. Should the recommended design be approved, an electrode conforming to the AWS E 6030 specification should be used in making the weld.

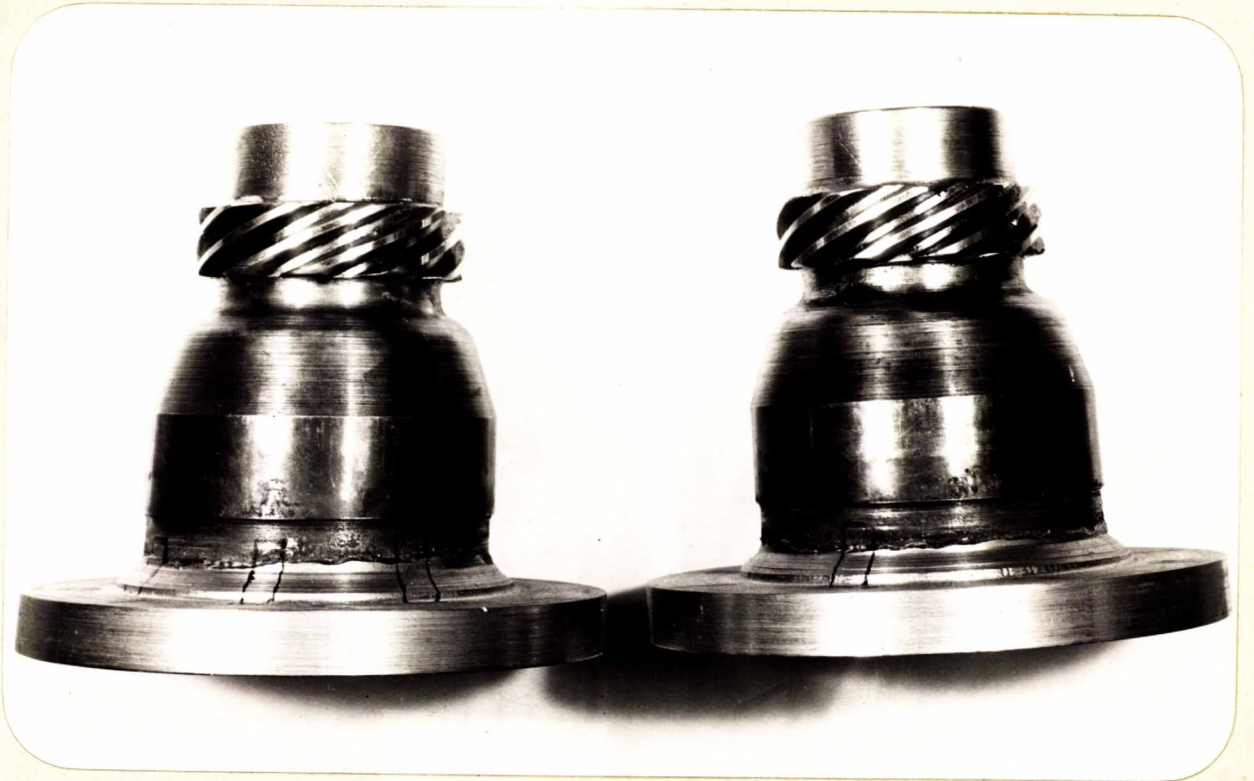
Figure 1.

A visual examination revealed that the outside weld was nearly completely machined away whereas the inside weld was not machined at all. The outside weld showed some evidence of undercutting, probably due to incorrect electrode inclination during welding. The inside weld showed a greater degree of convexity of contour than is desirable, probably as a result of too low welding current.

GENERAL SHAPE OF PROPELLER FLANGE ASSEMBLY.

White rectangles indicate areas from which  
macro and micro samples were machined.

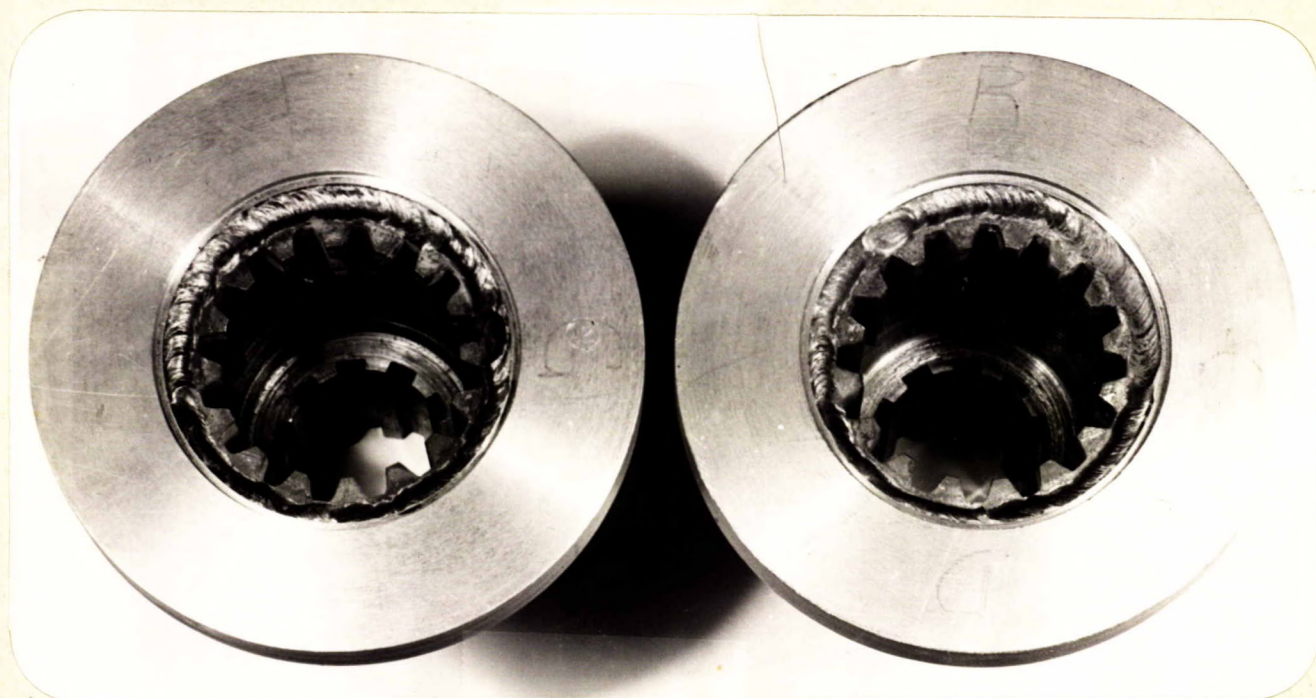
Figure 2.

BOTTOM OF ASSEMBLY, SHOWING INSIDE WELD.

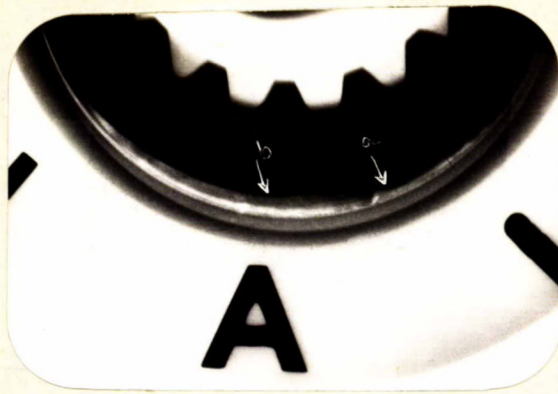
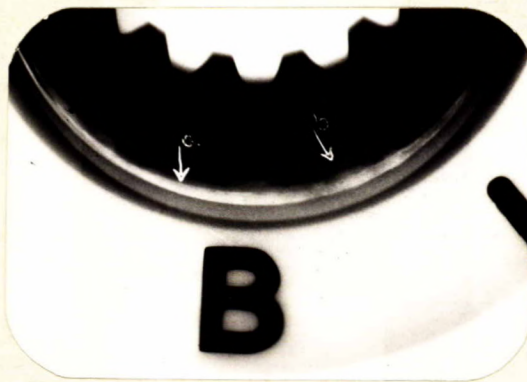
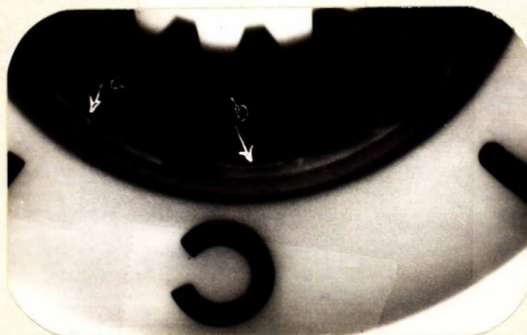
The x-ray examination revealed that both welds contained slag trapped in the roots and this extended almost completely around the weld. This was confirmed by the macro and micro samples. The danger associated with this defect is that it acts as a potent stress raiser and is therefore a fertile source of cracks in highly stressed parts. As previously shown, some of the macro samples are cracked both in the weld metal and coupling material, and these cracks have originated at the slag inclusion. Even if cracking had not occurred subsequent to welding it is most probable that service stresses would be sufficient to initiate cracking.

REPRODUCTIONS OF EXOGRAPHS OF WELDS.  
LETTERS SAME AS ON MACRO AND MICRO SAMPLES.

Legend: a = Slag in root of outside weld.  
b = " " " " inside weld.

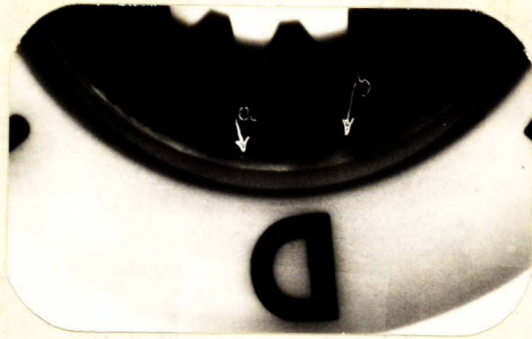
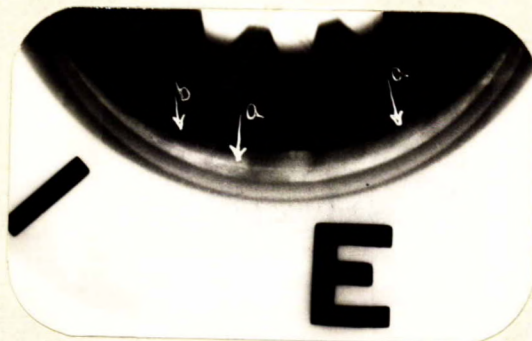
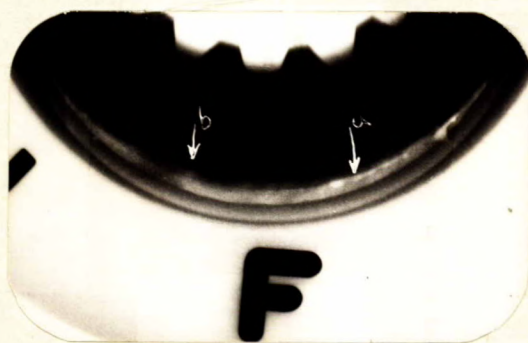
REPRODUCTIONS OF EXOGRAPHS OF WELDS.  
LETTERS SAME AS ON MACRO AND MICRO SAMPLES.

Legend: a = Slag in root of outside weld.  
b = " " " " inside weld.

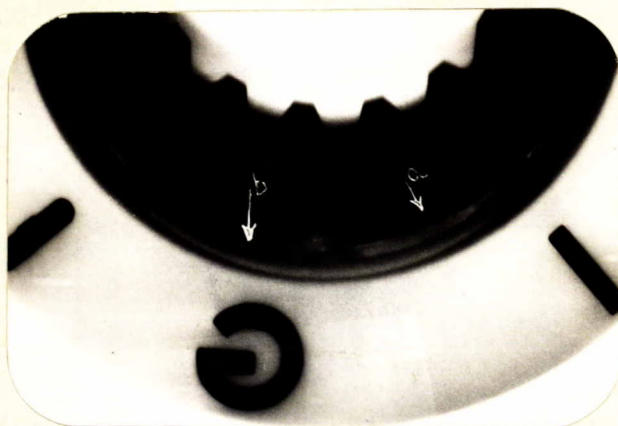
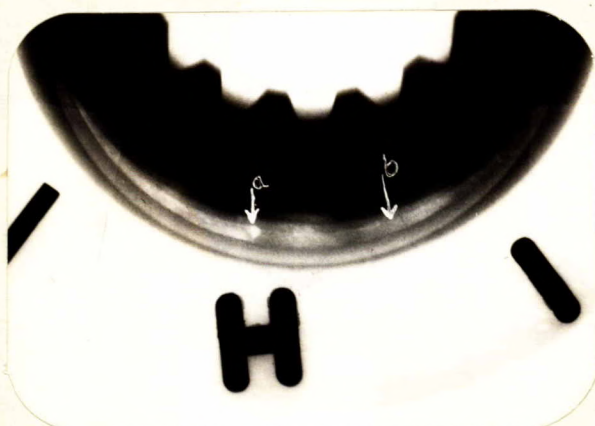
REPRODUCTIONS OF EXOGRAPHS OF WELDS.  
LETTERS SAME AS ON MACRO AND MICRO SAMPLES.

Legend: a = Slag in root of outside weld.  
b = " " " " inside weld.

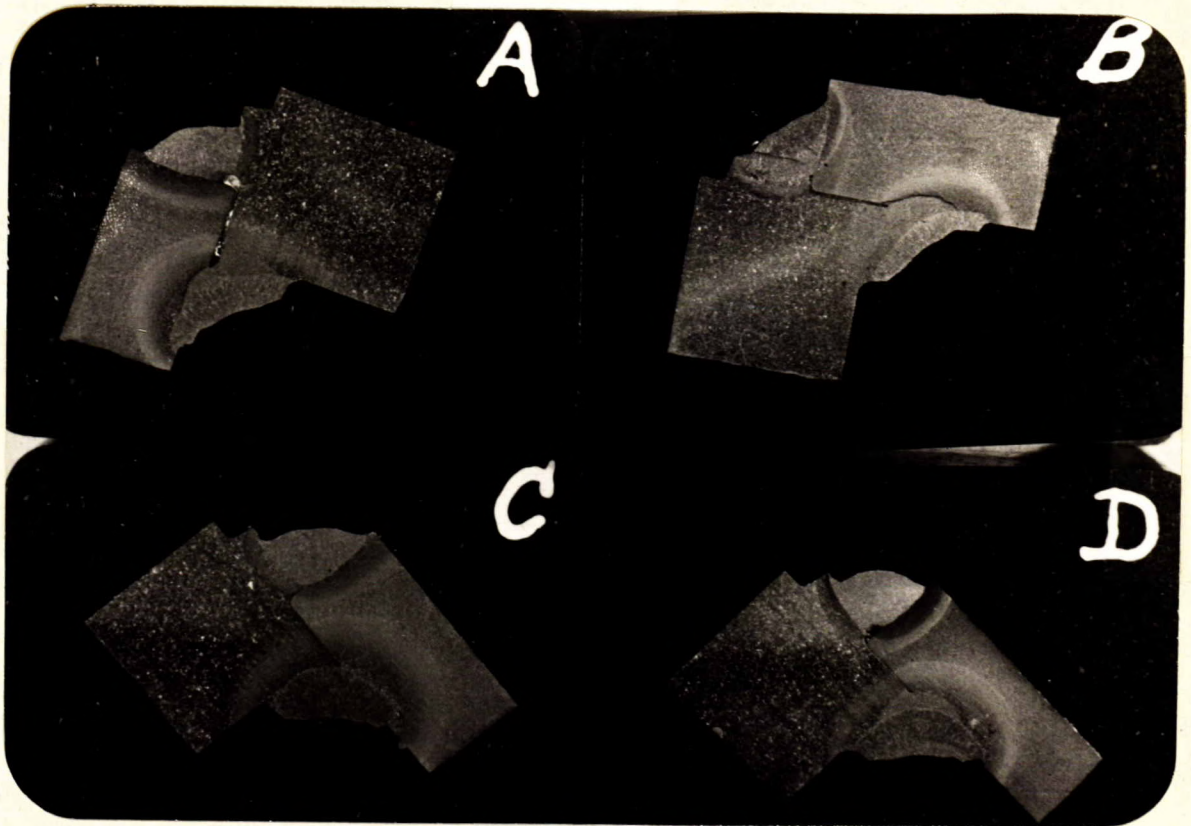
Figure 11.

MACRO SAMPLES OF WELDS.

Note slag inclusions at roots of welds,  
also cracks in Samples A and B.

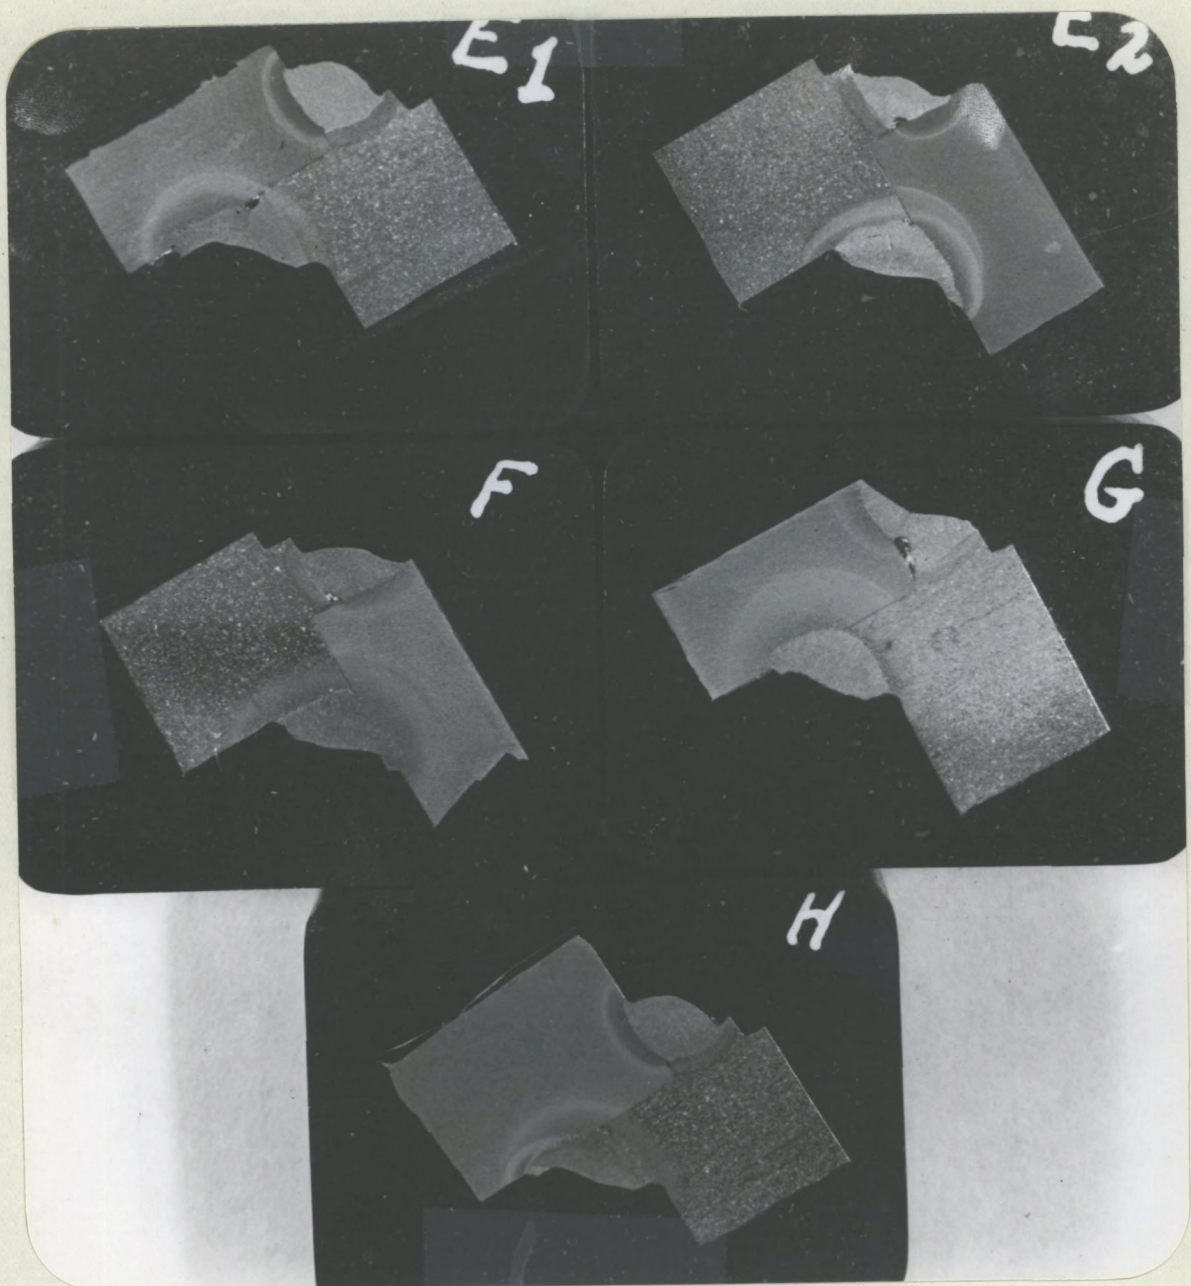
Figure 12.

MACRO SAMPLES OF WELDS.

Note slag inclusions at roots of welds,  
cracks in Samples G, E, and porosity  
in weld of Sample E.

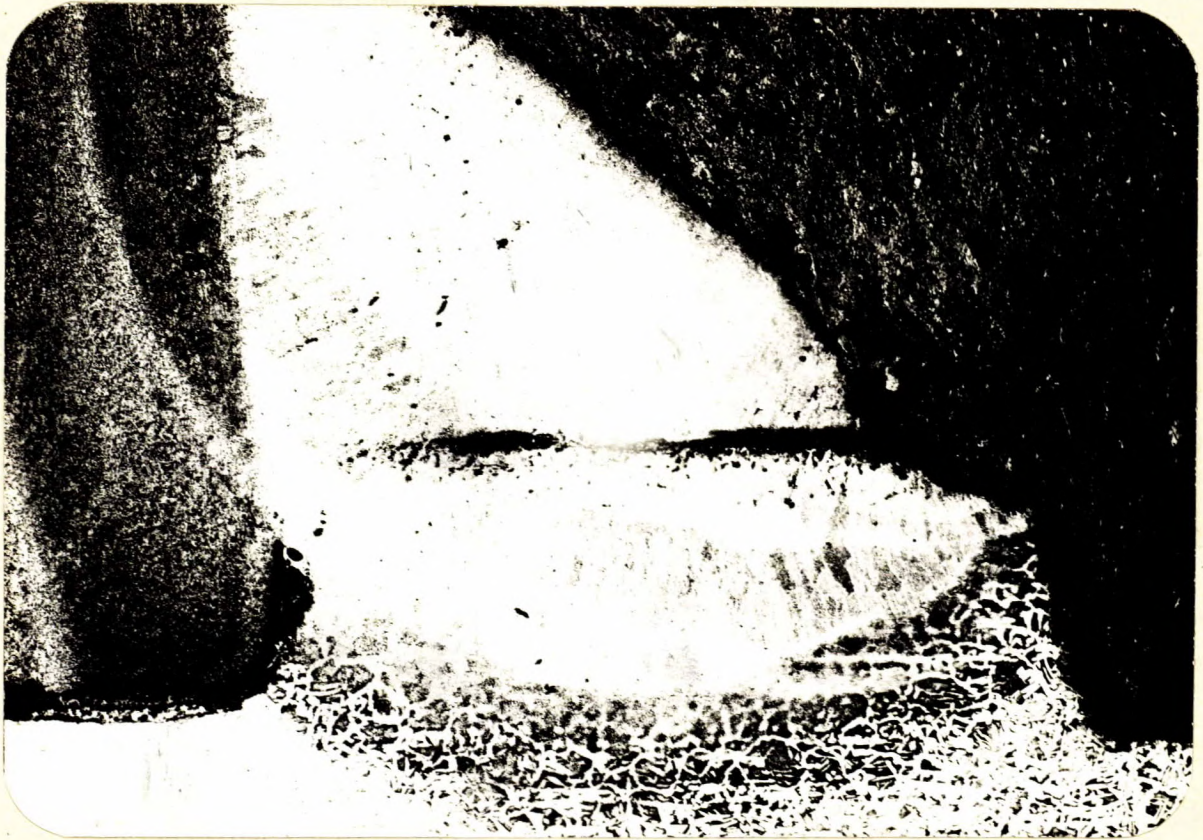
Figure 13.

WELD AREA B.

Note crack in weld metal.

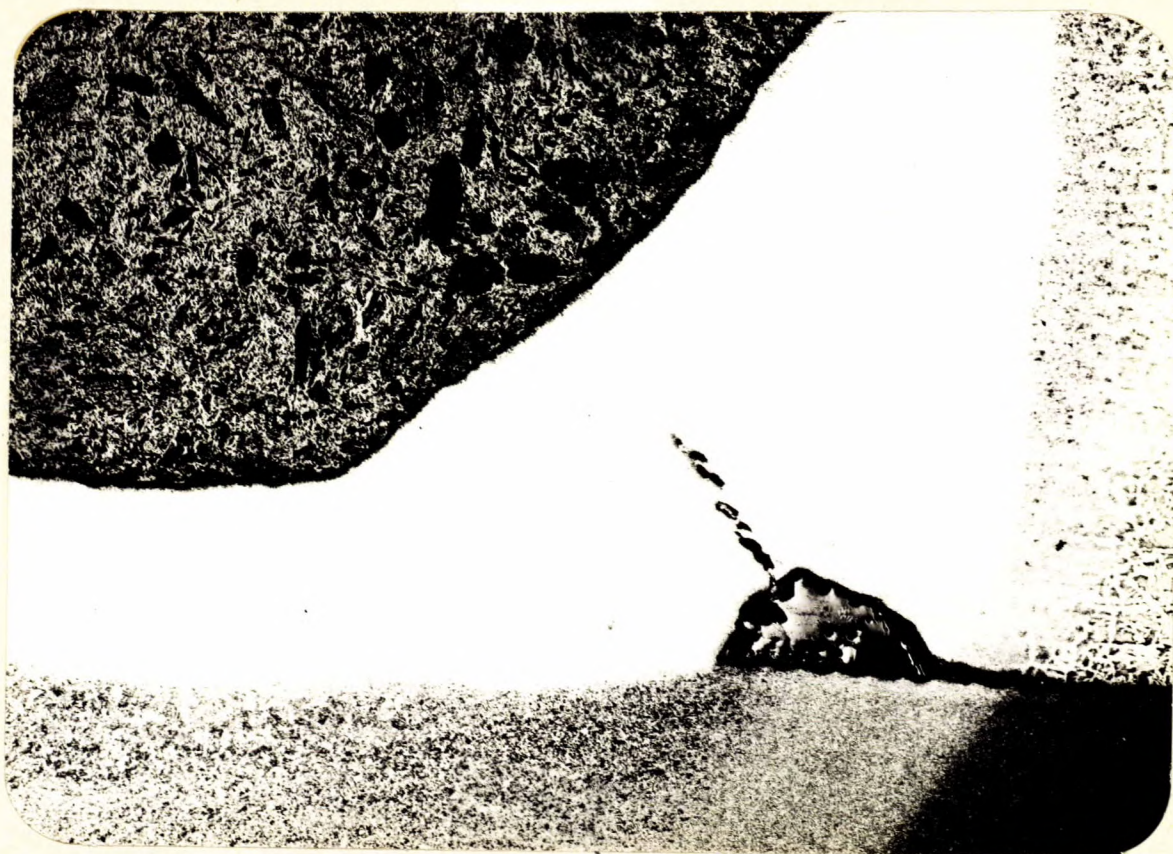
Figure 14.

WELD AREA E.

Note crack in weld metal, originating  
at slag inclusion at root of weld.

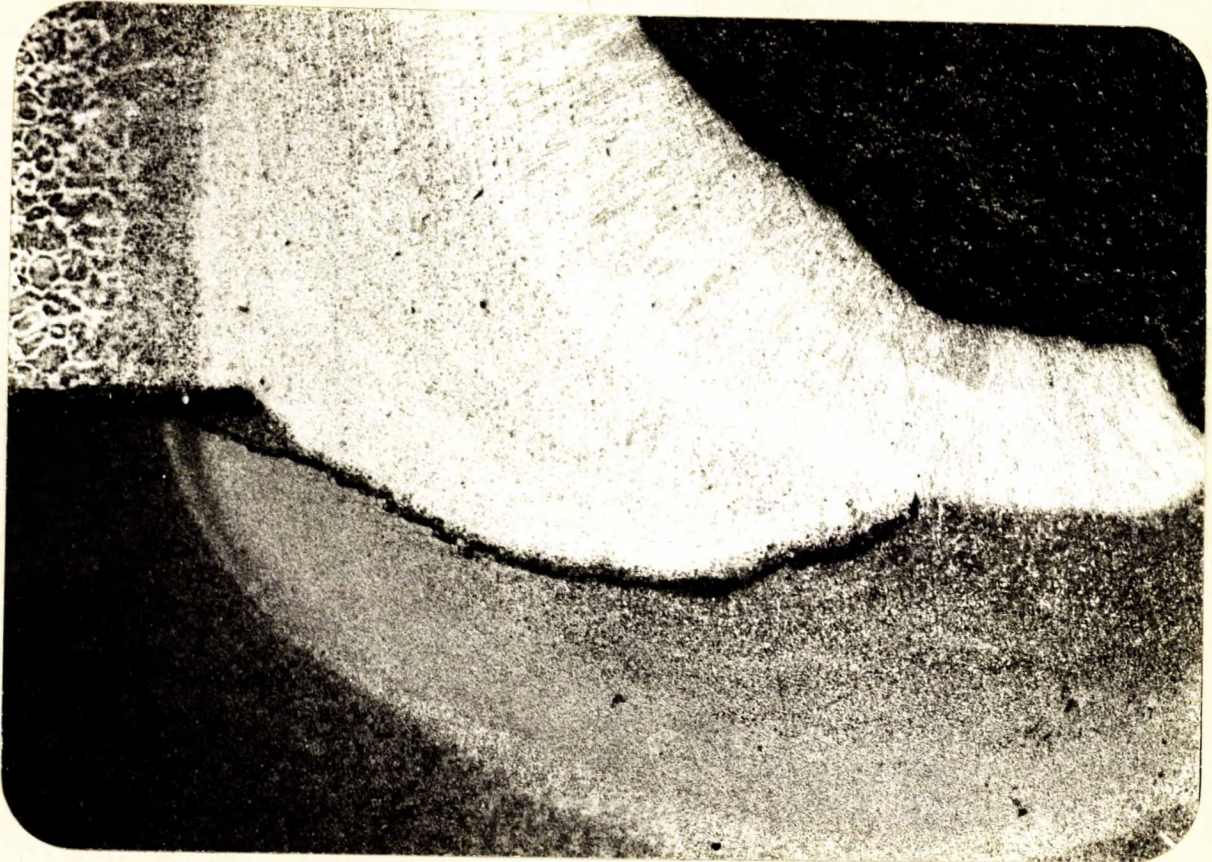
Figure 15.

WELD AREA B.

Note crack in fusion zone  
of coupling material.

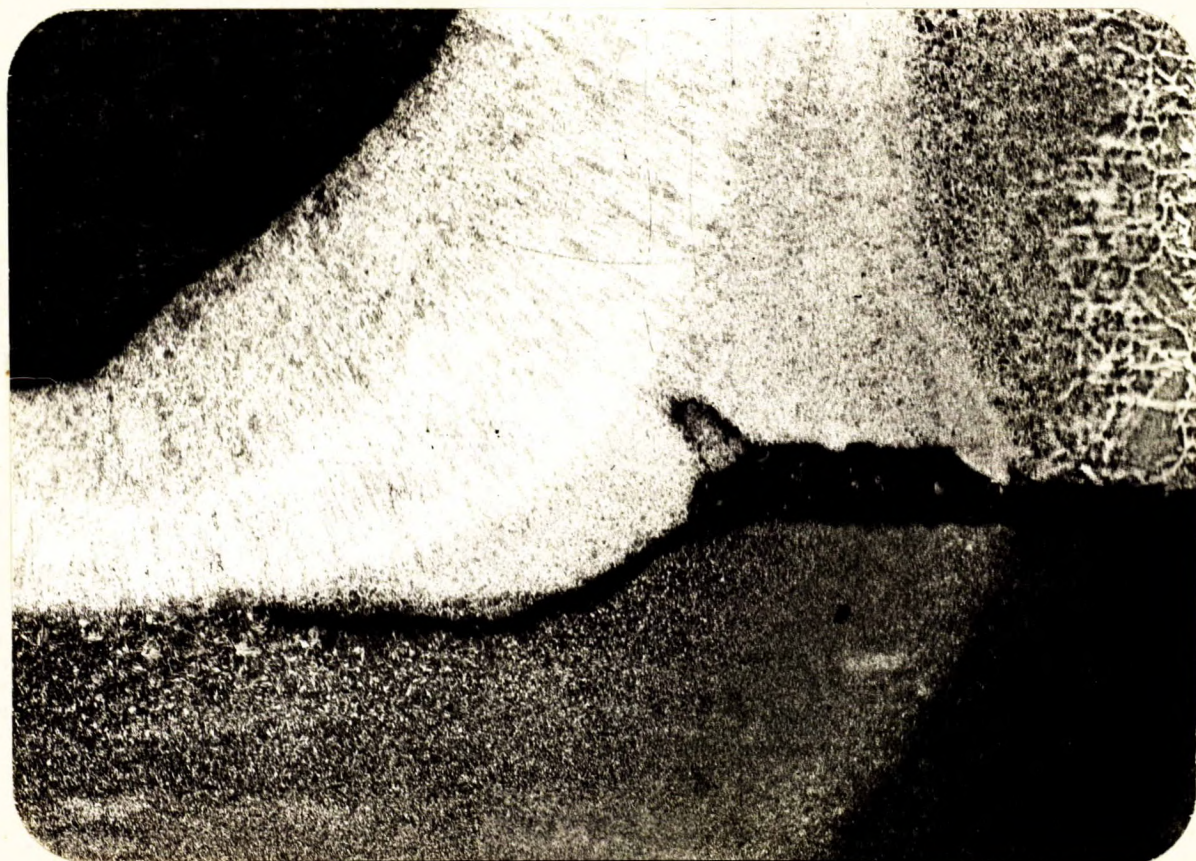
Figure 16.

WELD AREA A.

Note crack beginning at  
slag inclusion at root of weld.

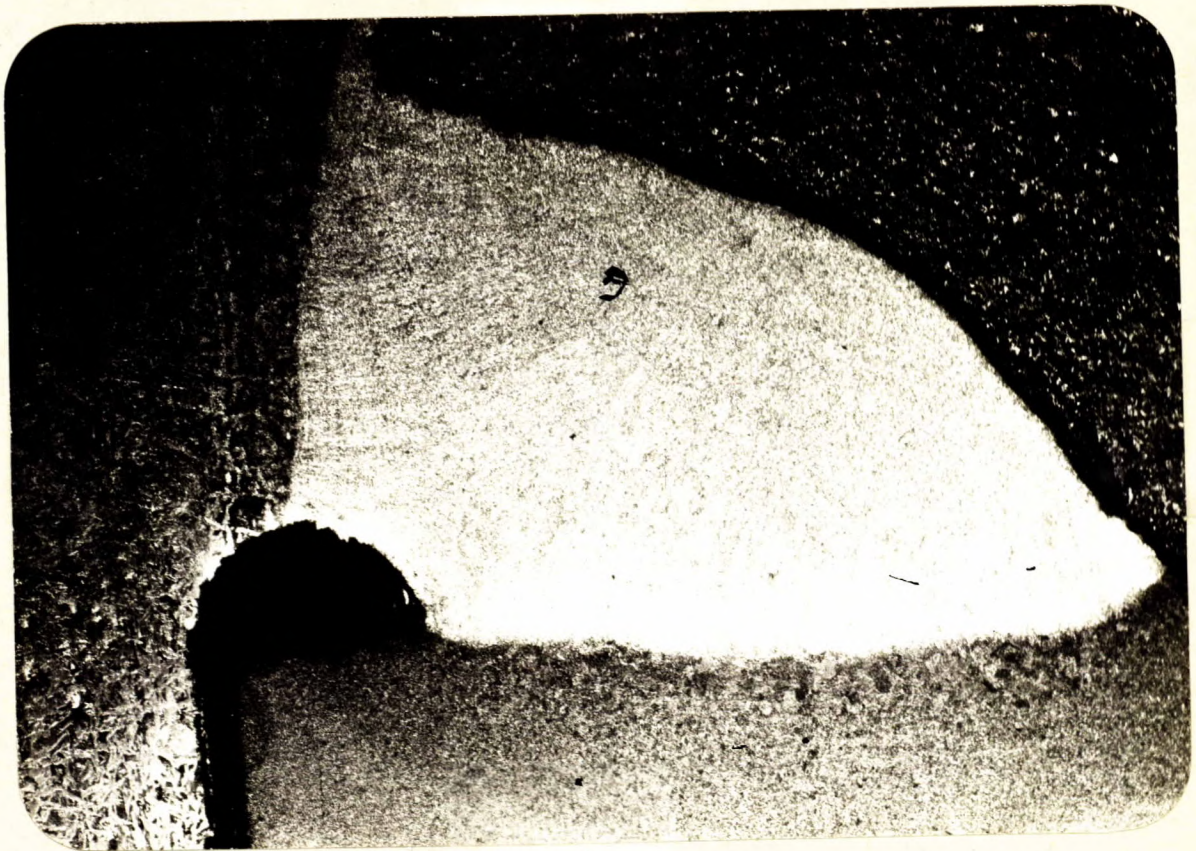
Figure 17.

WELD AREA D.

Note slag inclusion at root of weld.

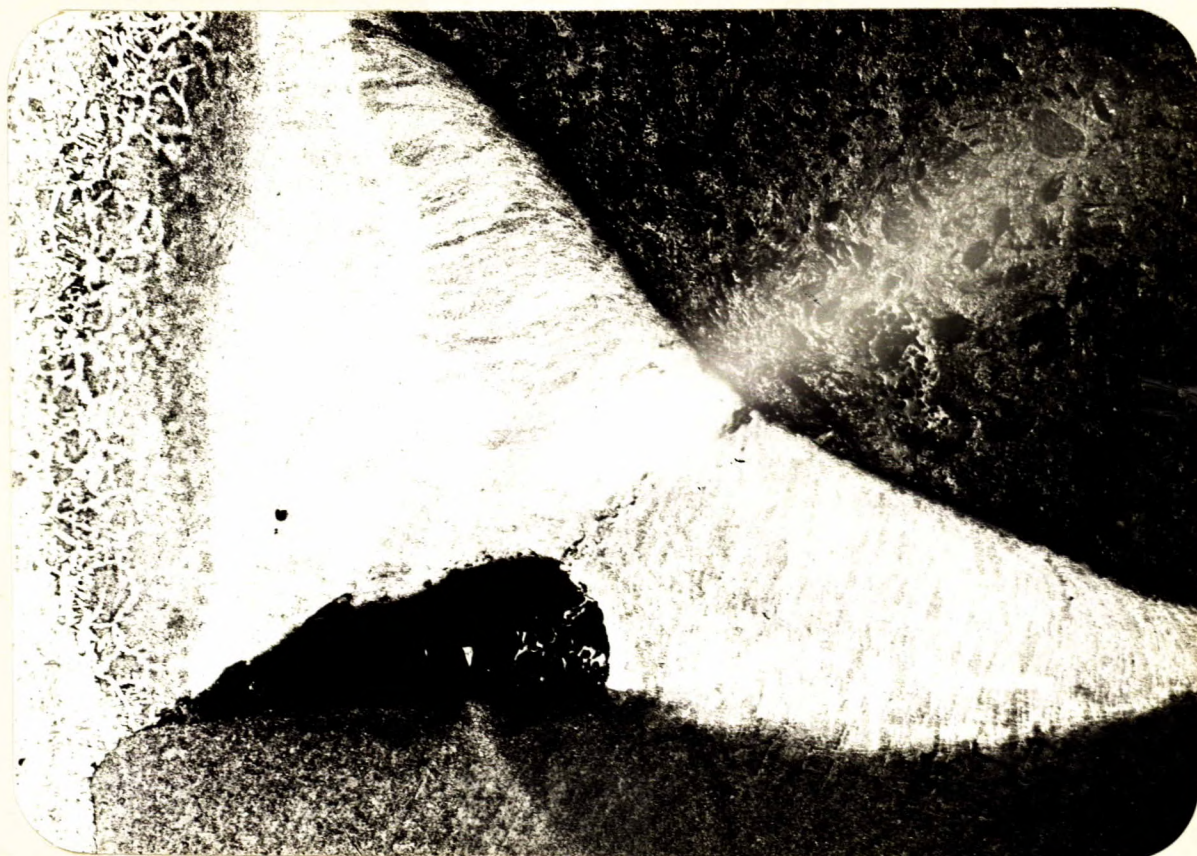
Figure 18.

WELD AREA G.

Note crack originating at slag  
inclusion at root of weld.

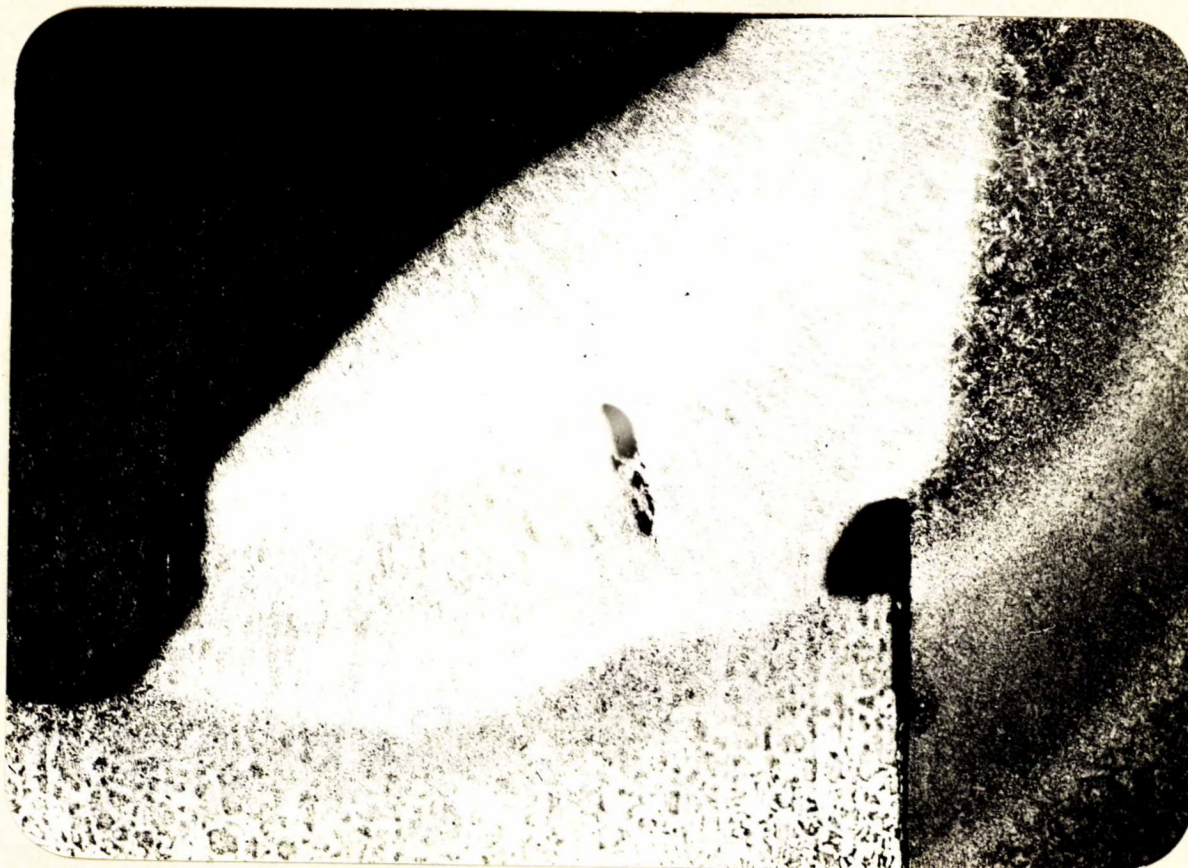
Figure 19.

WELD AREA E.

Note small slag inclusion at root of weld,  
and porosity in weld metal.

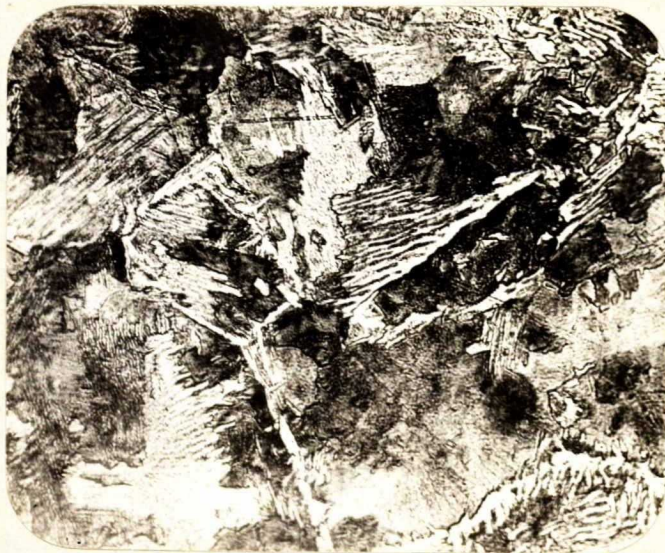
Figure 23.

The hardness tests and the microstructure both reveal the formation of a hard, brittle, martensitic structure adjacent to the weld and point to the necessity of corrective treatment.

X500, etched in 4 per cent picral.  
STRUCTURE OF HEAT-AFFECTED ZONE OF COUPLING MATERIAL.  
Coarse martensite.

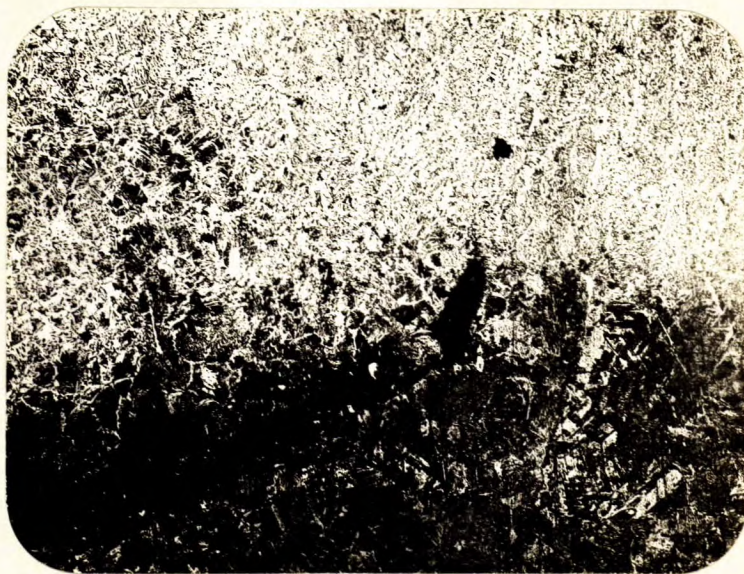
Figure 25.

X100, etched in 2 per cent nital.  
END OF CRACK IN FUSION ZONE OF COUPLING MATERIAL.
