March 1st, 1944.

ORE DRESSING AND METALLURGICAL LABORATORIES.

Investigation No. 1605.

Examination of Failed Copper-Lead
Connecting Rod Bearings.

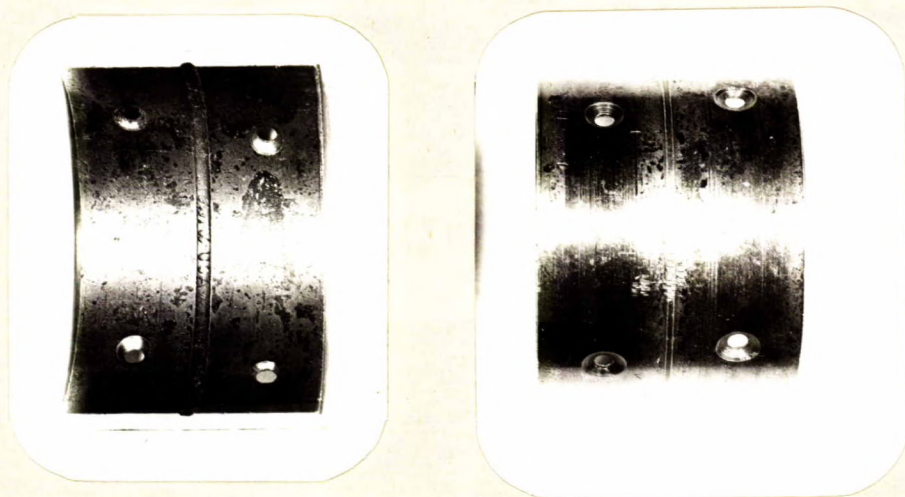
A photograph of two of the half bearings, as received, is given in Figure 1.

BEARINGS AS RECEIVED.
(Approximately $\frac{3}{4}$ size).

On the inner, concave surface of the bearing there was, in general, much more of what appeared to be a pitting-type corrosion than on the convex surface. On the outer, convex surface there were some glazed or shiny circumferential paths containing networks of fine cracks which were not noticeable in other parts of the bearing. These paths were frequently through the oil seepage holes but were sometimes in other locations. The most important point in this connection, however, is that areas of severest pitting on the inside of the bearing corresponded to areas of distress on the convex side.

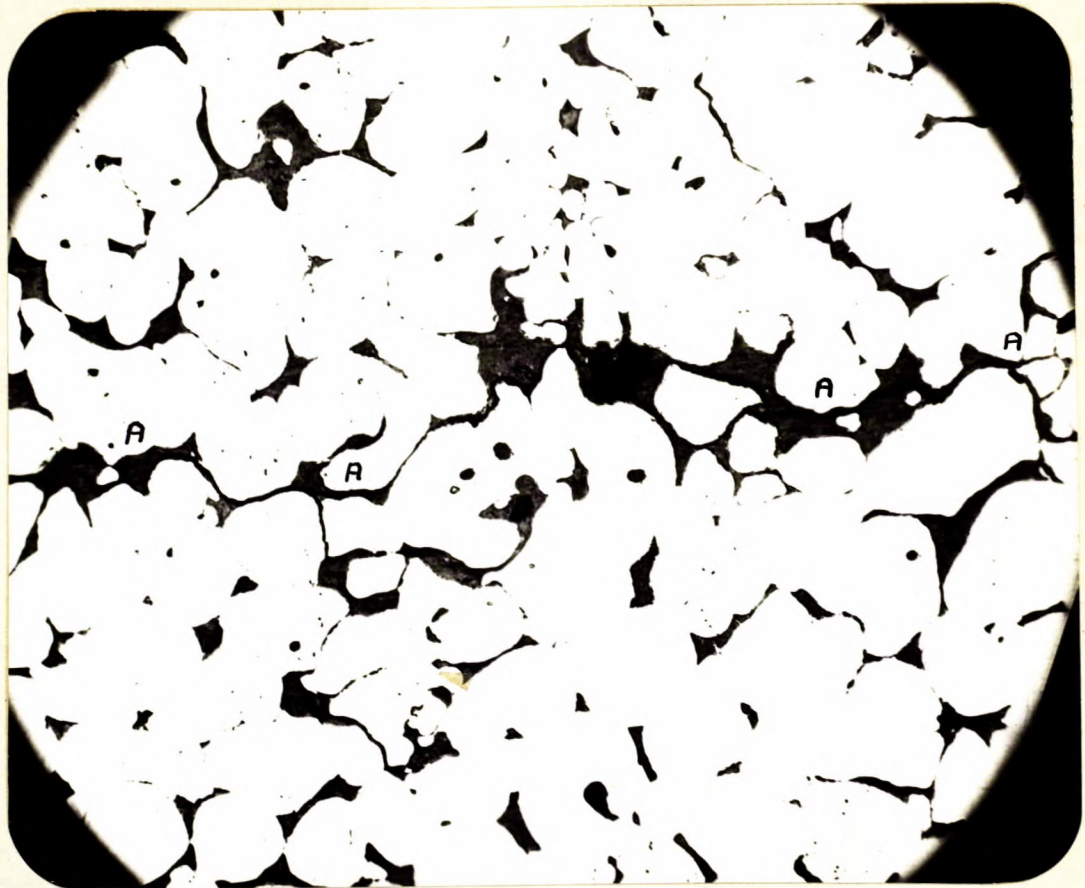
Figure 2.

Examination of some developing cracks in the glazed paths on the convex side of the bearings did not reveal any selective lead loss (see Figures 2 and 3).

X250, unetched.

TANGENTIAL SECTION FROM CONVEX BEARING SURFACE,
IMMEDIATELY BELOW SURFACE. VEHICLE NO. C-122.

Note fine crack proceeding through lead
areas of the alloy.

The lead was distributed intergranularly, with the lead areas frequently connected by fine stringers of lead (see Figures 2 and 3).

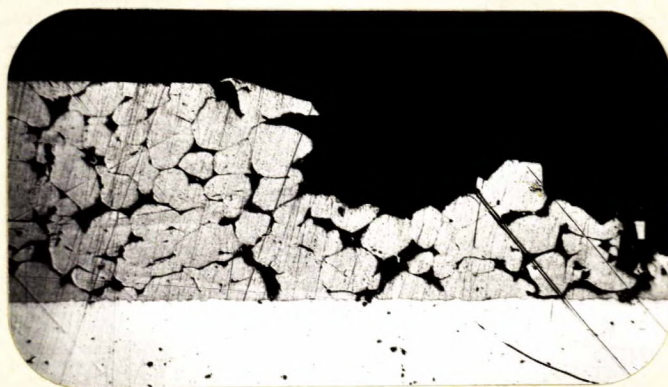
Figure 3.

On examination of sections through several flaked-out areas it was found that the bearing-to-steel bond exhibited no defects and was intact in all cases (see Figure 3).

X100, unetched.

RADIAL SECTION FROM CONVEX BEARING SURFACE,
WITH LEAD PRESENT TO THE OUTER EDGE.

Note partially flaked-out location showing bond intact.
