March 6th, 1944.

Investigation No. 1606.

Examination of Electrically Welded
2-Inch Mortar Bomb Tails.

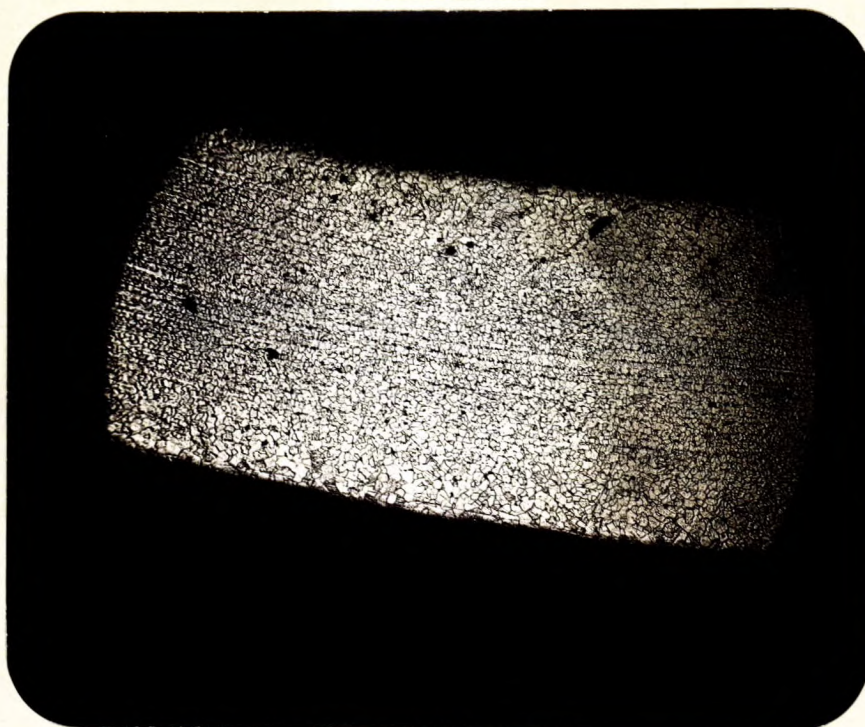
Figure 1.

It is interesting to note that the banded structure of the fractured tail piece is typical of hot-rolled steels which have not been subsequently annealed. Specification I.G. 397A states that the material shall be in the annealed condition before welding. On the other hand, none of the tube samples shows any evidence of cold work but all are definitely annealed. A visual examination of the tubing before and after pickling indicates that after the welding operation the tubes are given a light draw, insufficient to affect the structure. This final draw is probably for accurate sizing. In brief, it would appear that the processing operations are not the same in all cases.

BANDED STRUCTURE OF FRACTURED BOMB TAIL PIECE.

This is typical of hot-rolled, low-carbon steel
not annealed after finish rolling.

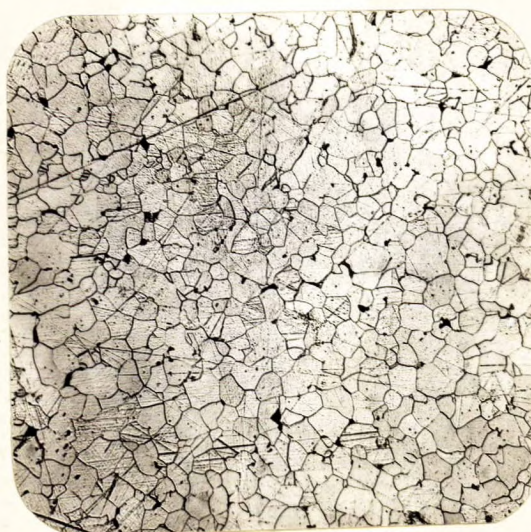
Figure 2.

ANNEALED STRUCTURE OF TUBING.

Compare with Figure 1.

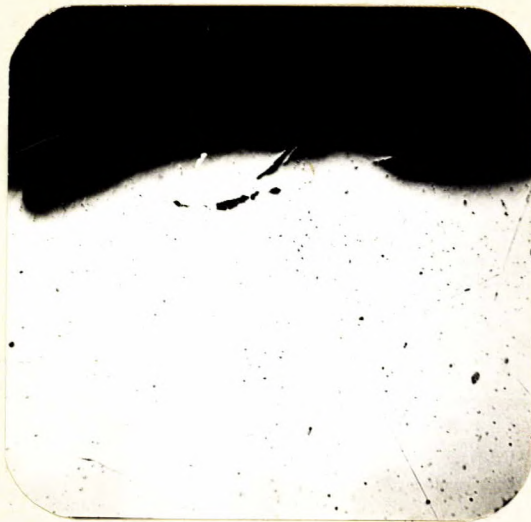
Figure 3.

A microscopic examination of the fractured tail gave no clue as to the cause of failure, beyond the presence of a large inclusion in the weld metal running at an angle of 45° to the tail edge. The lines of deformation at the edge of the fracture indicate good ductility of the metal and progressive tearing. The microscopic examination of sections of the tubing, however, reveals an area of lack of fusion at the root of the weld running at an angle of 45° to the edge. Of the twelve samples of the tubing, eleven show this type of defect. It is most probable that this defect is the cause of the failure of the bomb tail.

LARGE INCLUSION WITHIN WELD METAL
OF FRACTURED TAIL PIECE.

1. The edges of the strip should be cleaned with a wire brush or a grinding operation before welding. This would eliminate the slag inclusions and also one cause of lack of fusion.

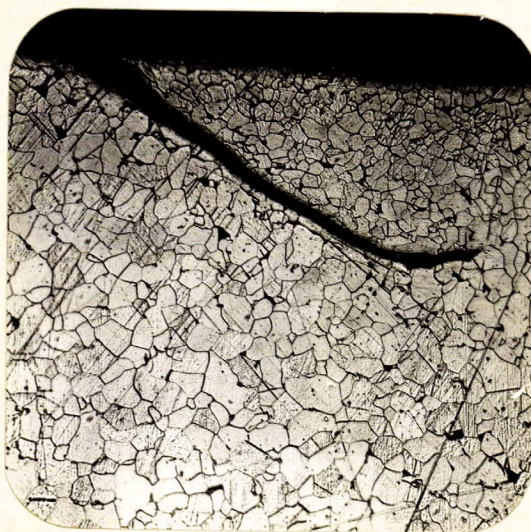
Figure 4.

It is not surprising that the microscopic examination of the fractured tail piece shows no evidence of this defect. Lack of fusion at the root of the weld is a potent stress raiser. This being the case, when the explosion of the propelling charge

2. The failure of the bomb tail was most probably due to lack of fusion at the root of the weld. This type of defect acts as a severe stress raiser and is therefore a fertile source of failure.

UNFUSED AREA AT ROOT OF WELD OF TUBING.

checked. It is probable that the welding current is too low.

This is the most frequent cause of lack of fusion.

The pressure rolls aligning the edges to be welded should be checked. It is possible that insufficient pressure is permitting the inner edges of the joint to be spaced too far apart.

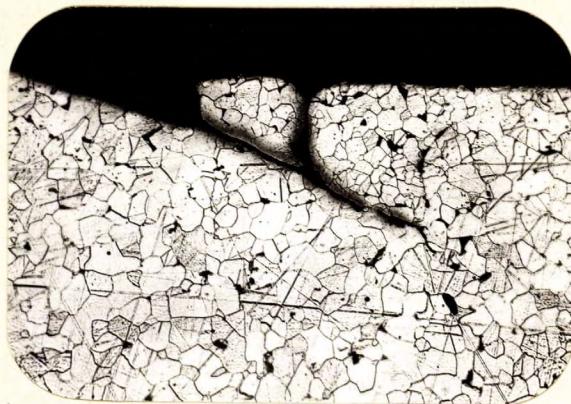
Figure 5.

UNFUSED AREA AT ROOT OF WELD OF TUBING.

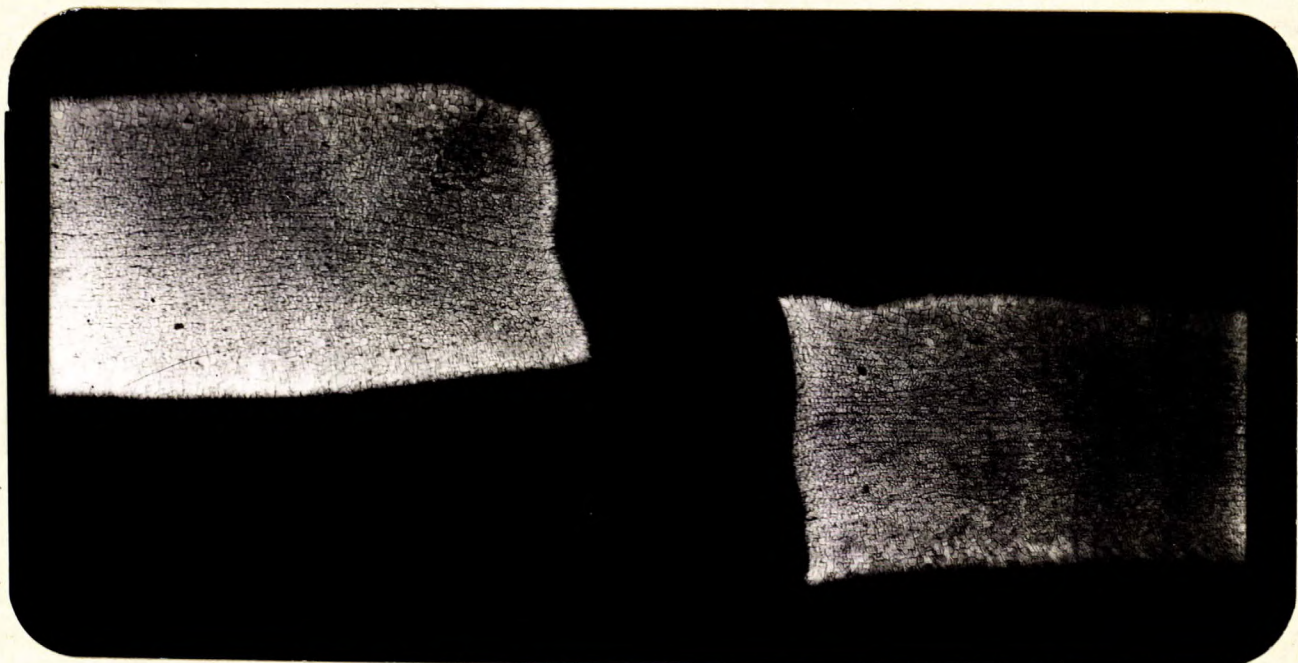
Figure 6.

A visual examination revealed no evidence as to the cause of the bomb tail failure. The appearance of the fracture indicates failure originating at a crack on the inside of the tail.

EDGES OF FRACTURE OF BOMB TAIL.

Note lines of deformation and
banded structure.

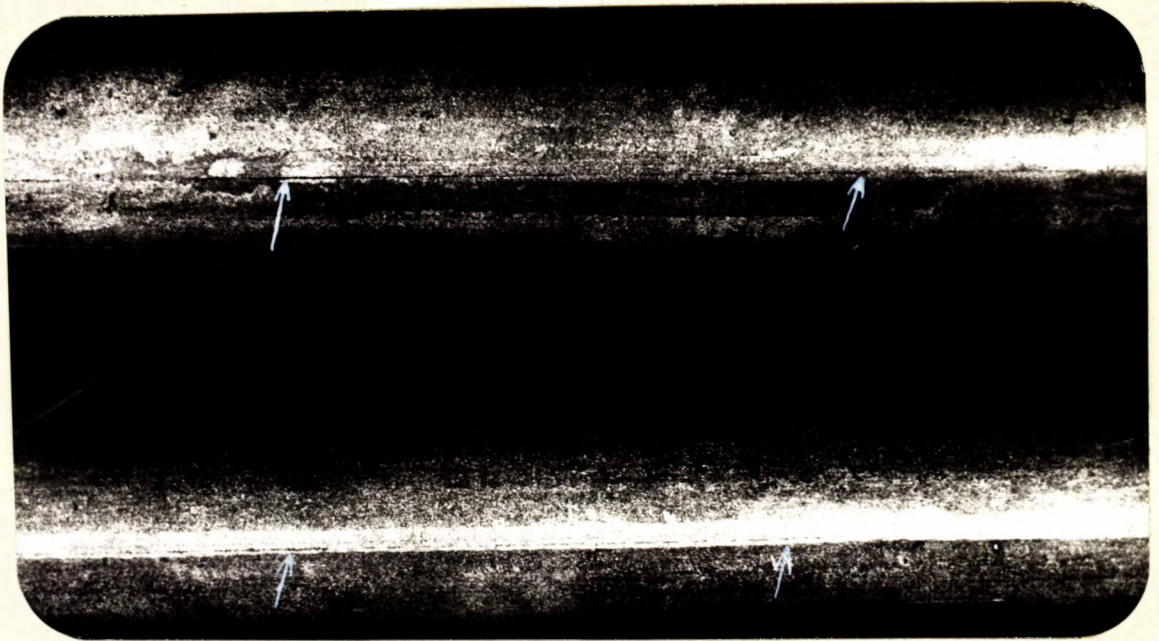
Figure 7.

(3) Two samples of tubing, selected at random, were pickled in a 50 per cent hydrochloric acid solution for 15 minutes at a temperature of 180° F. Figure 7 shows the appearance of the outside of the welds after this treatment. Numerous fine cracks may be seen on the weld surface. Figure 8 shows the unfused area at the roots of the welds.

OUTSIDE SURFACE OF WELDS OF TUBES AFTER
PICKLING IN HYDROCHLORIC ACID (HCl).

Note fine surface cracks.

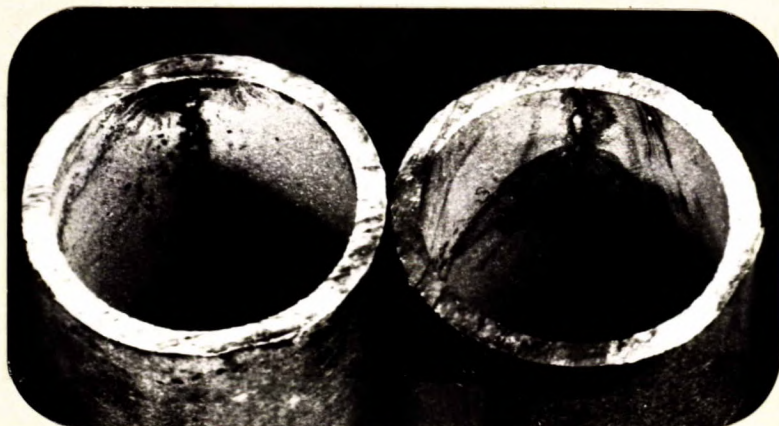
Figure 8.

INSIDE SURFACE OF WELDS OF TUBING AFTER PICKLING.

Note lack of fusion at root of weld.

The pronounced lack of fusion on the inside of the tubing is clearly visible and a rough check of material in stock would detect any tubing which might be satisfactory.
