March 7th, 1944.

ORE DRESSING AND METALLURGICAL LABORATORIES.

Investigation No. 1607.

Examination of Welded Feeder
Levers for Oerlikon Gun.

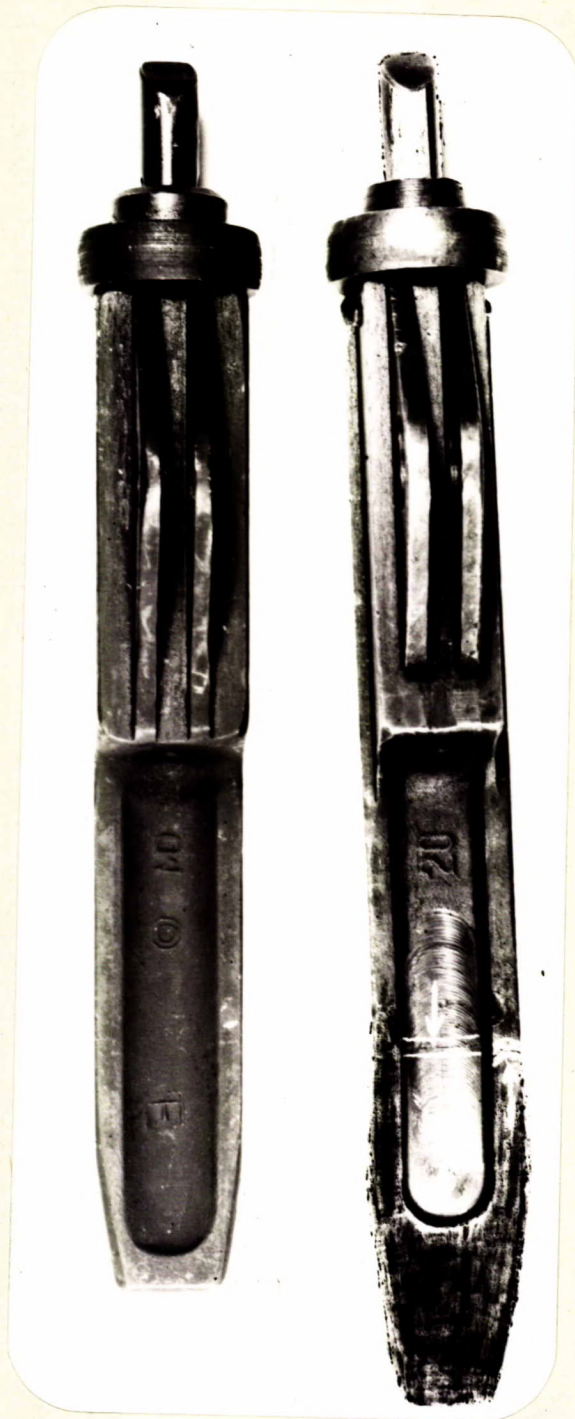
Figure 1.

(1) The two original and one welded (cracked) levers were given a careful visual examination. Figure 1 shows the original and the salvaged levers. Figure 2 is a close-up of the cracked area of the salvaged lever.

ORIGINAL AND SALVAGED LEVERS.

White lines indicate the areas of cracking.

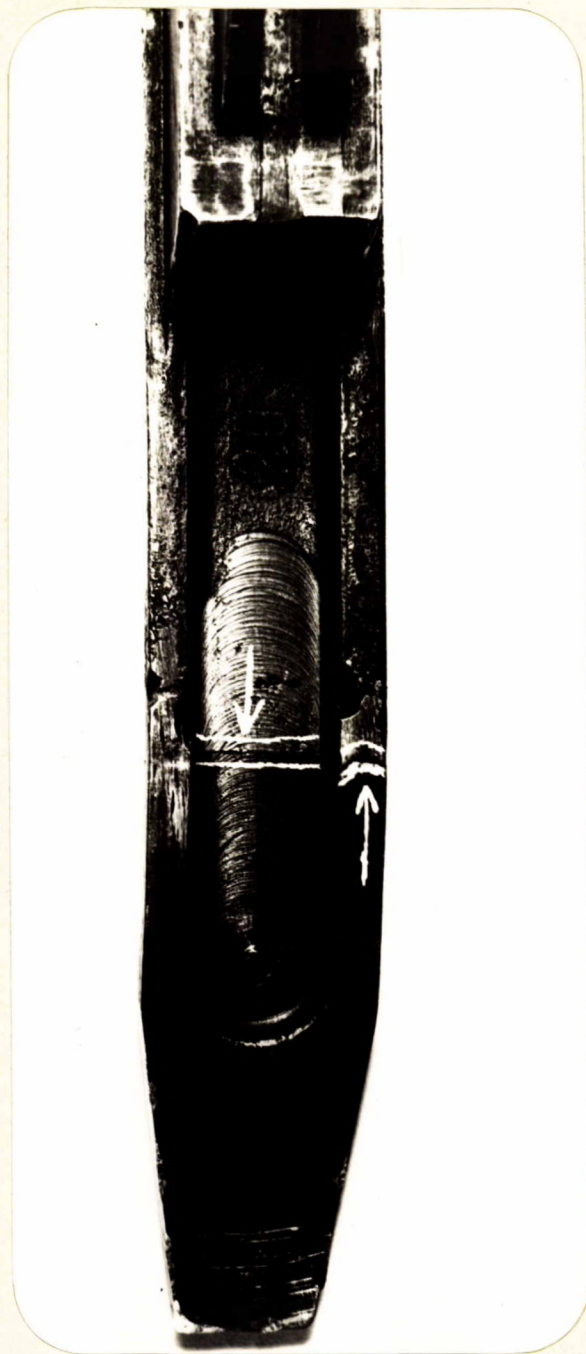
Figure 2.

A visual examination of the cracked lever reveals evidence of lack of complete penetration. Sections of this sample, examined under the microscope, confirm that this defect is present. It therefore seems highly probable that the cracking of this particular sample is due to the stress-raising effect of this defect. However, the widespread cracking of other levers

"CLOSE UP" OF CRACKED SALVAGED LEVER.

White arrow points to crack.

1. A sealing bead should be run on the back of the joint, to eliminate lack of fusion and incomplete penetration at the root of the weld. This sealing bead should be only thick enough to provide a small reinforcement, in order not to increase machining costs unduly.
2. After welding and subsequent machining, the levers should be normalized at 1550° F. for 1½ hours. This will eliminate any undesirable structure adjacent to the weld. This treatment can be made to serve a double purpose of normalizing and obtaining a gummetal finish. The levers, when the normalizing time has expired, can be cooled slowly to 1100° F. in the furnace and then oil-quenched. This treatment will produce the blue black oxide on the surface of the steel.

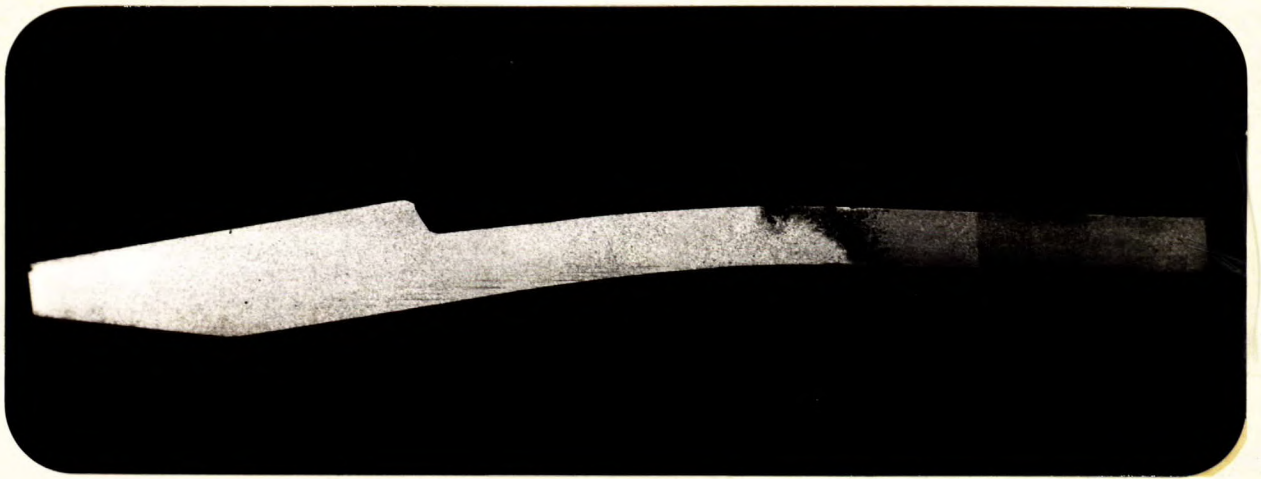
Figure 3.

(2) The cracked lever was sectioned through the centre in a longitudinal direction. Figure 3 shows this section after a light etch in 20 per cent nitric acid and alcohol solution.

LONGITUDINAL SECTION OF CRACKED LEVER.

Note crack and coarse-grained area in original lever material adjacent to weld.

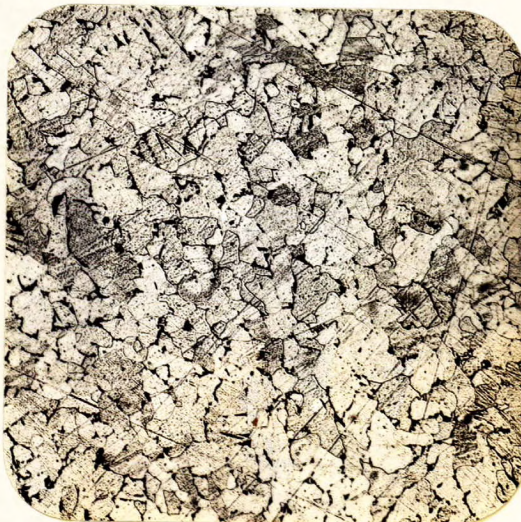
Figure 4.

The analysis of the extension material indicates that it is an SAE 1010 steel. The use of this material cannot be criticised, since it is too low in carbon and manganese contents to have a detrimental response to the thermal cycle of welding. The use of Airco No. 1 welding electrode cannot be criticised. The analysis given by its manufacturer indicates the development of physical properties fully adequate for this job. The analysis of the original lever material does not conform to any S.A.E., A.I.S.I., or N.E. grade of steel. The composition most closely approaches that of an SAE 1050 with 1 per cent nickel content. This steel in welding should be handled with caution since the carbon, manganese and nickel contents are conducive to making the steel sensitive to rapid cooling rates and, consequently, prone to brittleness.

NORMAL STRUCTURE OF SAE 1010 EXTENSION MATERIAL.

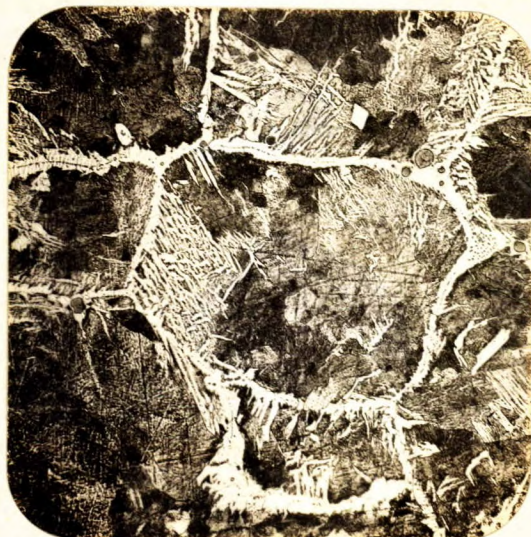
Figure 5.

As shown by the cracked sample, a coarse-grained Widmanstätten structure has been developed in the original lever material adjacent to the weld. This microstructure has a tendency towards brittleness and, assuming a sound weld, impact

may readily cause failure in the Widmanstätten area. This structure is the result of fairly rapid cooling through the critical range, and slightly higher cooling rates will result in the formation of hard, brittle martensite. This clearly indicates the necessity of a controlled process which will permit reproducible results from day to day independent of the human variable.

X100, etched in 2 per cent nital.
"
WIDMANSTATTEN STRUCTURE OF HEAT-AFFECTED
ZONE OF ORIGINAL LEVER MATERIAL.

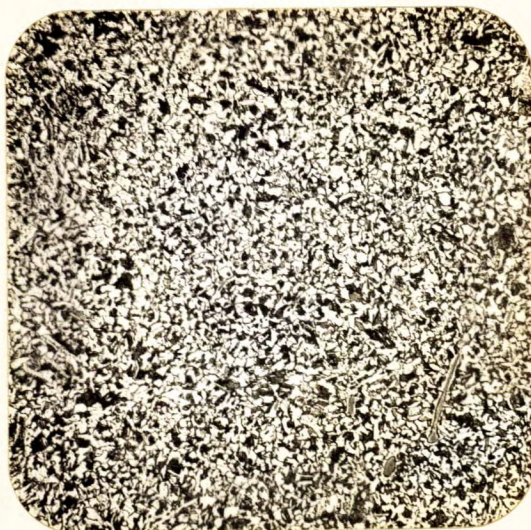
Figure 6.

X100, etched in 2 per cent nital.
NORMALIZED STRUCTURE OF NORMAL
ORIGINAL LEVER MATERIAL.
